Inspection Report

Inspection Date: 12/1/2010

Commercial Property Sample Report

All In One Home Inspection LLC

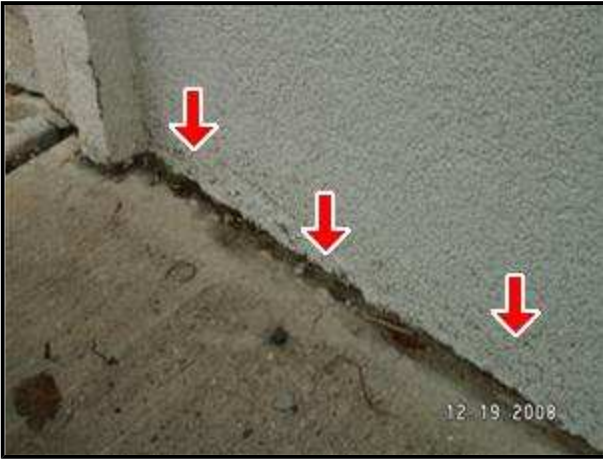
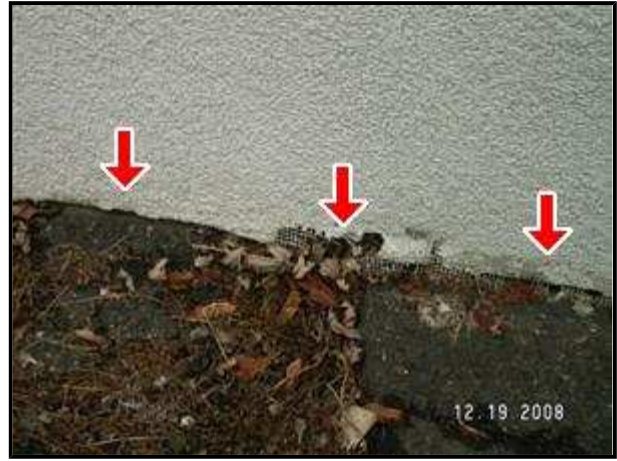
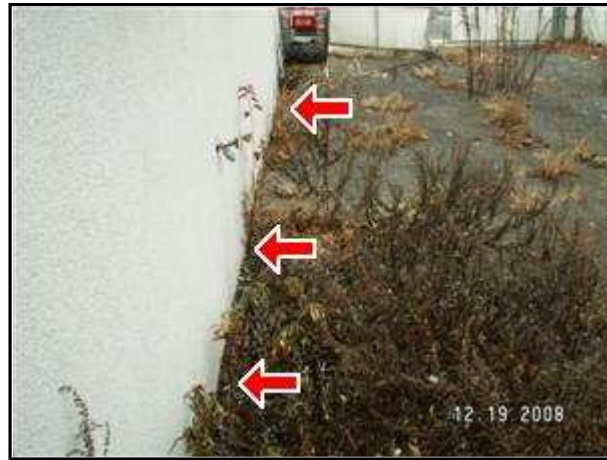
(2) EFIS siding should terminate 6" to 12" above grade level so it does not draw water up into wall. Water in the wall can lead to algae buildup on EFIS siding, mold buildup behind EFIS siding, and rot in wood siding and structural components. A lower trim piece called a drip screed is missing. The drip screed provides a finished edge, allows drainage and prevents water from being drawn up into wall. Evaluation and repair recommended by a qualified EFIS siding contractor.

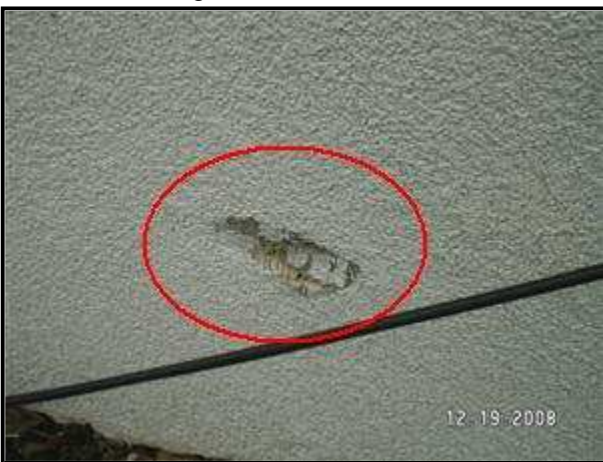
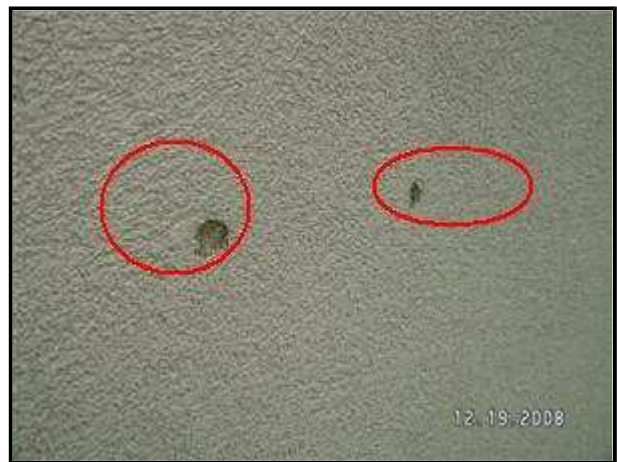
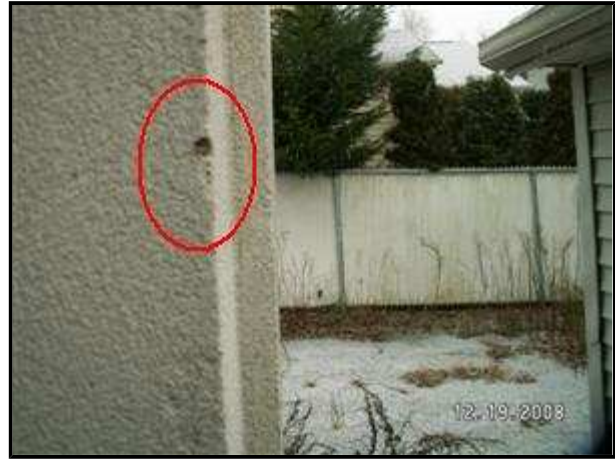
- 🏠 (3) The EFIS siding has nicks, dings or holes in several places. Repair siding to prevent the ingress of insects or moisture past siding to damage the interior spaces of home. Evaluation and repair recommended by a qualified EFIS siding contractor.

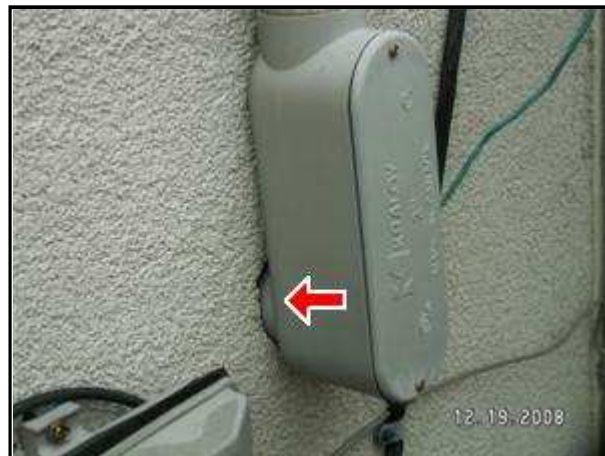
1.0 Picture 9

- 🏠 (5) The gap between the electrical conduit and siding needs closing off with sealant or liquid foam to prevent the ingress of moisture, insects and vermin.

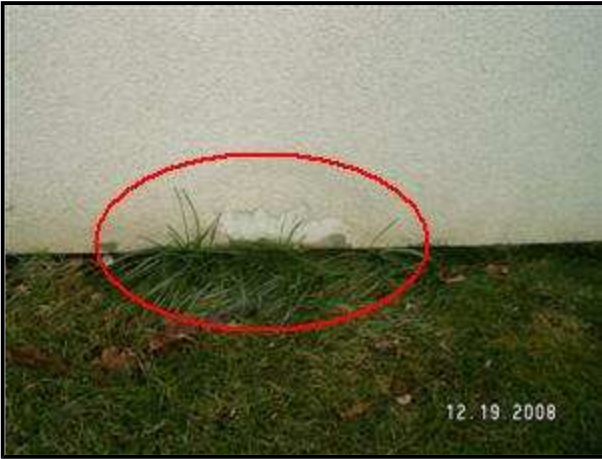
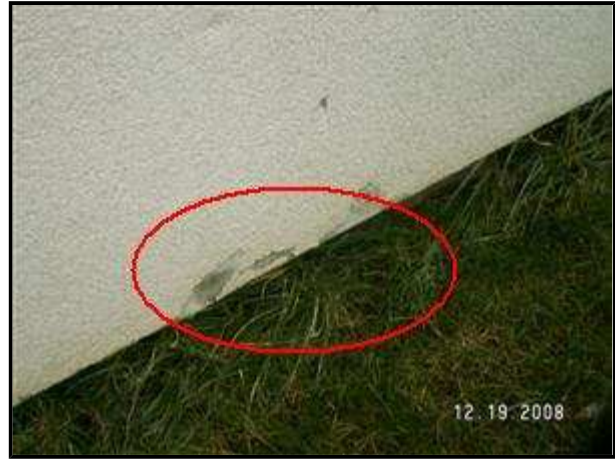
- 🏠 (6) EFIS siding at grade level is damaged from lawn maintenance equipment. EFIS siding should terminate 6" to 12" above grade level so it does not draw water up into wall. A lower trim piece called a drip screed is missing. The drip screed provides a finished edge, allows drainage and prevents water from being drawn up into wall. Evaluation and repair recommended by a qualified EFIS siding contractor.

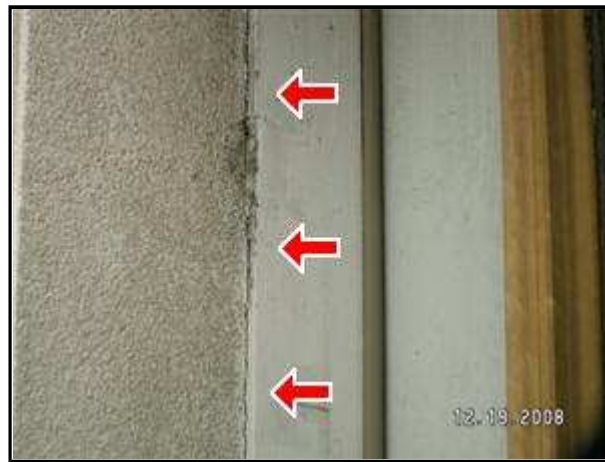
1.0 Picture 12

- 🏠 (7) The gaps and cracks where the EFIS siding meets the door and window frames caulked to prevent the ingress of damage causing moisture behind siding. Moisture behind siding can lead to rot and mold build up of siding and structural components.

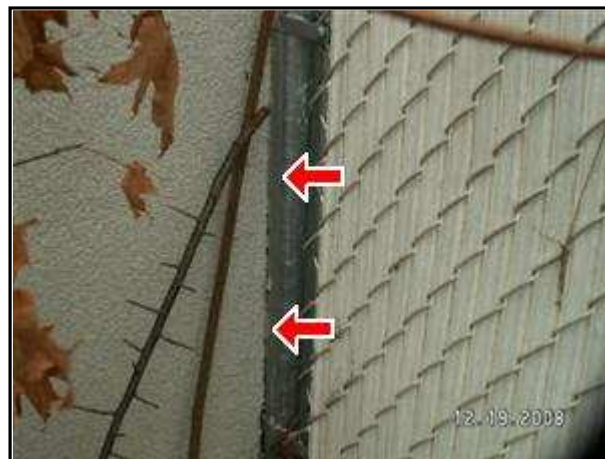
1.0 Picture 13

- 🏠 (8) The EFIS siding has been installed around the fence post. The gaps and cracks where the EFIS siding meets the fence post should be caulked to prevent the ingress of damage causing moisture behind siding. Moisture behind siding can lead to rot and mold build up of siding and structural components.

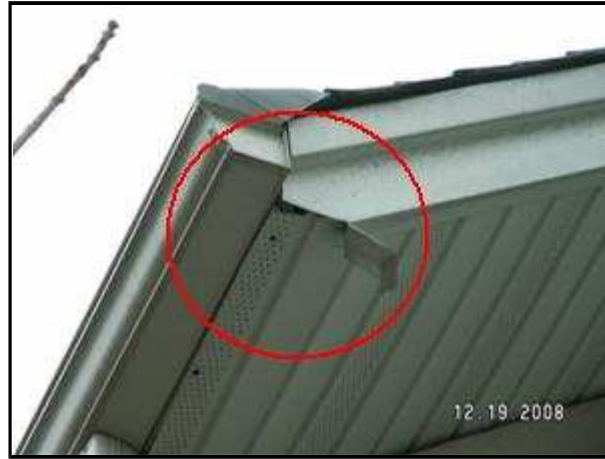
1.1 Picture 1

- 🏠 The eave trim is loose. Refasten trim to prevent ingress of moisture and insects to interior spaces.

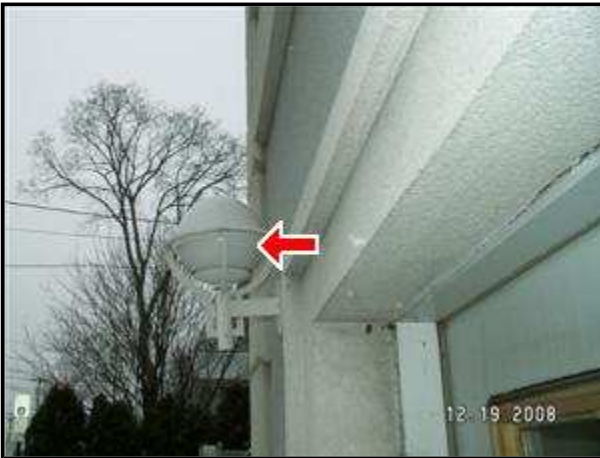
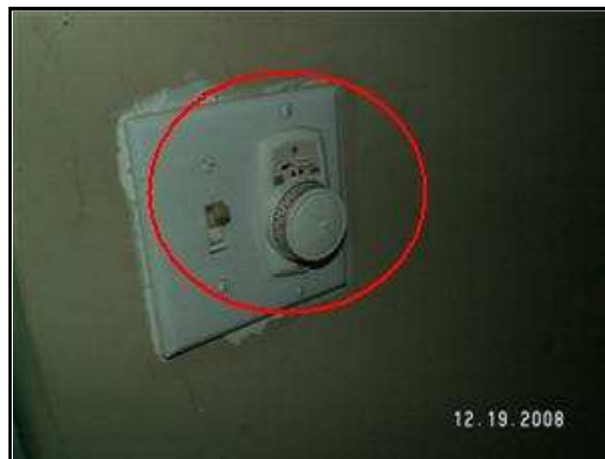
Exterior lights do not illuminate. The bulbs may be burned out, the switches broken or the lamp light sockets broken. Replace bulbs and try to operate lamp, otherwise repair recommended by a licensed electrician.

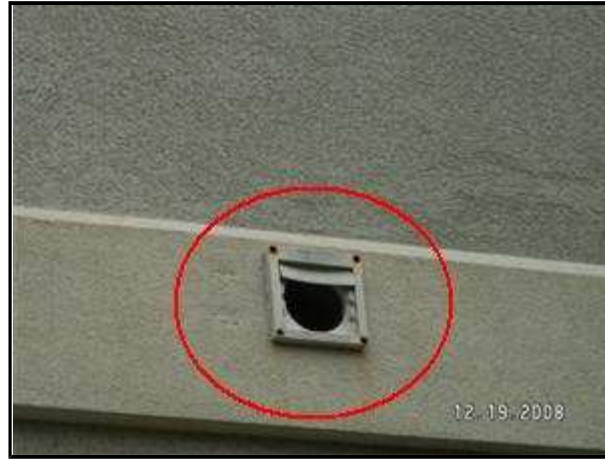
1.4 Picture 1

The exhaust vent is missing its flapper or louvers. Vermin and insect ingress past the vent opening is possible unless repaired or replaced by a qualified person or contractor.

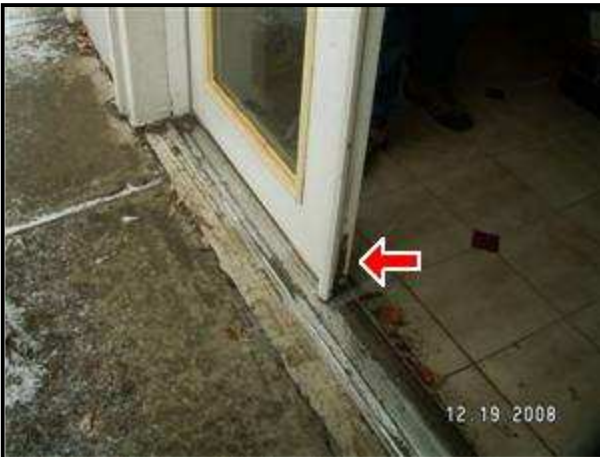
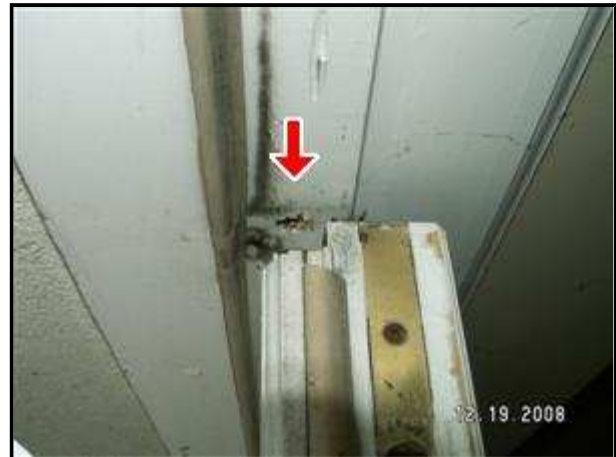
The door latch is stuck closed. Unable to open door at time of inspection. Recommend repair by a qualified person or contractor.

The striker plate is missing from the door frame. The door frame will become damaged trying to hold the door closed. Recommend replacement by qualified person or contractor.

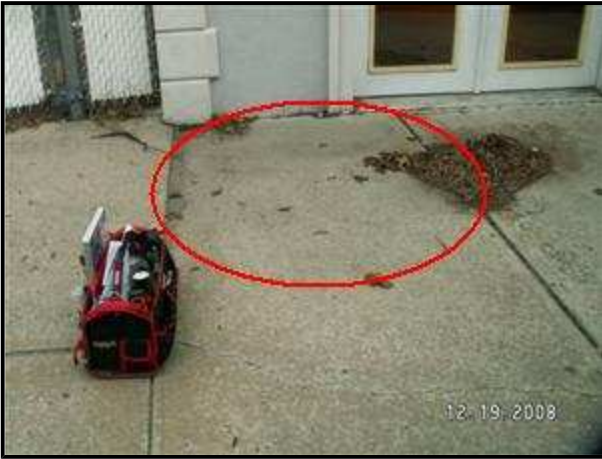
1.9 Picture 1

(1) The front walk has a low spot where water puddles by the front door. Puddling water may damage the nearby EFIS siding and seep past the front door sill. Dirt collecting at door sill may be wind driven or from splashing water on walk area. Puddled water by front door is a walking and slipping hazard. I recommend repairing the front walk so that water drains away.

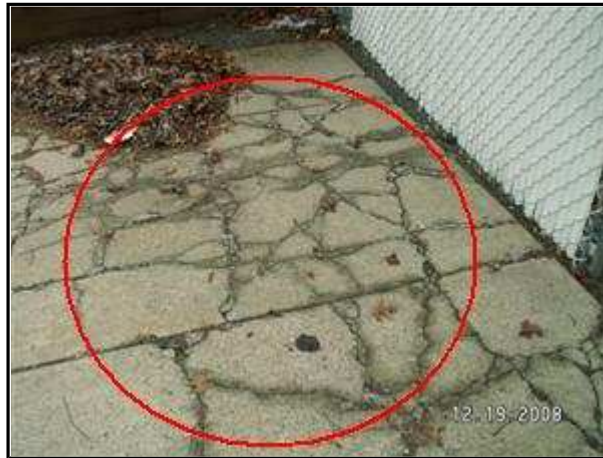
1.9 Picture 3

(2) The walk has cracks and is uneven. Tripping hazard present. I recommend repair by a qualified contractor.

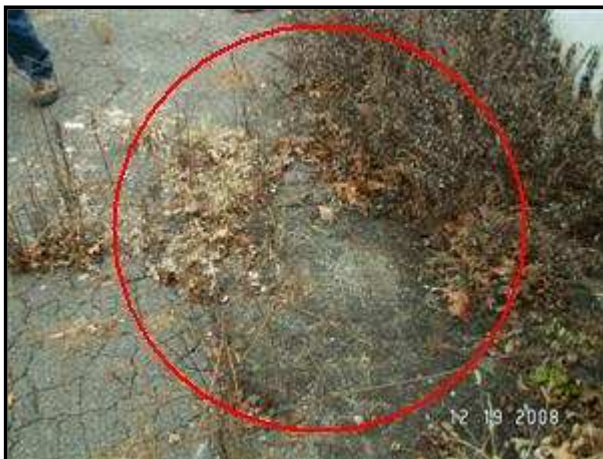
1.10 Picture 1

(1) The driveway is cracked, pitted and crumbling. Slipping and tripping hazards are present. Driveway is in need of replacement.

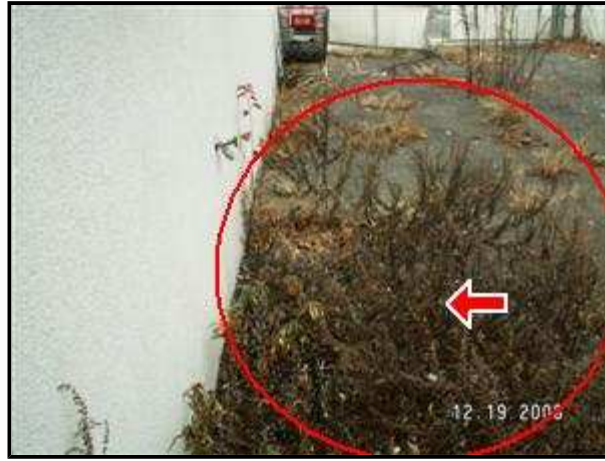
1.10 Picture 3

(2) Driveway overgrown with weeds. Recommend removal to prevent tripping hazards. The weeds are growing up between cracks in driveway. Recommend replacing driveway to prevent further weed growth.

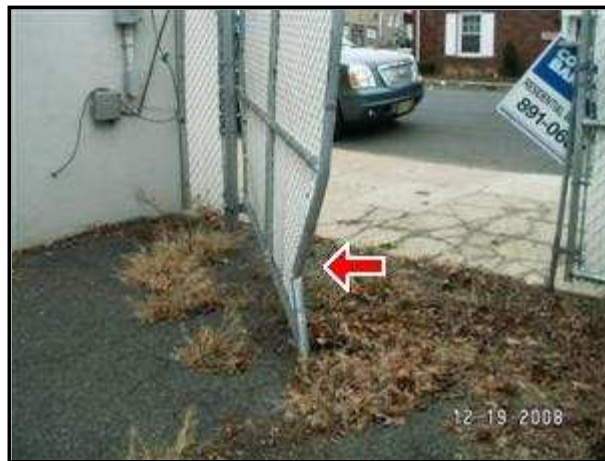
1.13 Picture 1

The fencing gate is damaged. The gate is in need of repair to swing closed and latch for security. Recommend repair or replacement by a qualified fence contractor.

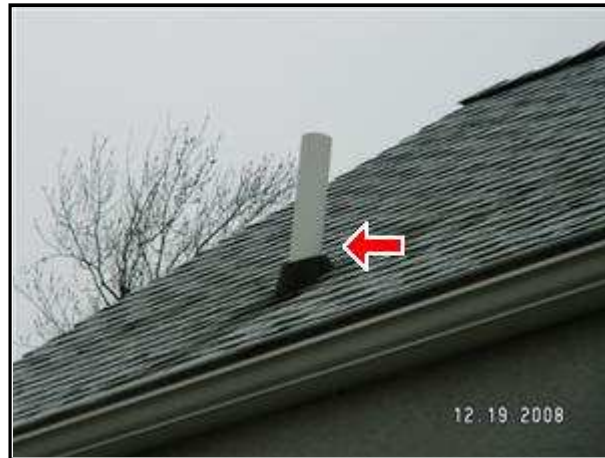
2.2 Picture 1

- 🏠 The flashing boot around the plumbing vent pipe appears to be pushed in. The flashing boot may collect and seep moisture into the attic and interior spaces of home. The flashing around the plumbing vent needs repair.

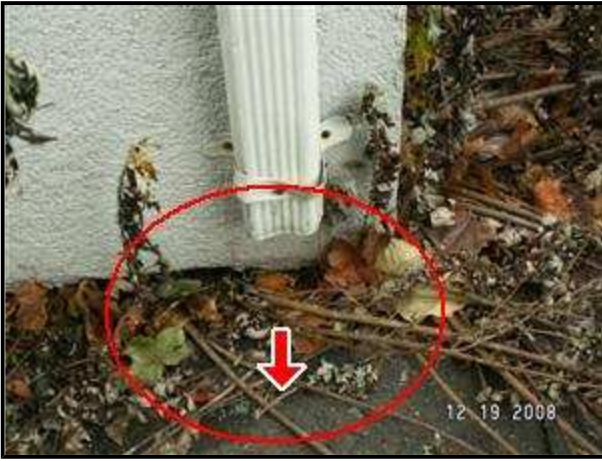
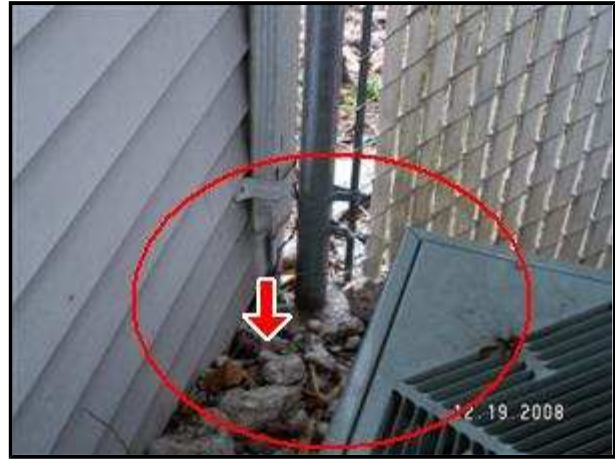
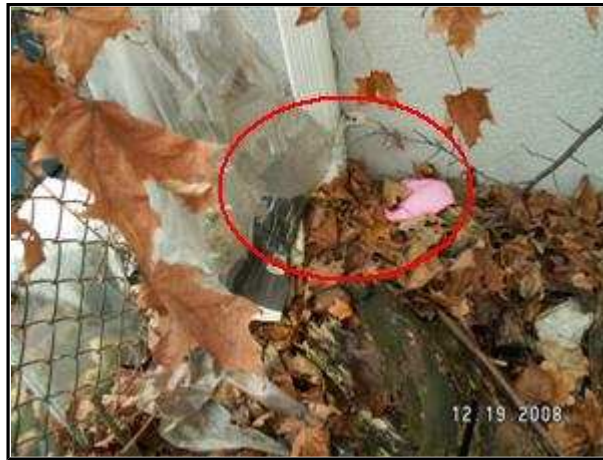
- 🏠 (1) Drainage around downspout and leader appears to puddle against foundation. Puddling against foundation can cause damage to structure and leakage into basement or crawlspace areas. Recommend regrading earth around structure and/or extending leaders to carry rain water further from foundation area.

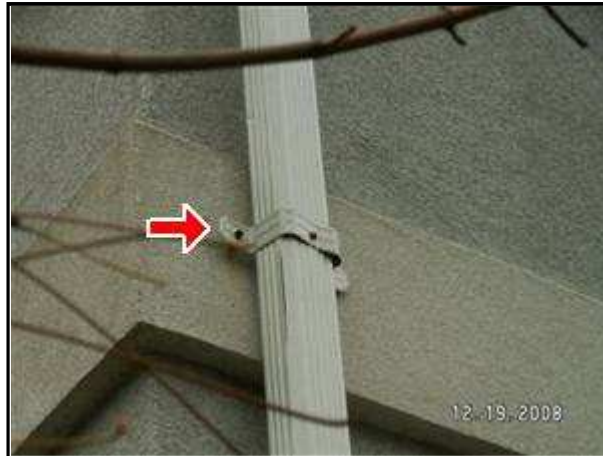
2.4 Picture 4

- 🏠 (2) Downspout brackets are loose in several places leaving the downspouts with limited support. Repair brackets so that downspouts remain in place.

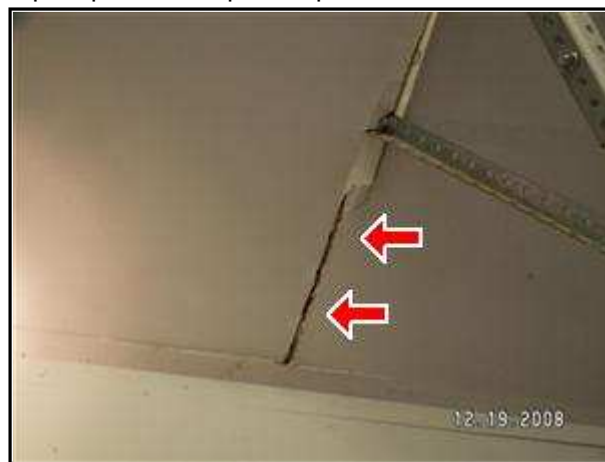
3.0 Picture 1

Cracks in the sheet rock in of tape, spackle and paint repairs.

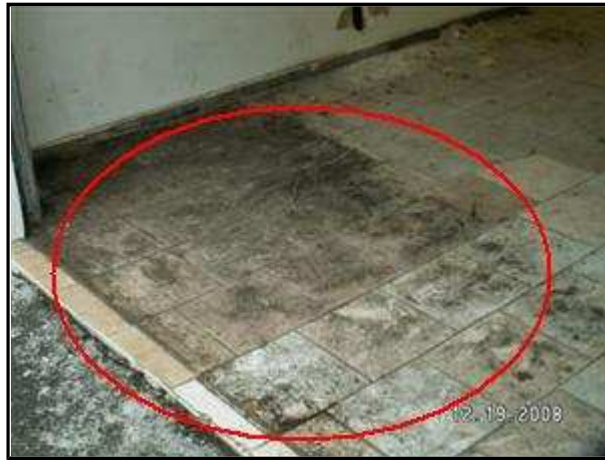
3.2 Picture 1

Signs of debris and moisture stains present on garage floors. The garage door may have been left open for the

collection of debris. Repair door seals and drainage around front of garage door to prevent further moisture penetration. The garage door may have been left open for the collection of debris.

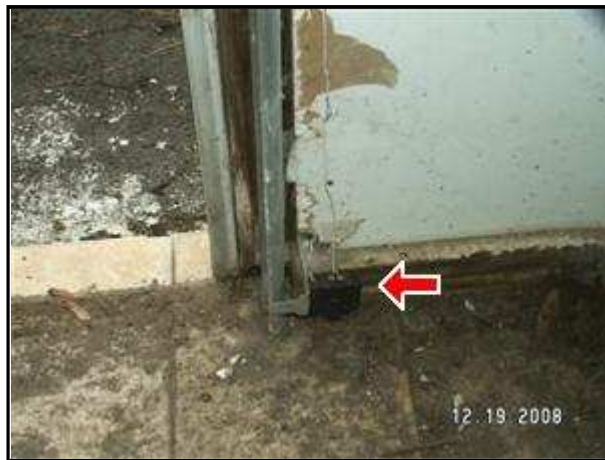
3.4 Picture 1

- 🏠 (1) Left Side - The safety beam is not mounted on wall. The garage door does not want to close when operated. Repair needed for safety and normal operation of garage door.

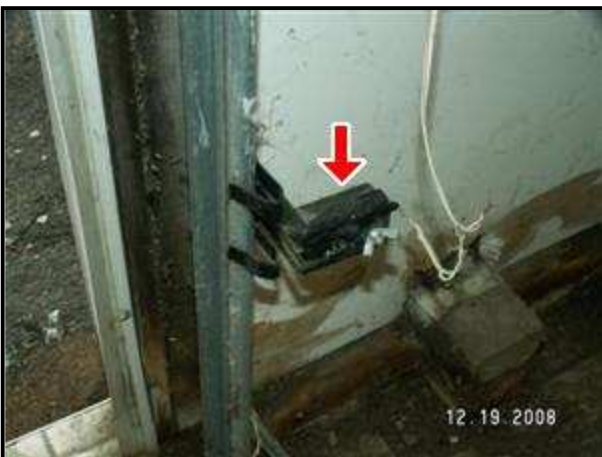
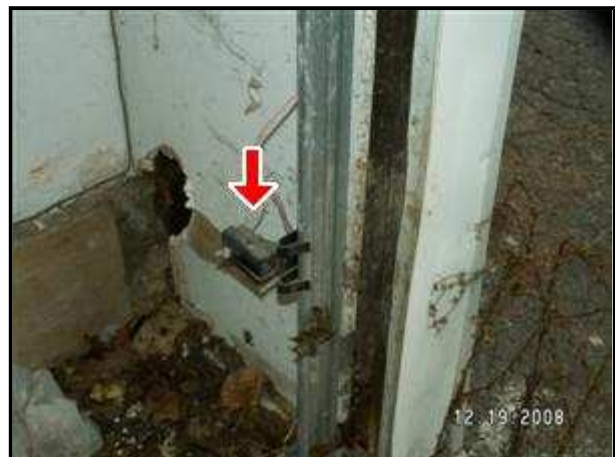
- 🏠 (2) Right Side - The automatic door opener safety beam is out of alignment or has a dirty sensor lens causing the garage door to not close. The beam needs to be realigned or repaired to allow normal opening and closing.

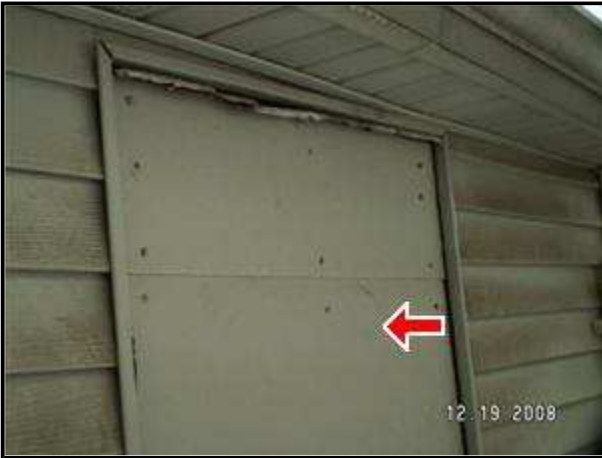
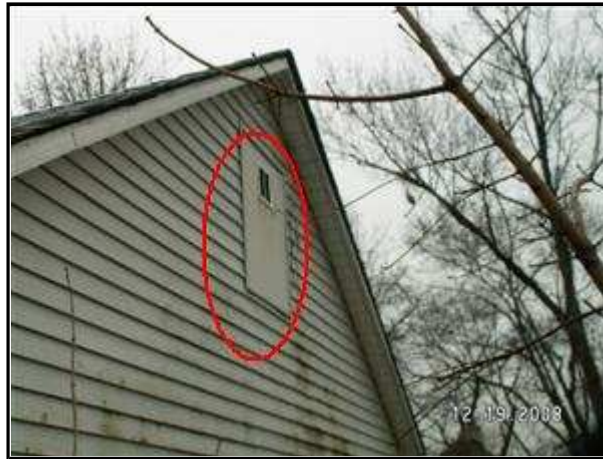
- 🏠 Windows have been secured with a material that does not appear to be a traditional exterior siding material. Recommend evaluation and repair by a qualified siding contractor or general contractor.

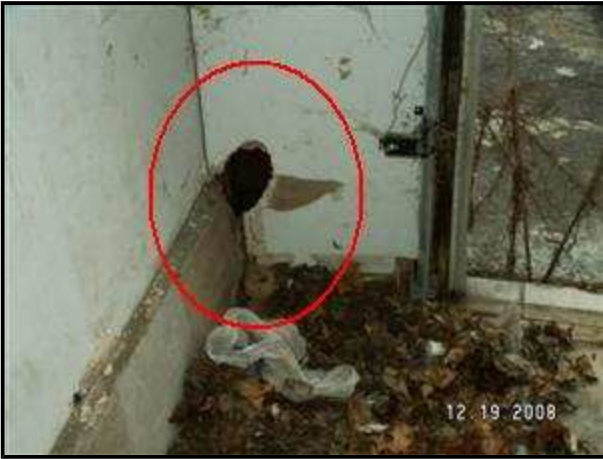
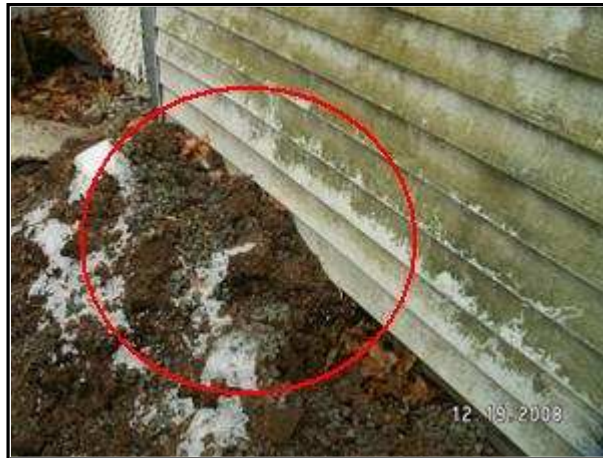
- 🏠 (1) Vermin damage present in several areas around foundation. Vermin have dug through earth to enter closed garage area. Sills, framing and sheet rock walls have been damaged. Rot present in sill boards along back wall. Recommend evaluation and repair of sills, walls and framing by a general contractor. Recommend removal of vermin by a qualified pest control contractor.

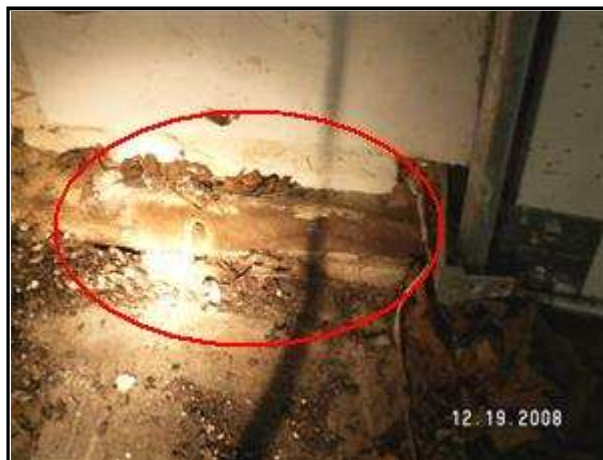
3.9 Picture 4

- 🏠 (2) The sill plate in the left front corner is rotted and crushed. Signs of wood destroying insect damage present. Sill plates are in need of evaluation and repair by a general contractor. Recommend treatment for the control of wood destroying insects.

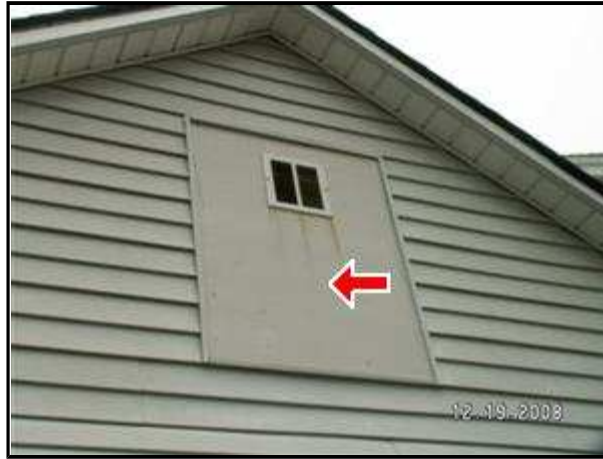
3.9 Picture 5

- 🏠 (3) The attic access is sealed, the attic was not observable at time of inspection. Recommend installing an attic access hatch.

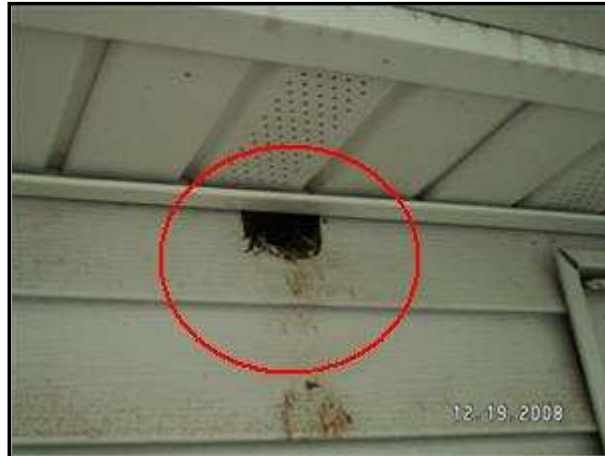
3.10 Picture 1

- 🏠 (1) Birds nest present in exterior wall of garage. Recommend nest removal and siding repair by a qualified siding contractor.

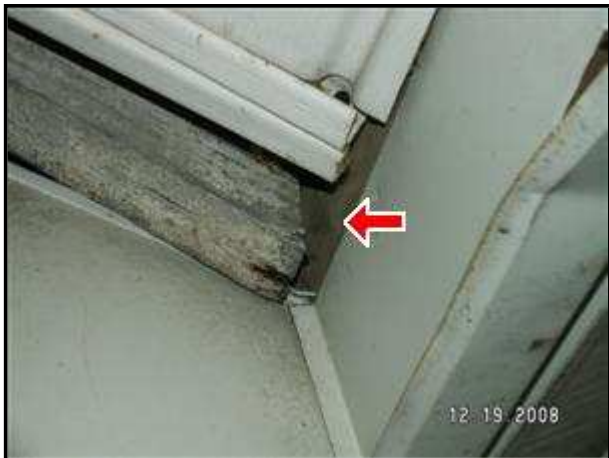
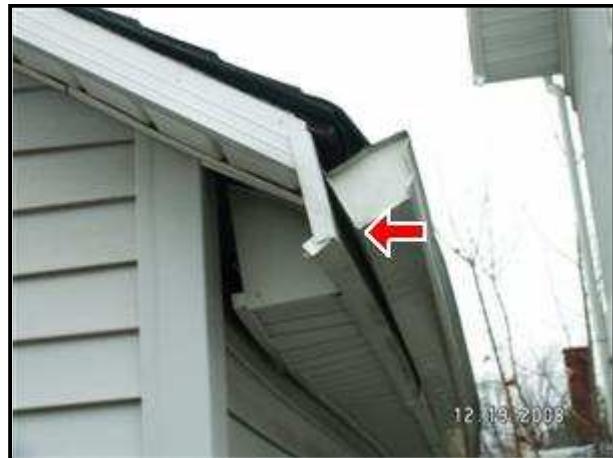
- 🏠 (2) The fascia board is detached and lifting from ends of roof rafters. The fascia board appears to be lifting enough to damage and twist gutters. The fascia needs to be reattached and the gutter refastened for proper roof drainage to occur.

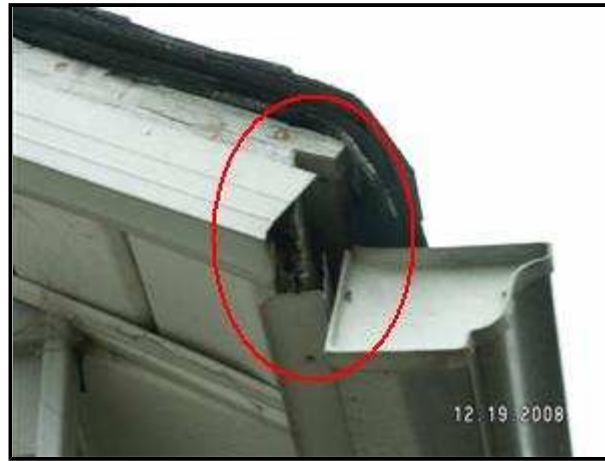
3.10 Picture 4

- 🏠 (3) The eave trim is missing, the fascia board appears rotted and weathered. Refasten trim to prevent ingress of damage causing moisture and insects to interior spaces.

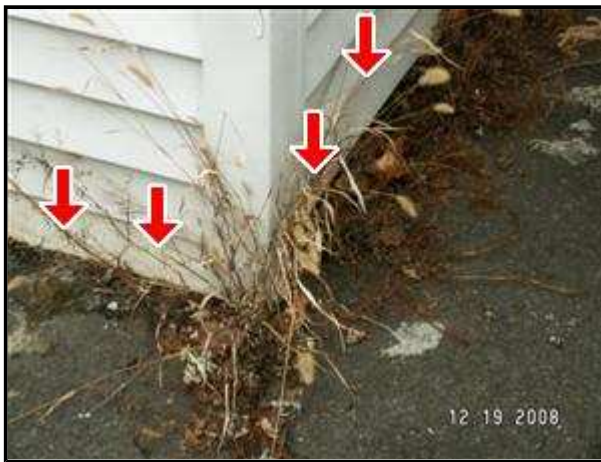
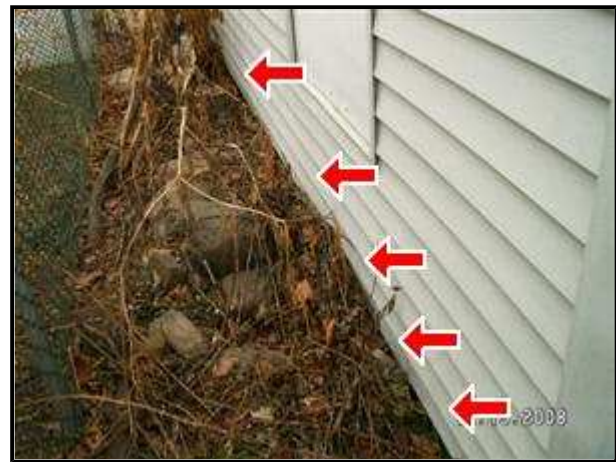
- 🏠 (4) Vinyl siding below grade level. Siding below grade level will remain moist and be a path for the entrance of Wood Destroying Insects (WDI). Re-grade earth around garage so that siding is above soil/debris and a some foundation is exposed making it more difficult for WDI to enter.

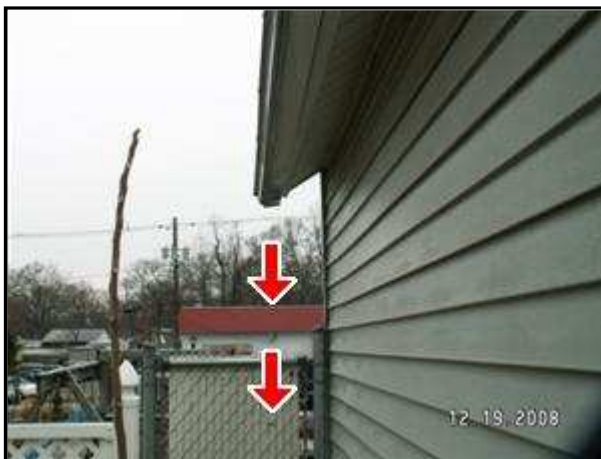
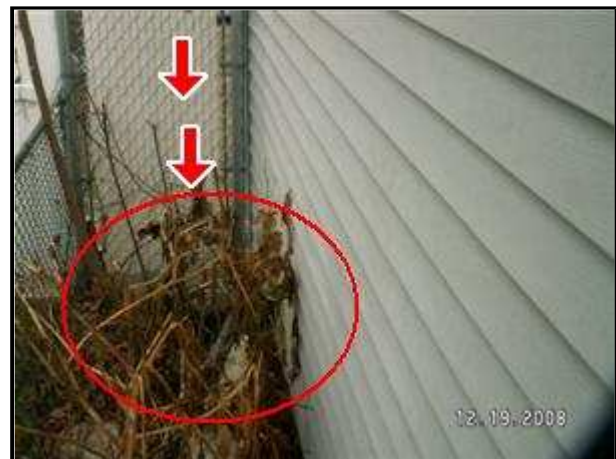
- 🏠 (5) Downspouts are missing. Water may run down siding, splash against foundation and puddle against foundation during rain storms. Puddling water against foundation may leak into basement causing moisture damage. Downspout repair is recommended.

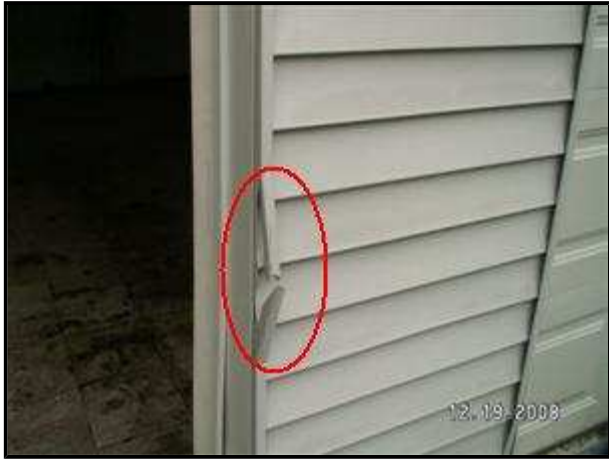
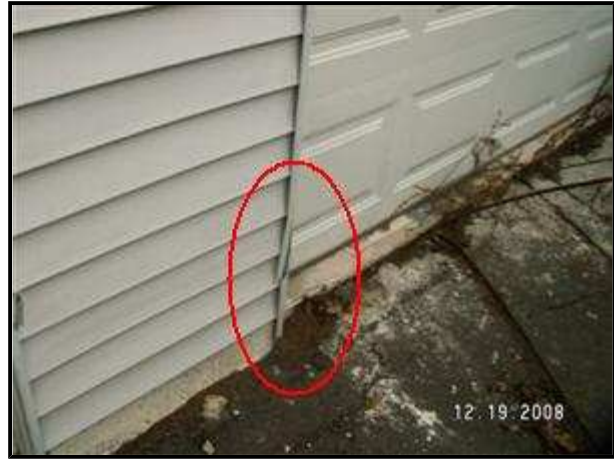
- 🏠 (6) Garage door trim is damaged. The door trim helps hold siding in place and helps guide rain running down siding. Trim is in need of replacement by a qualified siding contractor.

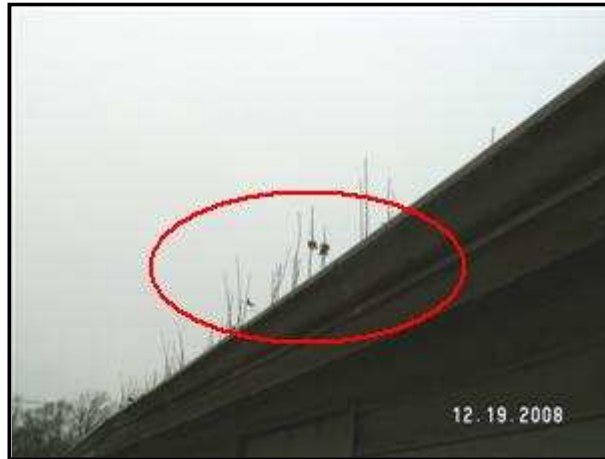
3.10 Picture 11

(7) The gutters are full of debris in areas and needs to be cleaned. Debris in gutters are blocking downspouts, causing gutter overflows and rain splatter onto siding and foundation. Cleaning of gutters is recommended to prevent unwanted water damage to exterior and interior of home. Consider installing gutter guards to help prevent build up of debris in gutters.

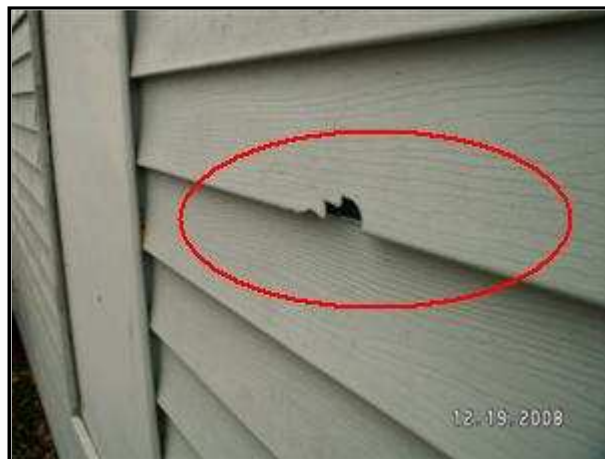
3.10 Picture 12

(8) The holes in the siding should be repaired or replaced by a qualified siding contractor to prevent the ingress of moisture, insects or vermin.

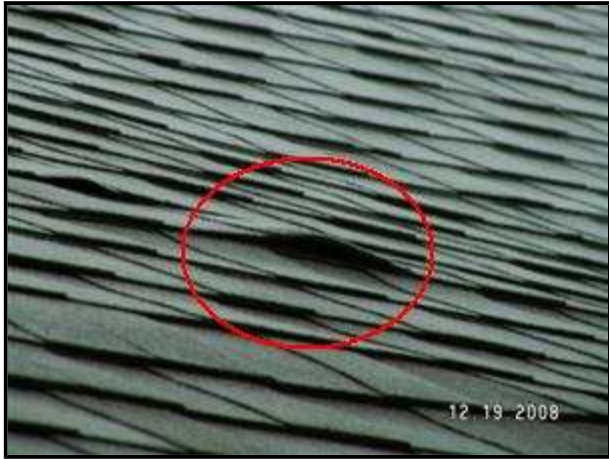
3.10 Picture 13

(9) Several fasteners are popped up under the shingles of the roof's surface. These fasteners should be driven back down before they puncture through the overlaying shingle, shortening the life of the shingles and causing leakage. I recommend repair by a qualified roofing contractor.

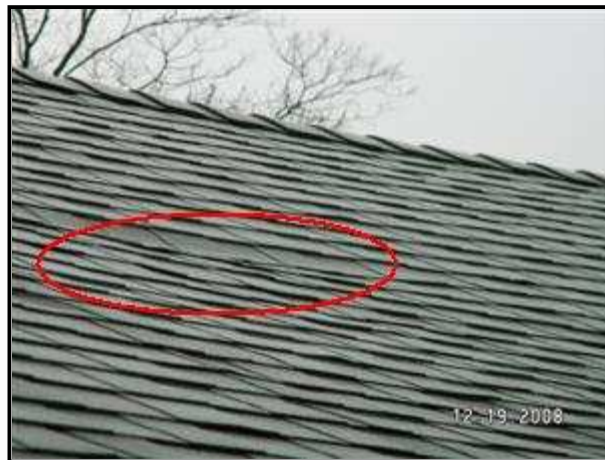
3.10 Picture 15

(10) An area of roof sheathing appears to be soft, settled or missing. Unable to observe sheathing from attic space. Recommend evaluation and repair by a qualified roofing contractor.

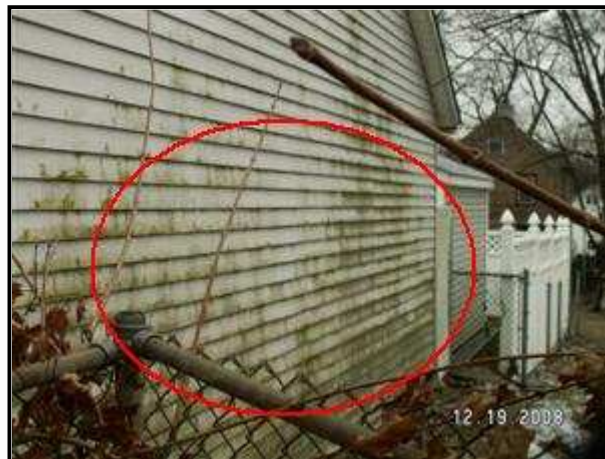
3.10 Picture 16

(11) The siding is covered with algae. This side of the home appears to be in the shade and the air seems to hold humidity for algae to form. Recommend periodic cleaning.

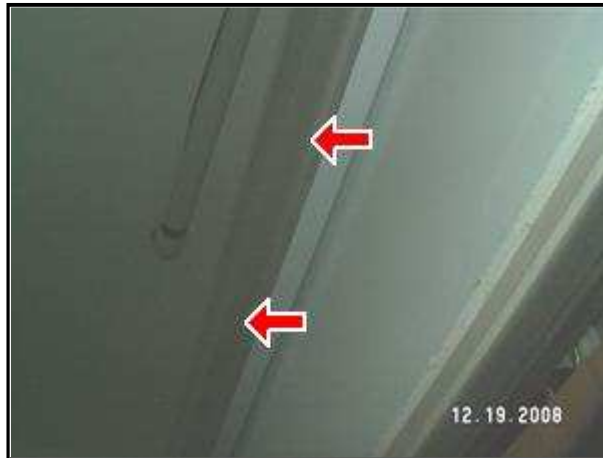
4.5 Picture 1

The light was not working. Either the bulb is burned out or the electrical circuit is in need of repair. Replace bulb, otherwise make repairs with a licensed electrician.

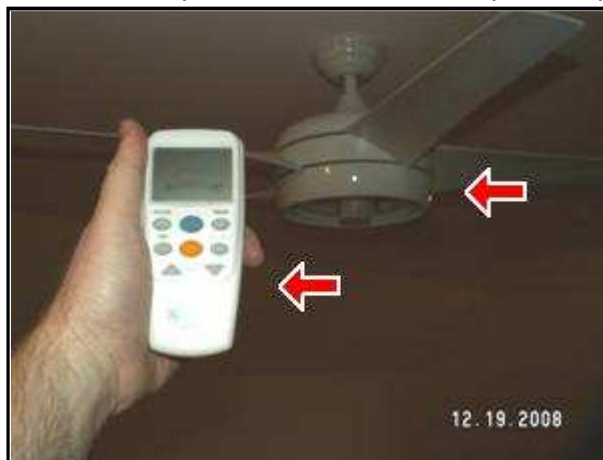
4.9 Picture 1

The ceiling fan was inoperative at time of inspection. The fan needs repair or replacement.

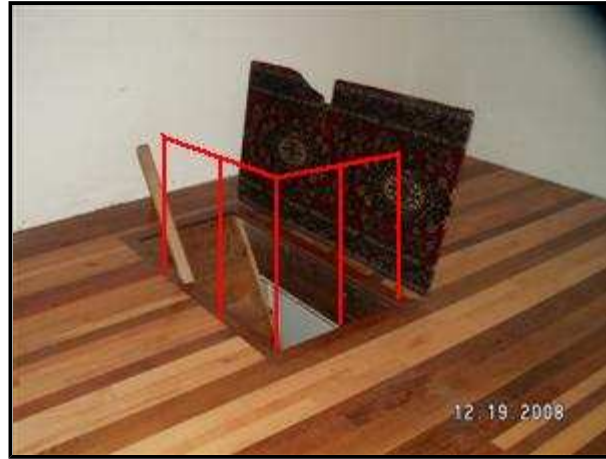
4.10 Picture 1

(1) The hand/guard rail for the stairs is missing. A fall or injury could occur if not corrected. A handrail should be installed for safety.

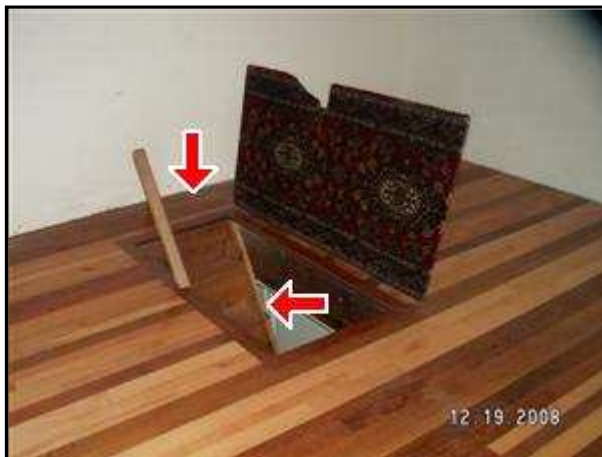
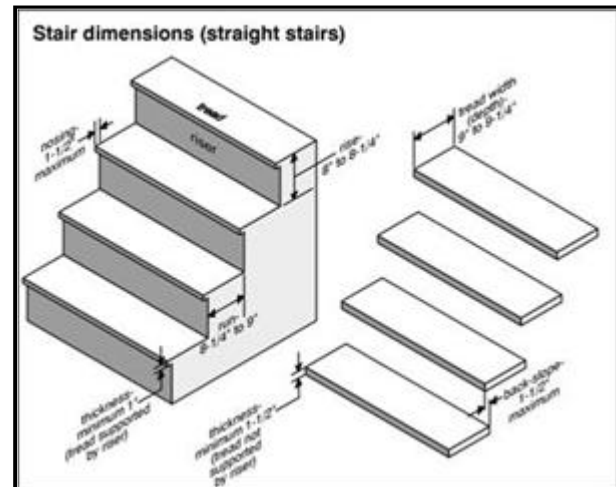
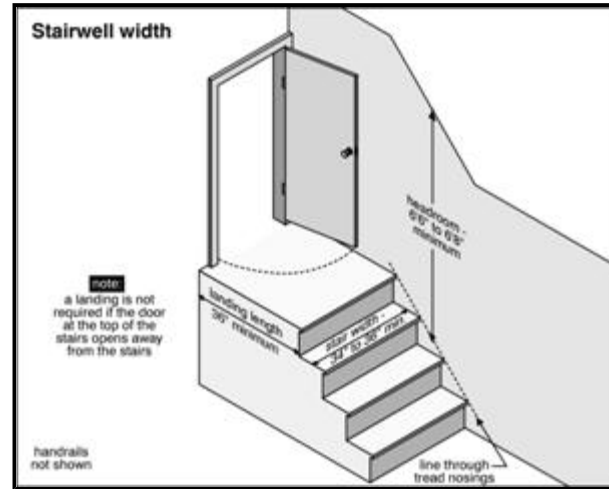
Falling hazards are present due to steepness, head clearance and landing width. Evaluation and repair recommended by a general contractor for safety.

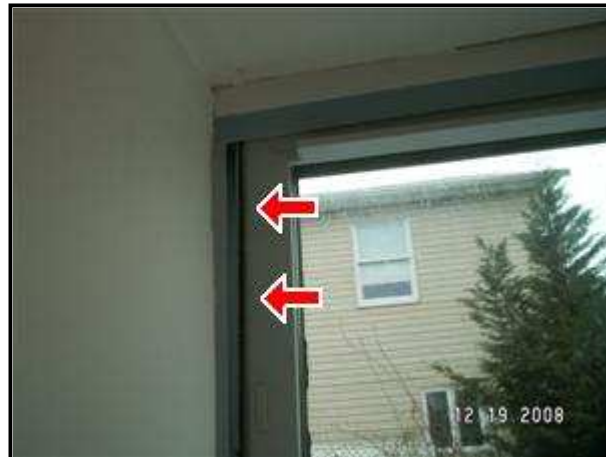
4.15 Picture 1

- 🏠 (1) The bathroom window is undersized for the frame. When the window slides up and down it gets loose in the frame and has gaps and openings that appear, ingress of moisture and insects past window is possible. The window needs repair or replacement by a qualified window contractor.

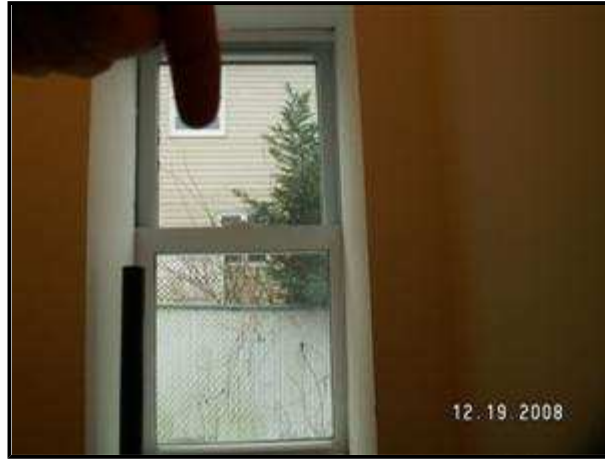
4.15 Picture 2

- 🏠 (2) Upper window sashes broken, windows drop uncontrollably, safety hazard. Recommend repair or replacement.

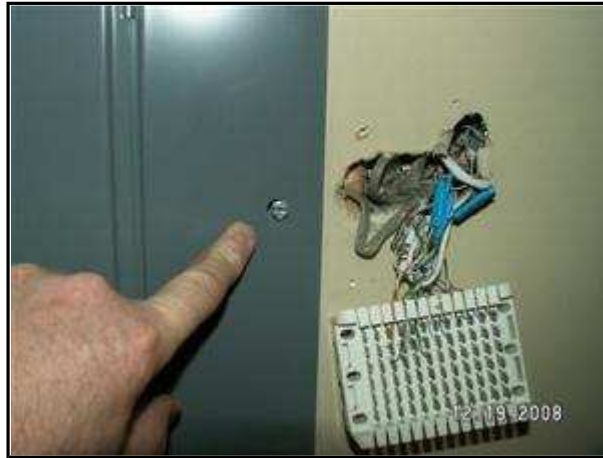
5.1 Picture 1

- 🏠 (1) Panel cover fasteners are undersized, sharp and pointy posing an electrical fire and safety hazard. The panel cover is not firmly fastened to the electrical panel. Screws may penetrate panel wiring when the cover is refastened. Wires resting against pointed screws may poke through insulation over time to cause a short circuit when least expected. Recommend replacement with the manufacturers recommended fastener, usually a screw with a blunt threaded end.

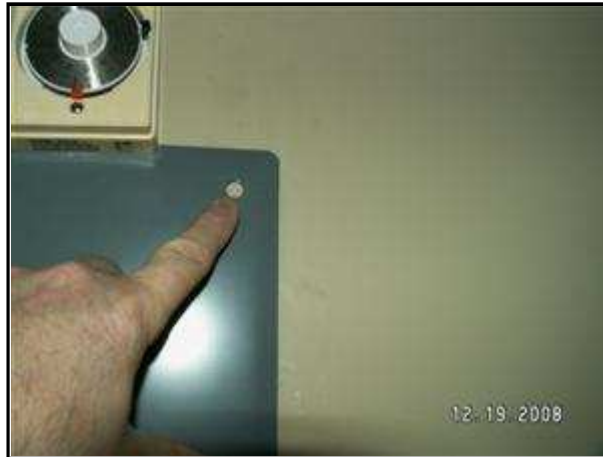
5.1 Picture 2

- 🏠 (2) Fasteners are missing that hold the electrical panel cover to the circuit breaker box. A safety hazard exists because the cover is not fastened securely and may fall off. An electrical shock hazard exists because the cover is not bonded (grounded) directly to the electric breaker box, a layer of sheetrock is between the cover and electrical panel cover. I recommend evaluation and repair by a licensed electrician.

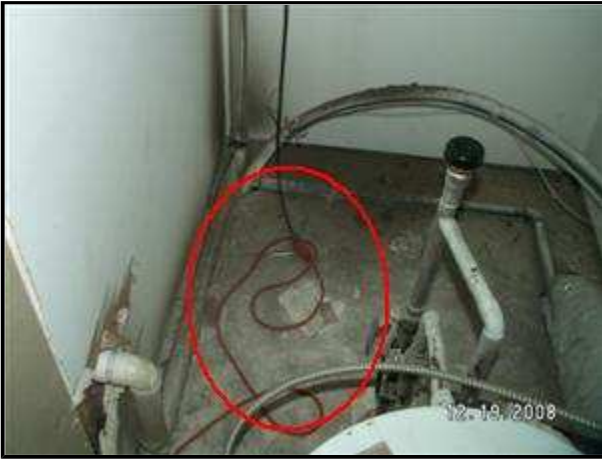
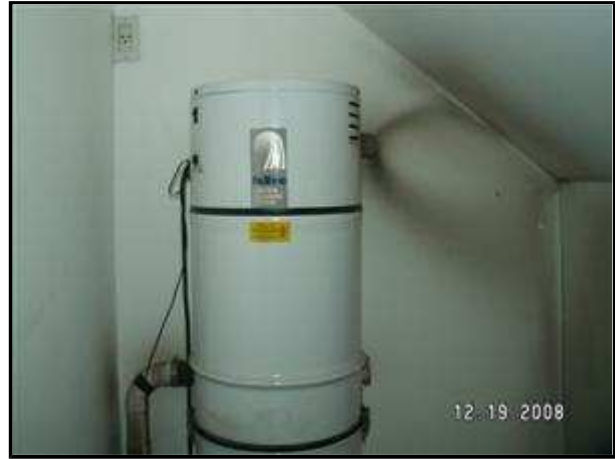
- 🏠 Extension cords should not be permanently installed as an outlet, remove for electrical and fire safety. I recommend an electrician install a local outlet near the vacuum.

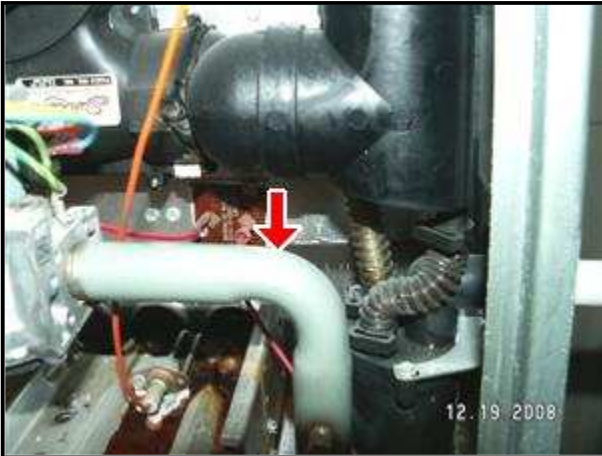
7.0 Picture 1

- █ A leak is present in the exhaust piping of the furnace. The leak is causing rust and corrosion of the furnace burner and cabinet assembly. Moisture is dripping from the furnace cabinet onto the utility closet floor. The floor is becoming damaged from moisture. Moisture is dripping back through the furnace exhaust either from flue gas condensation or a leak (installed intake and exhaust reversed?) in the exterior vent pipe. I recommend evaluation and repair by a qualified HVAC technician.

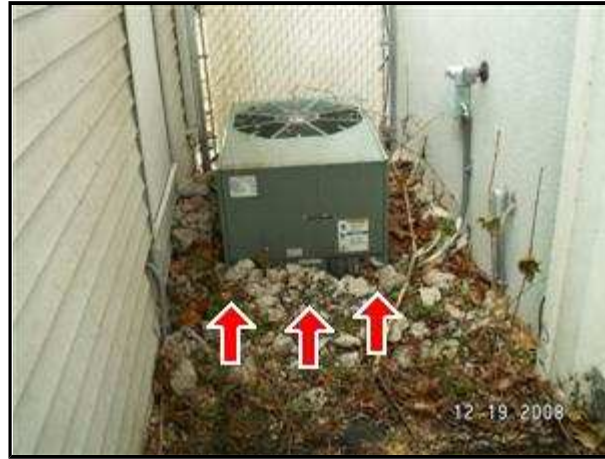
7.3 Picture 1

- (1) The A/C systems were not tested for proper operation due to the outside air temperature being 55 degrees or less. Operating AC systems in cold weather may lead to compressor damage. Consult with the home owner as to the last date of operation and service. Consult with your attorney on how to minimize the risk of the AC systems not operating when warm weather returns.
- █ (2) Debris from the garden and yard cover the base of the AC condenser. Debris will trap moisture against metallic surfaces to promote rust and corrosion. Debris in cooling fins will reduce cooling efficiency. I recommend placing the AC condenser(s) on a pad and regrading garden surfaces to keep condensers free of garden and yard debris.

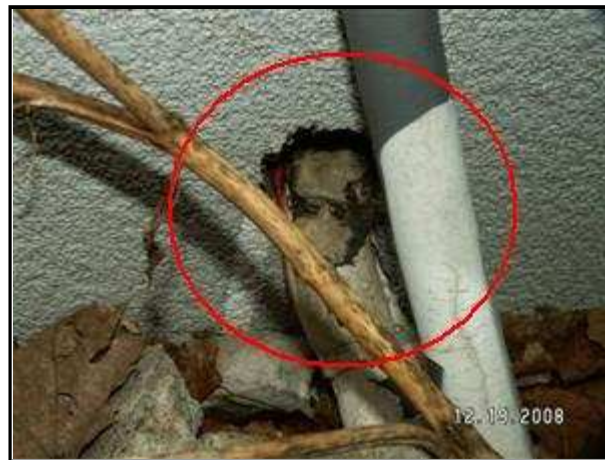
7.3 Picture 2

- 🏠 (3) The holes where the refrigerant lines pass through the siding should be sealed and plugged to prevent the ingress of moisture, insects and vermin.

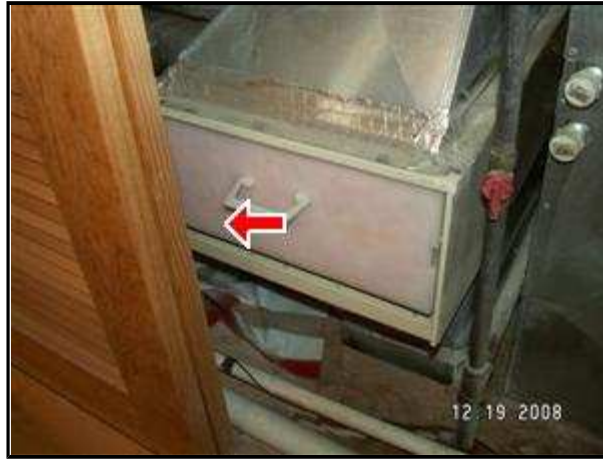
7.7 Picture 1

- 🏠 (2) The closet door blocks changing the HVAC system filter. Recommend altering doors or moving filters for easier access.
