Inspection Report

Inspection Date: 1/1/2011

MultiFamily Sample

All In One Home Inspection LLC

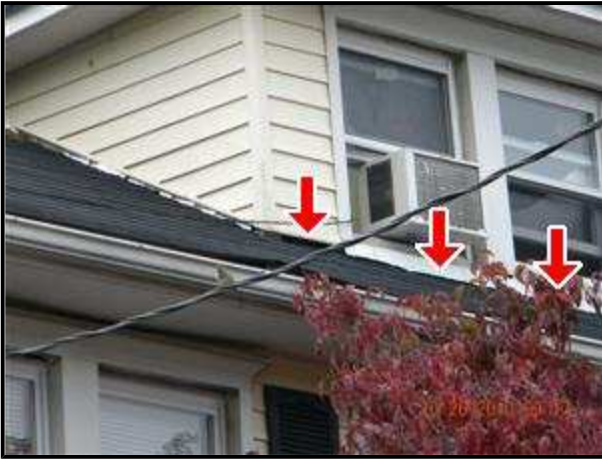
1.0 Picture 1

Flashing between the siding and roof appears to be missing. Flashings are usually installed to help prevent moisture from leaking past roof and siding. Repair recommended by a qualified contractor.

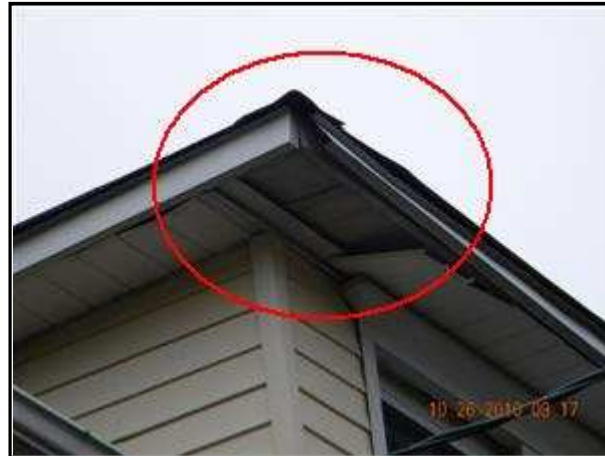
1.1 Picture 1

- 🏠 Soffit panels are loose and missing. Repair recommended by a qualified contractor to prevent the ingress of insects and vermin to the interior spaces of the home.

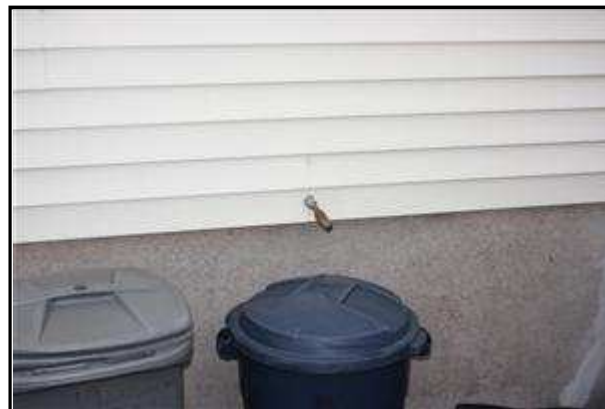
1.2 Picture 1

- 🏠 What appears to be plumbing for an exterior spigot is present. The spigot is missing and the water turned off. Remove protruding piping for safety or repair plumbing to make exterior water supply operable.

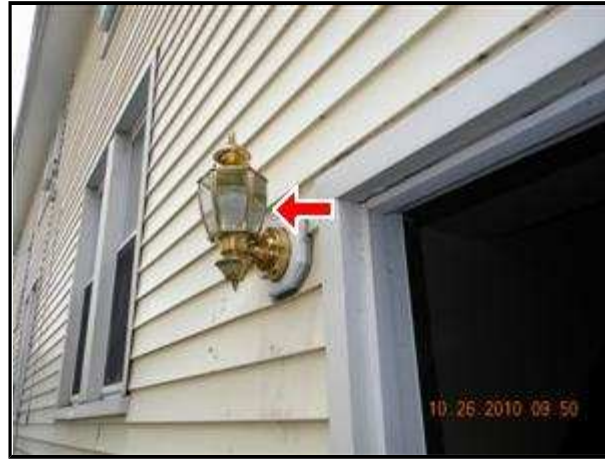
1.3 Picture 1

- 🏠 Exterior lights do not illuminate. The bulbs may be burned out, the switches broken or the lamp light sockets broken. Replace bulbs and try to operate lamp, otherwise repair recommended by a licensed electrician.

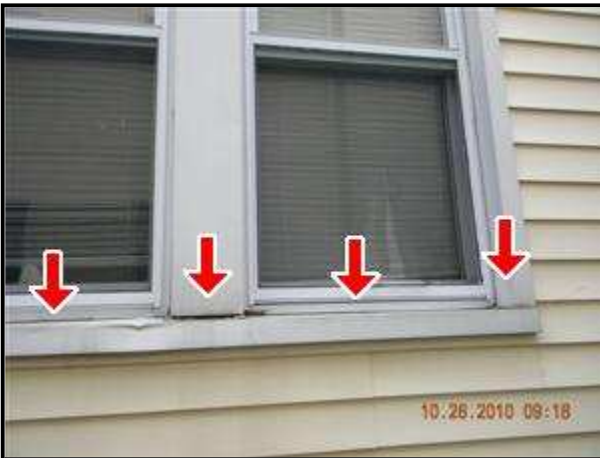
1.5 Picture 1

(1) The caulk between the window frame and trim is deteriorated. Unless repaired the gap between the frame and trim may let in moisture and insects. Repair recommended to prevent the ingress of moisture and insects.

Window frame trim is damaged or missing on some windows. Window frame trim is in need of repair to help prevent weather damage to windows leading to eventual leakage.

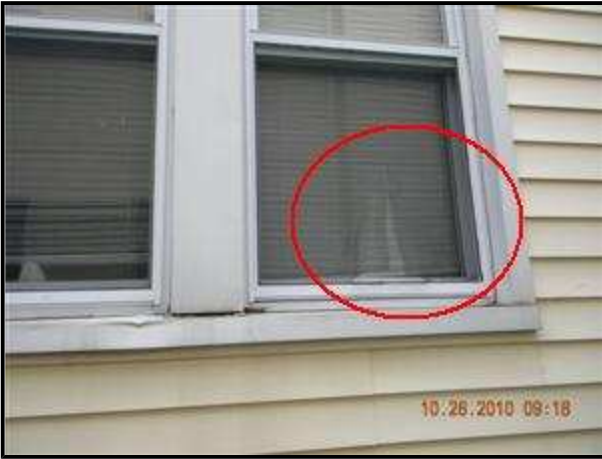
1.5 Picture 4

(2) Window screens are torn or damaged on a number of windows. Recommend repair or replacement to prevent the ingress of insects and vermin.

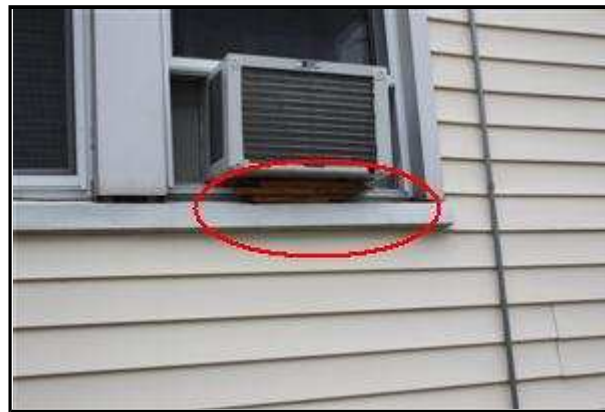
1.5 Picture 6

- 🏠 (3) Propped up AC units are damaging window sills and window trim. Window AC units should be self supporting to help minimize damage to windows and frames.

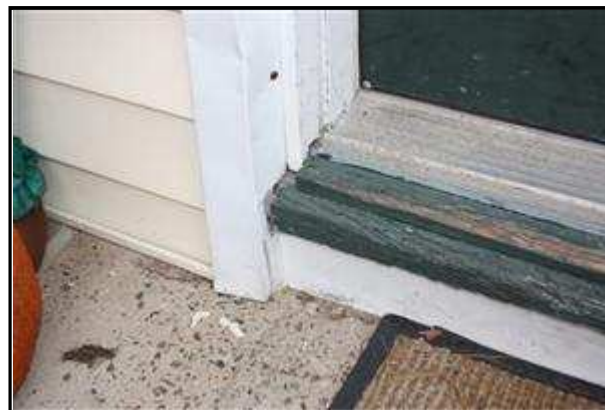
1.6 Picture 1

- 🏠 The door sill wood is weathered and paint had flaked off. Further deterioration of paint, wood and trim may occur if not repainted/repaired. Eventual leakage past door and siding will occur if not repaired. I recommend a qualified contractor inspect and repair as needed.

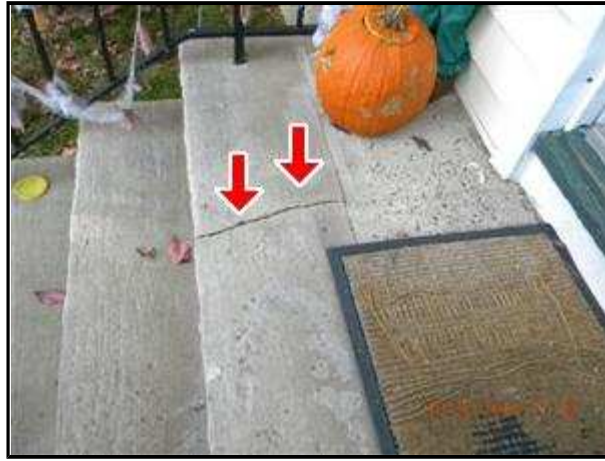
1.7 Picture 1

- 🏠 (1) Step treads are cracked. The cracks will be prone to further damage from thermal expansion/contraction and moisture/ice expansion in winter. Recommend sealing, patching or replacing step treads to prevent further moisture and ice damage to step, brick and mortar.

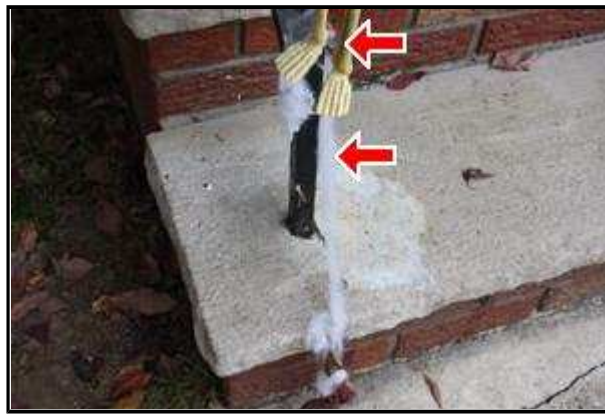
1.7 Picture 2

- 🏠 (2) Railings loose at front steps. Railings will continue to loosen and damage steps. Loose railings are a tripping and falling hazard. Repair railings for safety and to prevent further damage to steps.

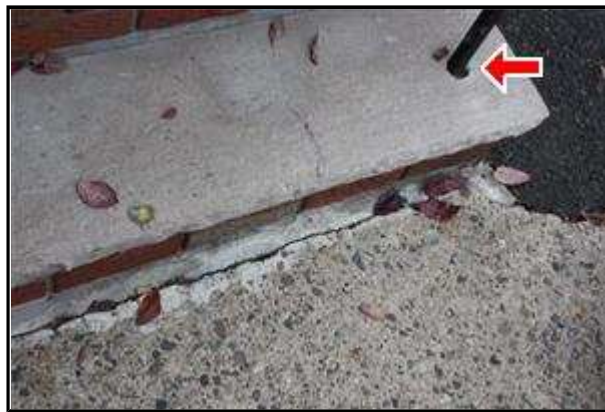
1.7 Picture 3

- 🏠 (3) Mortar or sealant missing from holes where railings pass through step treads. Tread holes may be prone to the collection of dirt and moisture. Moisture in the railing holes may lead to ice damage to treads in winter and/or railing rust at mounting holes. Recommend sealing holes to prevent the accumulation of moisture.

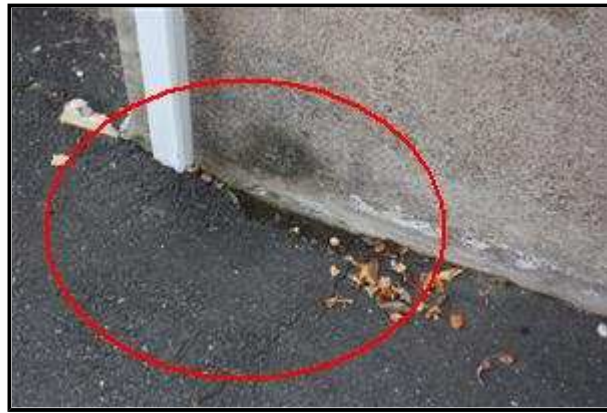
1.10 Picture 1

- 🏠 The driveway appears sloped towards the structure causing rain water to drain down the driveway against the foundation. Water puddling or draining against the foundation can cause moisture damage to the foundation and basement areas in the form of leaks and mold build up. Consider re-sloping the driveway away from the foundation. A temporary repair might be to caulk and seal the crack or gap between the driveway and

foundation to prevent moisture ingress.

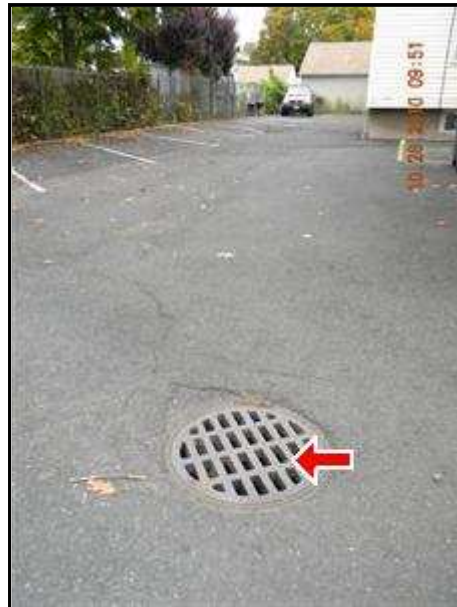
1.12 Picture 1

Note: The town may have an easement to maintain the drainage pipe that appears to run through the yard. Review the survey and consult with homeowner and town.

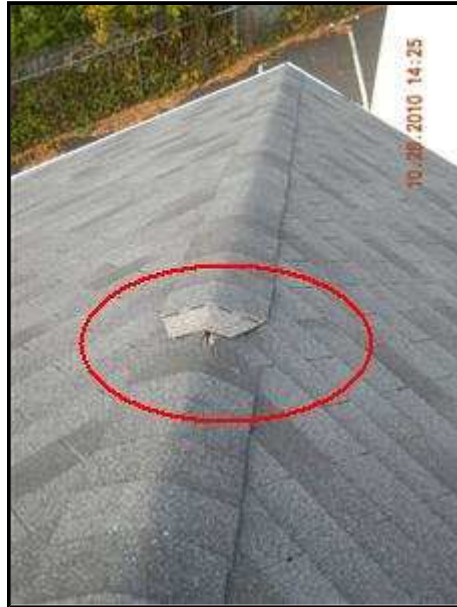
2.0 Picture 1

(1) Shingles are missing along the roof ridge. The roof sheathing is exposed. Repair roof to prevent leakage into the home.

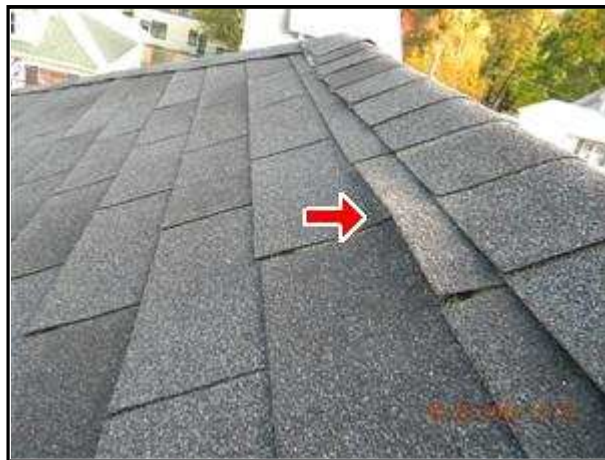
2.0 Picture 2

(2) Roofing nails are popped up under the shingles of the roof's surface. These nails should be driven back down before they puncture through the overlaying shingle, shortening the life of the shingles and causing leakage. I recommend repair by a qualified roofing contractor.

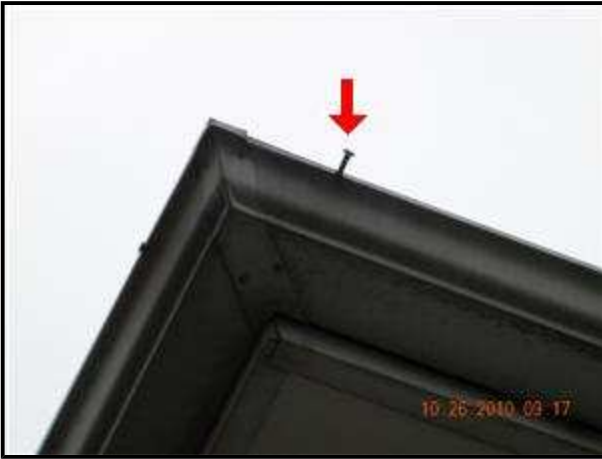
2.4 Picture 1

(1) The gutter is loose and sagging from the fascia. Rain water is spilling over the lip of the gutter at the sag point. The gutter needs to be tightened against fascia and sealed.

Gutter fasteners have popped out along roof line. Gutters need to be refastened or have present fasteners hammered back in to prevent the gutter from becoming loose and falling.

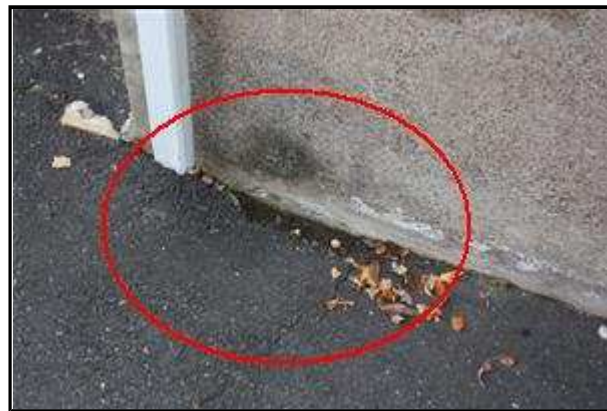
2.4 Picture 3

- 🏠 (2) Drainage around downspout and leader appears to puddle against foundation. Puddling against foundation can cause damage to structure and leakage into basement areas. Recommend regrading earth around structure and/or extending leaders to carry rain water further from foundation area.

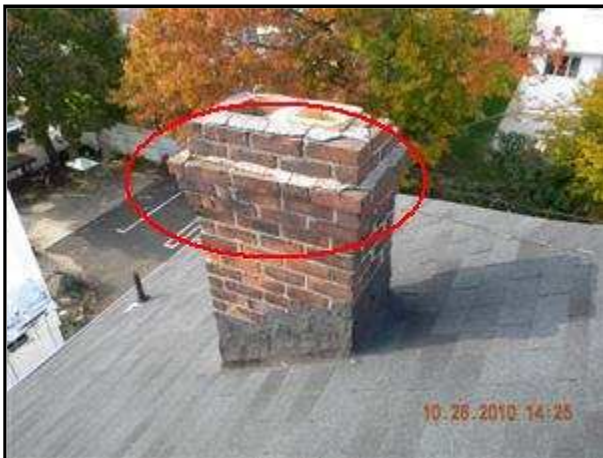
2.5 Picture 1

- 🏠 (1) First few courses of brick and mortar are loose and need repair. Chimney will deteriorate at an accelerated pace unless repaired due to moisture ingress and the freeze-thaw cycle of winter. Repair is recommended by a qualified chimney contractor.

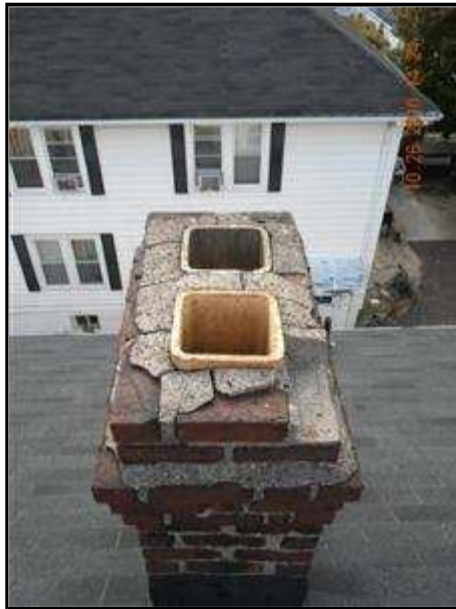
2.5 Picture 5

🏠 (3) The concrete chimney cap is cracked. The cracked chimney cap may let moisture enter the cavity between the chimney wall and flue pipe. Moisture in the chimney can damage bricks, block, mortar and flue pipe. I recommend patching cracks in cap or replacing cement cap to prevent deterioration of chimney.

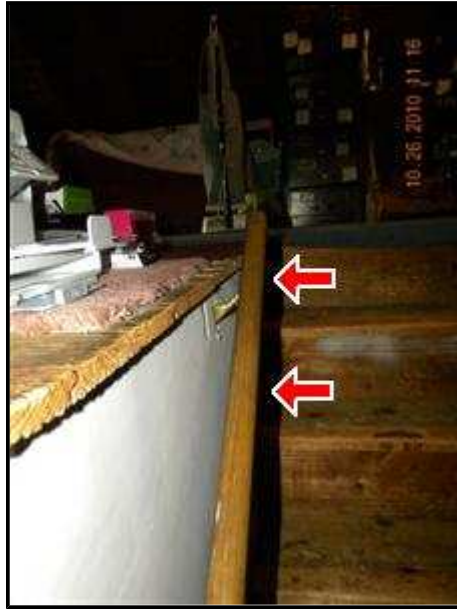
2.8 Picture 1

🏠 Attic stair railings are loose. The railings need repair for safety by a qualified contractor.

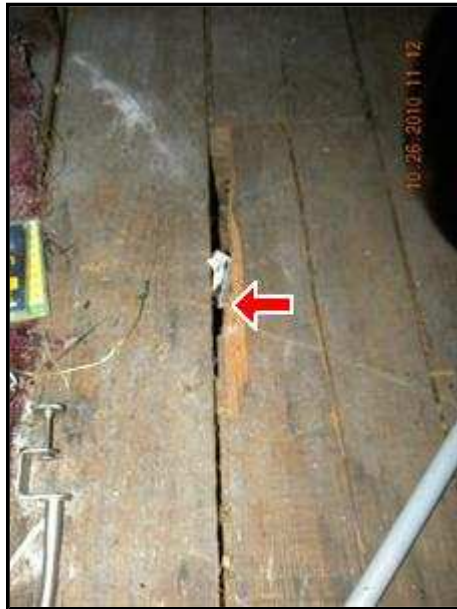
2.9 Picture 1

- Attic and wall insulation is missing between ceiling and wall joists. For best operating efficiency of the heating and cooling systems insulation should cover the ceilings and fill the walls of the living spaces in the home. I recommend the installation of insulation by a qualified contractor.

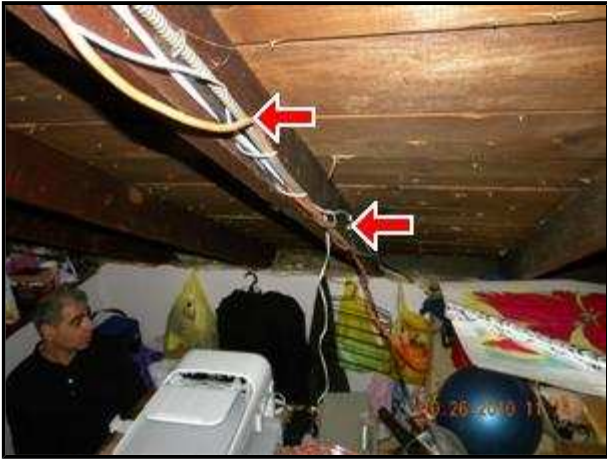
2.10 Picture 1

- Permanently installed extension cords are installed to run power to appliances and accessories around the home. Permanently installed outlets should be located where needed for electrical safety. Evaluation and installation recommended by a qualified electrician.

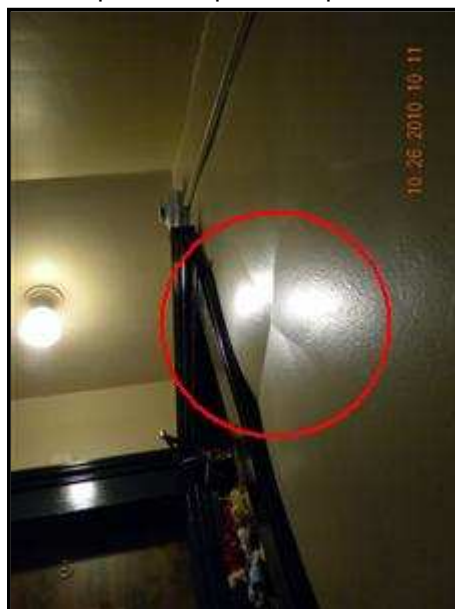
3.1 Picture 1

Plaster walls are cracked. Walls in need of paint and plaster repairs.

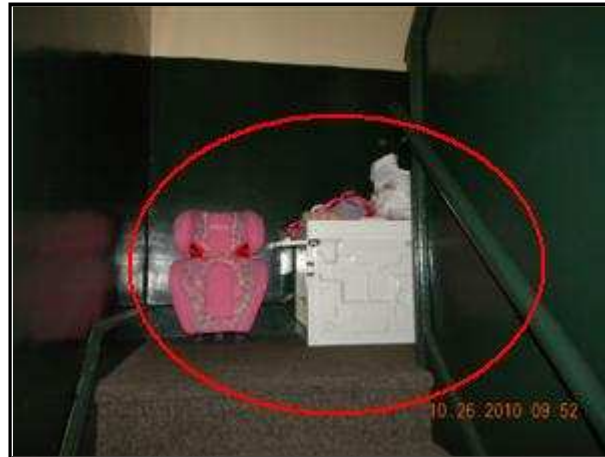
3.6 Picture 1

- 🏠 Personal belongings are blocking stairs in case of emergency. Stairs should be kept clear for safe and easy egress.

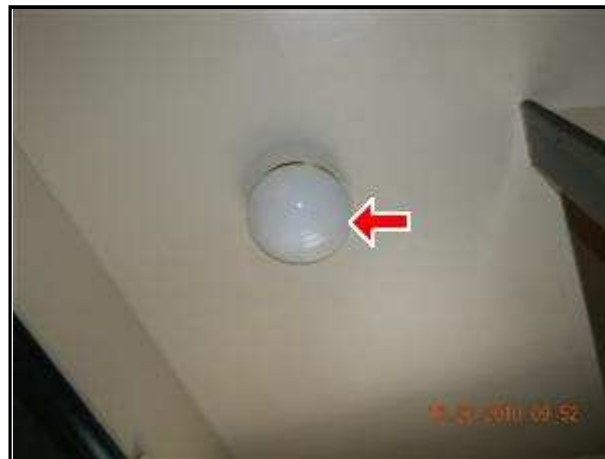
3.7 Picture 1

- 🏠 The light does not illuminate. The bulb may be burned out, the switch broken or the lamp light sockets broken. Replace bulbs and try to operate lamp, otherwise repair recommended by a licensed electrician.

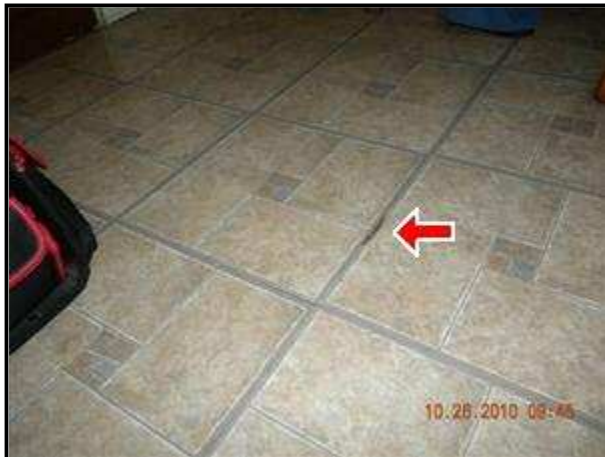
4.3.A Picture 1

Floor tiles are chipped and broken. Repair or replacement recommended.

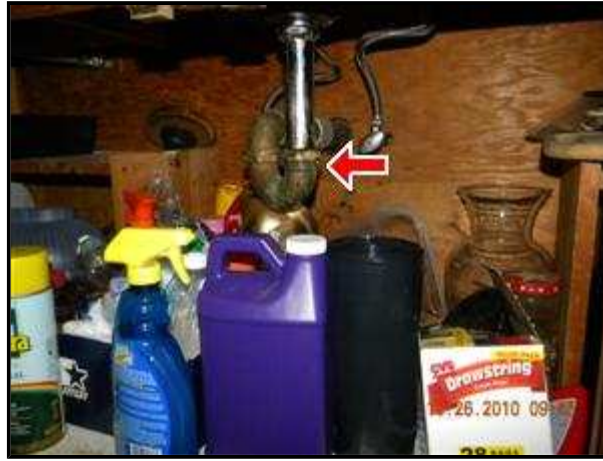
4.7.A Picture 1

The sink drain shows signs of past leakage but was not leaking at the time of inspection. The sink drain is in need of repair prior to the reoccurrence of further damage causing moisture leakage.

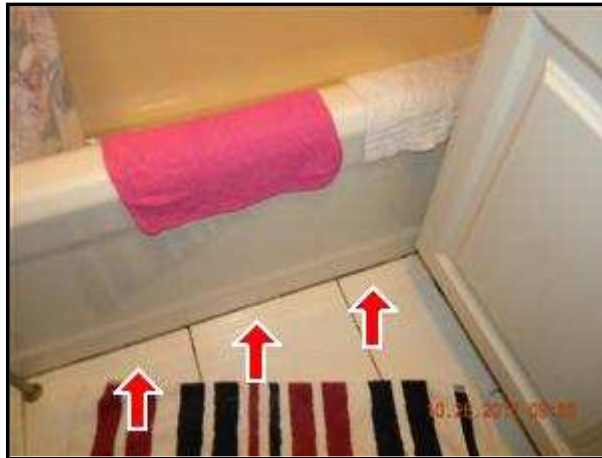
4.27.A Picture 1

(1) The grout where the floor meets the tub is cracked and loose, which can lead to moisture penetration behind floors and walls. Moisture behind flooring and walls can damage wood, soften sheathing and cause mold build-up. Grout should be repaired to prevent the ingress of moisture behind the flooring and walls.

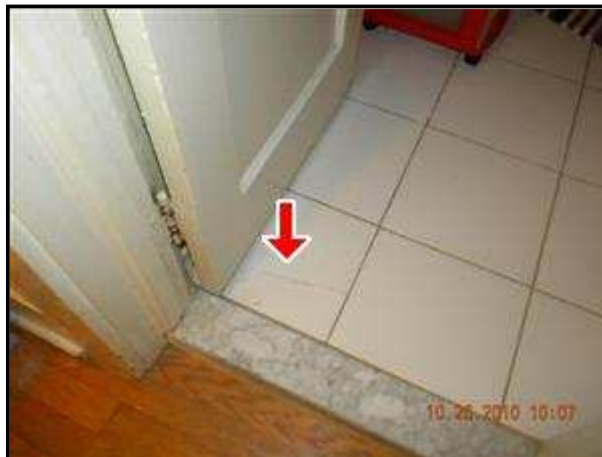
4.27.A Picture 2

(2) Cracked tile noted on floors.

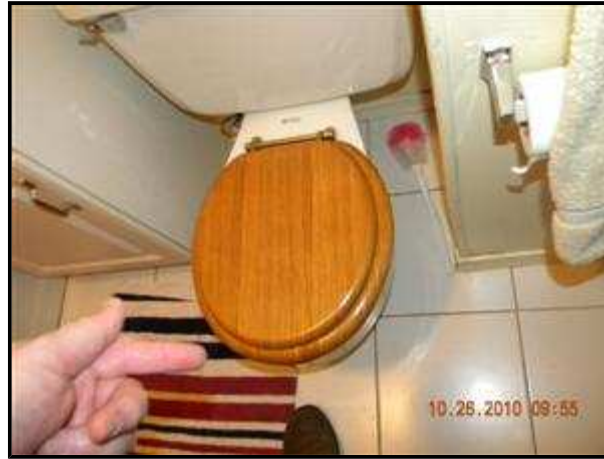
4.32.A Picture 1

(1) The toilet is loose at floor at the bath. Repairs may involve re-setting the toilet on a new wax seal. I recommend a qualified licensed plumber repair or correct as needed.

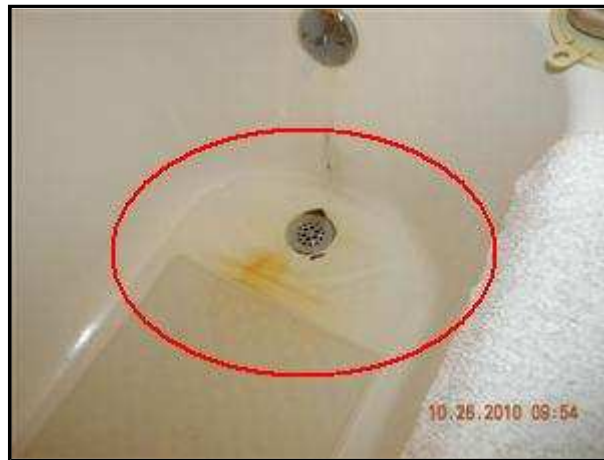
4.32.A Picture 2

(2) The tub is draining slowly. The tub drain needs cleaning or repair by a licensed plumber.

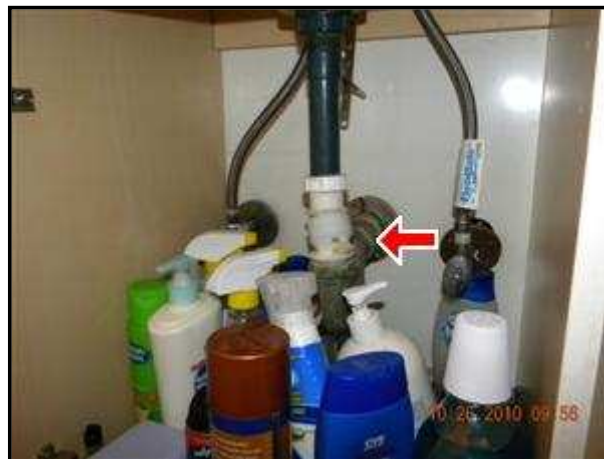
4.32.A Picture 3

(3) The sink drain shows signs of past leakage but was not leaking at the time of inspection. The sink drain is in need of repair prior to the reoccurrence of further damage causing moisture leakage.

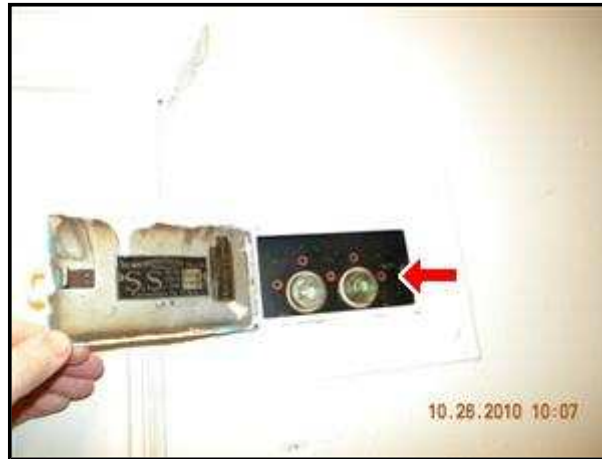
4.40.A Picture 1

A fuse panel is present for protecting house circuits. Although not illegal, fuse boxes are considered outdated and should be replaced with a circuit breaker panel. The fuse boxes appear to have no electrical protection for the home owner from shock hazards when fuses need changing, fuse sockets and wiring connections are all exposed to touching. I recommend changing fuse panels to modern updated circuit breaker panels.

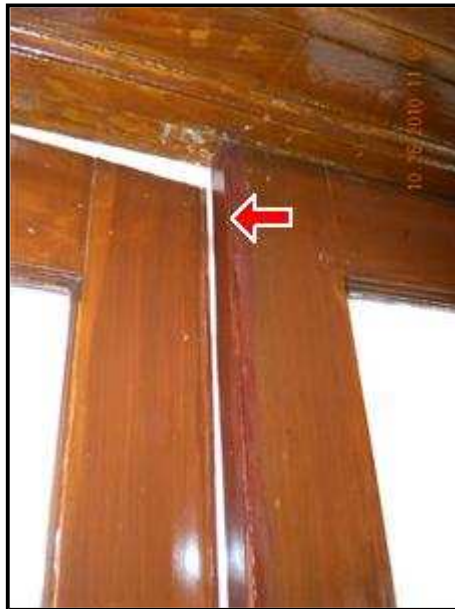
4.19.B Picture 1

(1) The doors have strips of wood installed that prevent closing. The doors need repair to close.

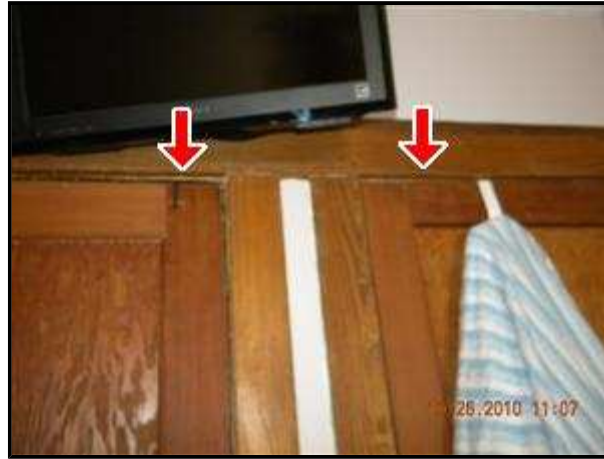
4.19.B Picture 2

(2) The door binds in door frame and does not latch closed. Repair recommended by a qualified contractor.

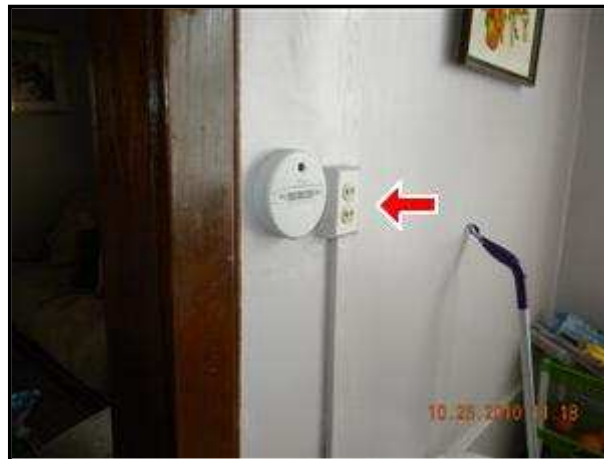
4.22.B Picture 1

Only one outlet per room noted in most rooms. Extension cords noted around the perimeter of rooms with few outlets. Rooms should have more outlets installed for convenience and electrical/fire safety. Evaluation and installation recommended by a licensed electrician.

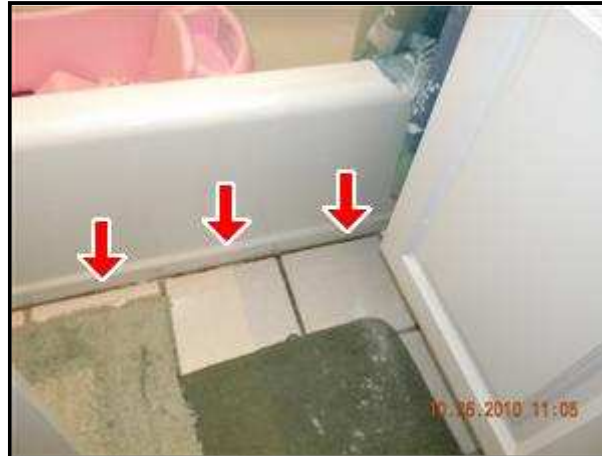
4.28.B Picture 1

The caulking where the floor meets the tub is cracked and loose, which can lead to moisture penetration behind floors. Moisture behind floor can damage wood, soften sheathing and cause mold build-up. Caulking should be repaired to prevent the ingress of moisture behind the flooring.

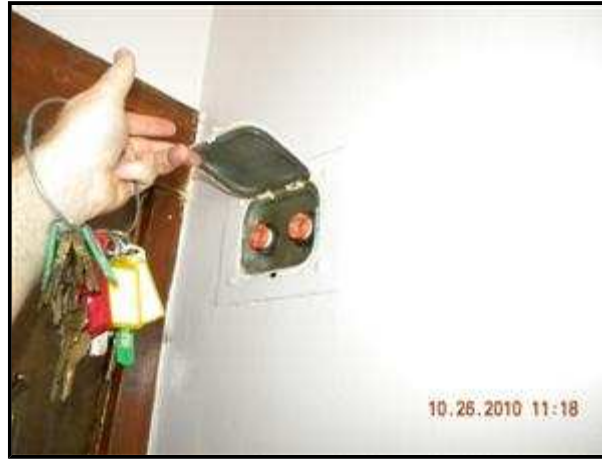
4.42.B Picture 1

A fuse panel is present for protecting house circuits. Although not illegal, fuse boxes are considered outdated and should be replaced with a circuit breaker panel. The fuse boxes appear to have no electrical protection for the home owner from shock hazards when fuses need changing, fuse sockets and wiring connections are all exposed to touching. I recommend changing fuse panels to modern updated circuit breaker panels.

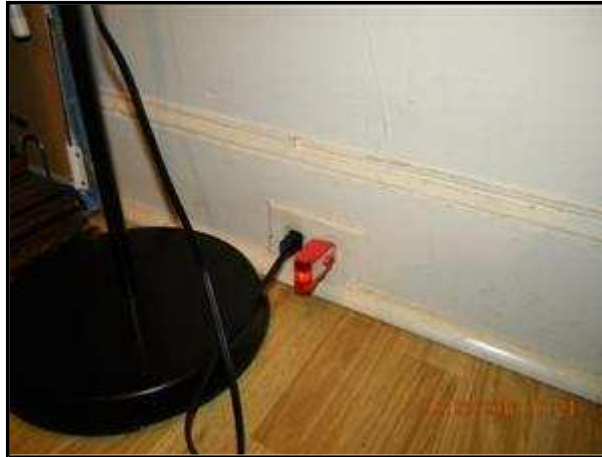
4.20.C Picture 1

(1) Outlets with three prongs have open grounds, this electrical hazard presents a safety issue to the occupants of the home, repairs are recommended. A qualified licensed electrician should perform repairs that involve wiring.

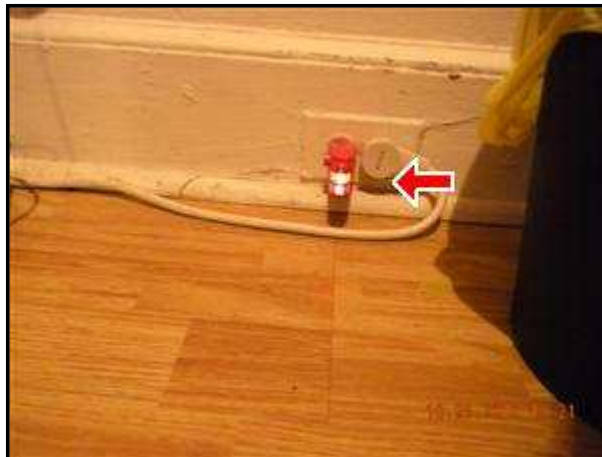
4.20.C Picture 2

(2) Outlet is reverse polarity. This is considered a safety hazard until repaired. Repair recommended by a licensed electrician.

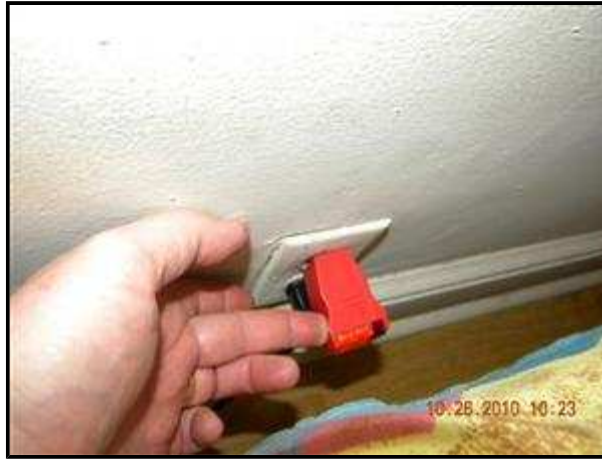
4.20.C Picture 3

(3) Outlets and/or electrical boxes loose, this is a safety hazard until repaired. Repair recommended by a licensed electrician.

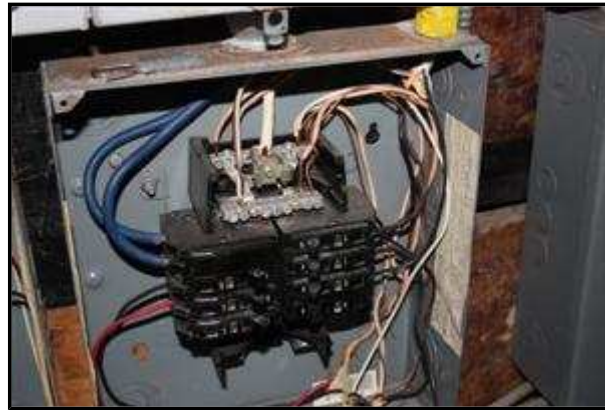
4.39.C Picture 1

(1) Rust is present on the electrical panel. Corrosion is present on the circuit breakers and wire connections. The moisture source is typically leakage from outside at the mast head, service wire entrance at the meter box or the meter box enclosure cover. Repair of the moisture leakage source and clean up of the corrosion in the enclosure is recommended by a licensed electrician.

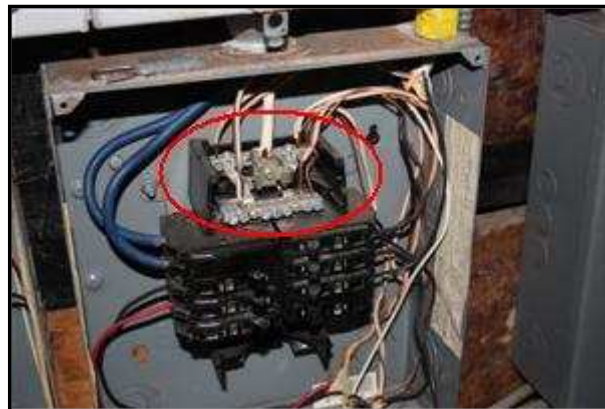
4.40.C Picture 1

Double tapped wires are present at the electrical panel. Double tapped wires will make poor electrical connections which will result in overheated wires. The convention is one wire per screw. Consult with a licensed electrician to evaluate and make repairs.

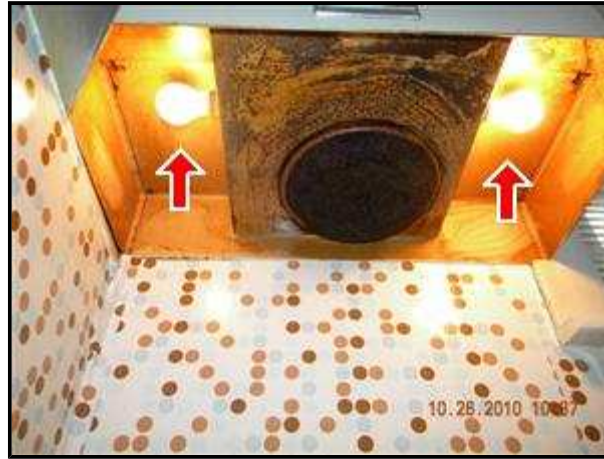
4.11.D Picture 1

The light is missing its protective cover. Cooking activity and cooking splatter may accidentally shatter exposed light bulb. A safety hazard is present until repaired.

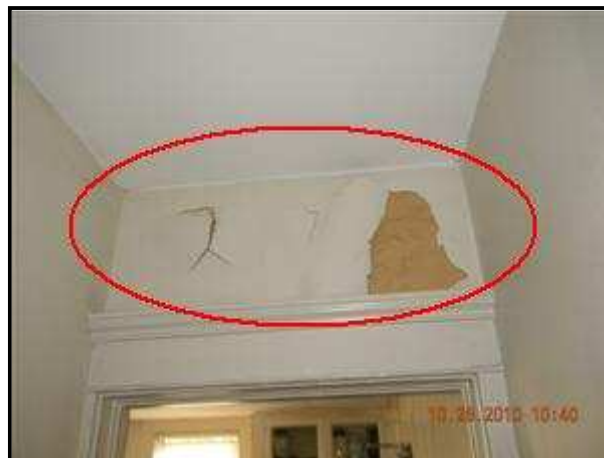
4.15.D Picture 1

Due to the age of home, lead paint may be present on walls and door frames. Take precautions when working around old paint. For further guidance consult with the EPA website for Lead Paint:
<http://www.epa.gov/lead/> .

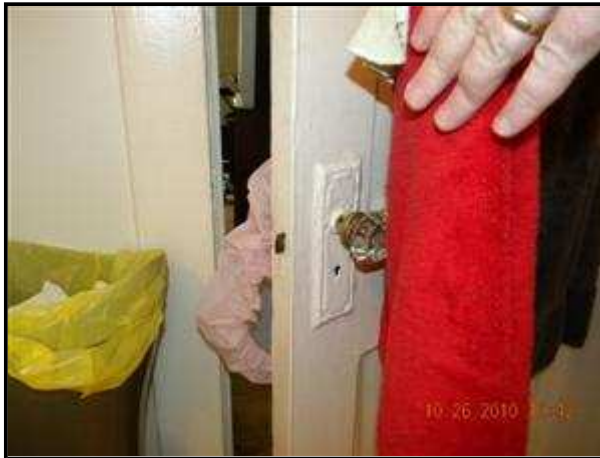
4.27.D Picture 1

Doors do not latch closed. Adjustment or repair required for doors to latch closed.

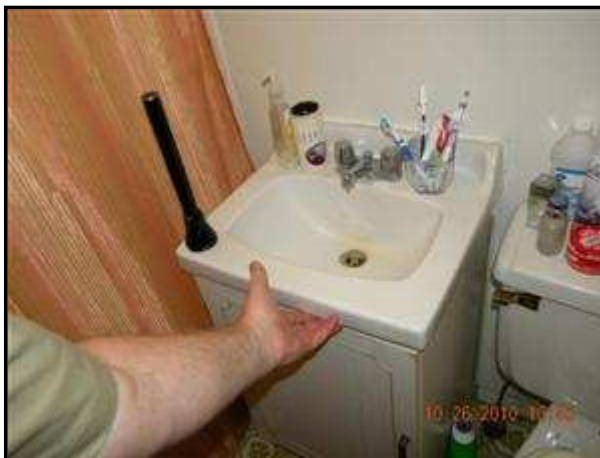
4.29.D Picture 1

The countertop and cabinet are loose from the wall. The countertop and cabinet should be attached at the wall for safety and to prevent leakage from loosened pipes.

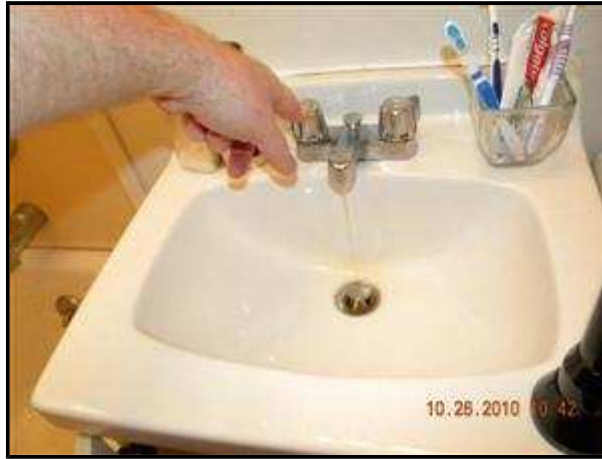
4.30.D Picture 1

A sink valve is not working. The valve needs repair for the convenience of hot and cold water at the bathroom sink. Repair recommended by a licensed plumber.

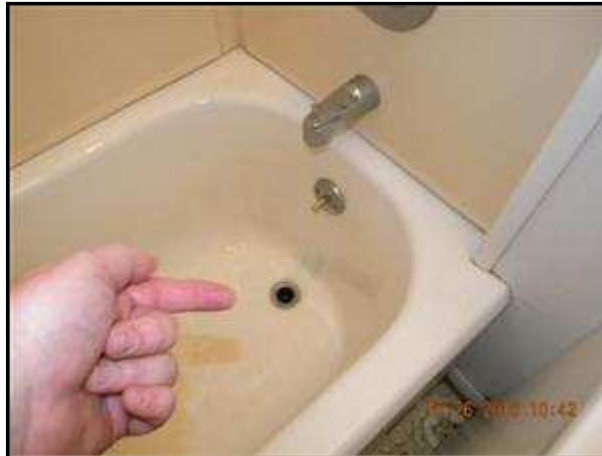
4.31.D Picture 1

4.31.D PLUMBING DRAIN, WASTE AND VENT SYSTEMS (BATHROOMS)**Comments:** Repair or Replace

The tub stopper hardware is not working or missing. Repair or replacement recommended by a qualified contractor.

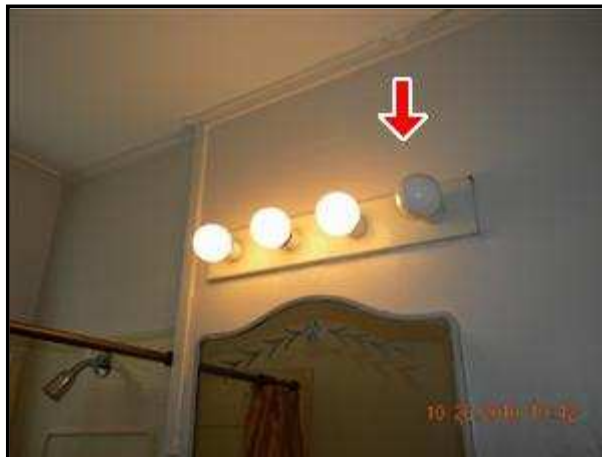
4.32.D Picture 1

A bulb on the lamp is not on. Bulb replacement or circuit repair required.

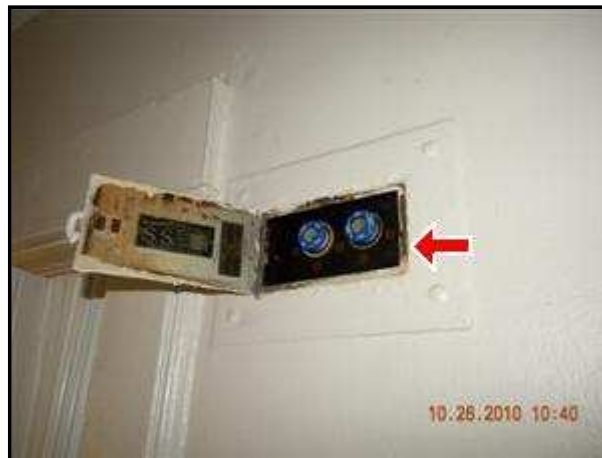
4.39.D Picture 1

- 🏠 A fuse panel is present for protecting house circuits. Although not illegal, fuse boxes are considered outdated and should be replaced with a circuit breaker panel. The fuse boxes appear to have no electrical protection for the home owner from shock hazards when fuses need changing, fuse sockets and wiring connections are all exposed to touching. I recommend changing fuse panels to modern updated circuit breaker panels.

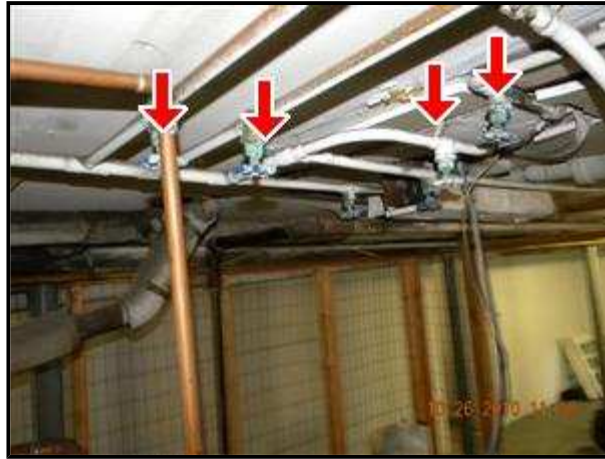
7.2 Picture 1

Corrosion and signs of leakage present on valves. Valves should be repaired or replaced prior to further uncontrolled leakage.

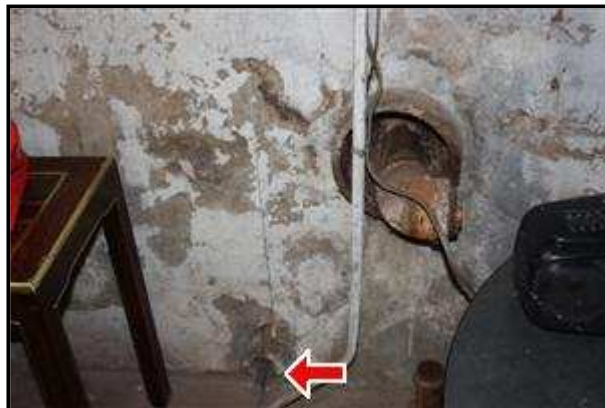
7.4 Picture 1

The hot water is supplied from the hot water heater next door. The hot water pipe passes under the driveway between buildings in an access conduit.

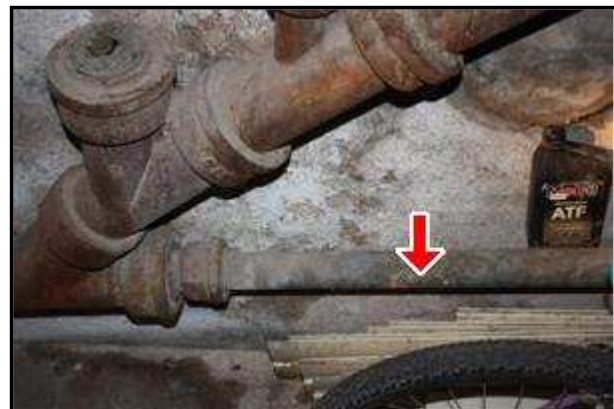
7.5 Picture 2

- 🏠 Several waste drain lines are galvanized pipe. Galvanized pipe is known to clog from rust and corrosion from the inside. Tubs and sinks may eventually drain slow throughout the home. Eventual repair may be required by a qualified licensed plumber.

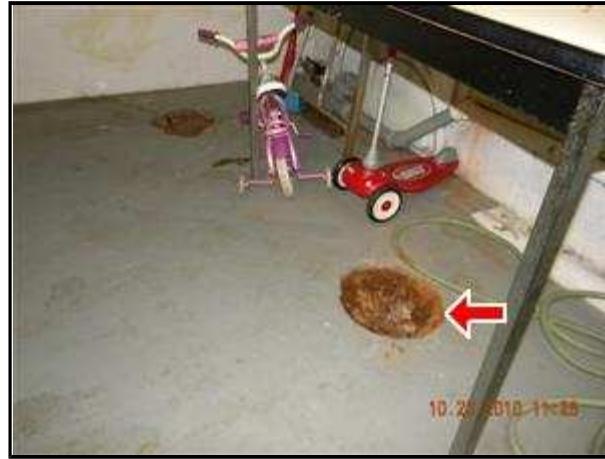
7.6 Picture 1

Sump pits are full of debris. Sump pits should be kept free of debris for moisture control.

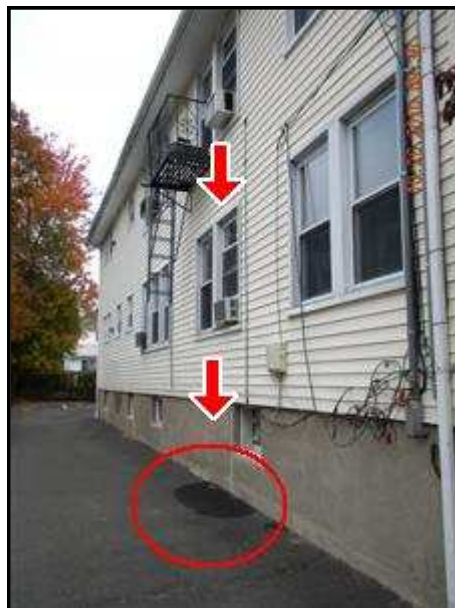
8.3 Picture 1

- 🏠 Condensate from window AC units is running down siding and puddling against the foundation. Water running continuously over the siding may find its way past windows and flashing to damage the interior spaces of the home. Water puddling against the foundation may leak into the basement area. Condensate drains on AC units need repair to move drainage away from foundation.

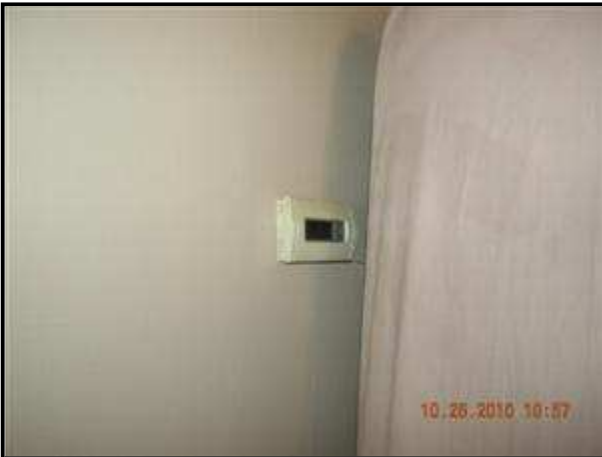
8.4 Picture 1

The thermostat for the whole building is located in apartment #3.

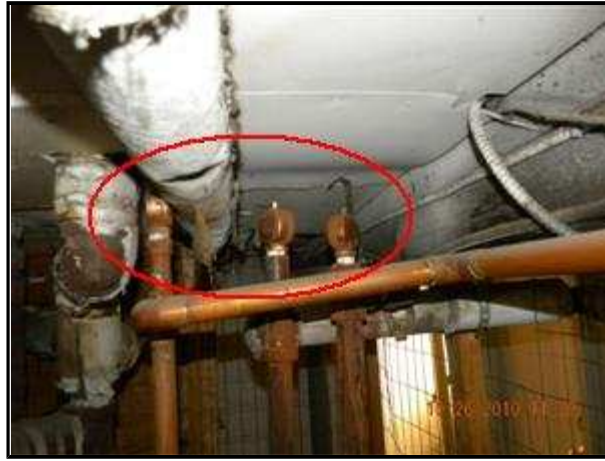
8.6 Picture 1

(1) The steam return vents in the basement have failed and are leaking. Vents and steam pipes are heavily corroded. Replace vents to prevent moisture leakage and improve steam system efficiency. Repair recommended by a qualified plumber.

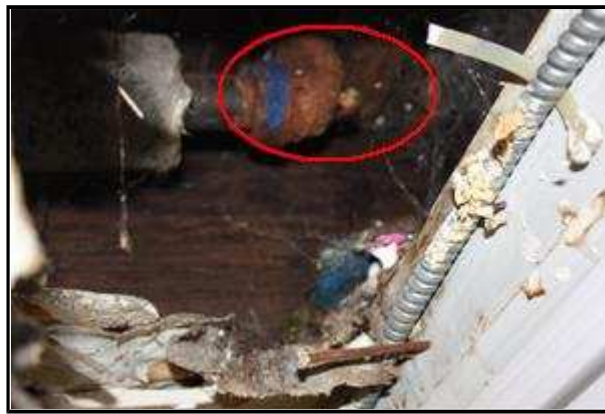
8.6 Picture 2

- 🏠 (2) Steam pipes and fittings are heavily corroded. Repair pipes to prevent further damage causing leakage. Repair recommended by a qualified plumber.

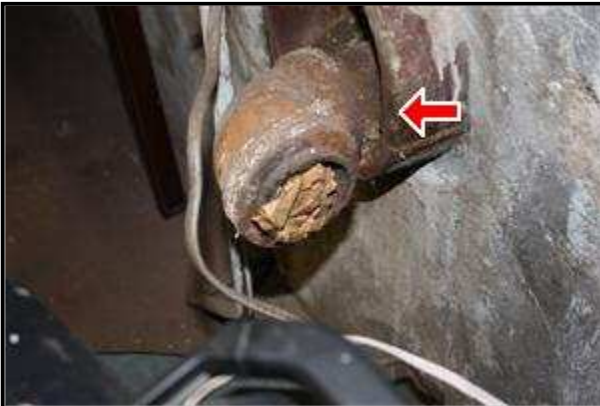
8.6 Picture 3

- 🏠 (3) A steam pipe between buildings is abandoned.

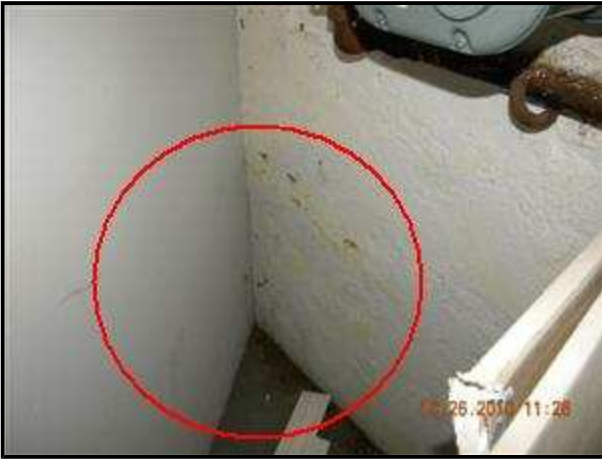
9.0 Picture 1

(1) White efflorescence (powder substance) on block wall indicates moisture is in contact with the masonry. This does not necessarily indicate that intrusion will occur. I recommend checking the gutters and the downspout drain lines for proper operation. Also, a water proofing paint could be applied to the interior side of the block if necessary. Efflorescence is found on many homes without water intrusion occurring inside the building. But, it should alert you to the possibility that future steps may be needed.

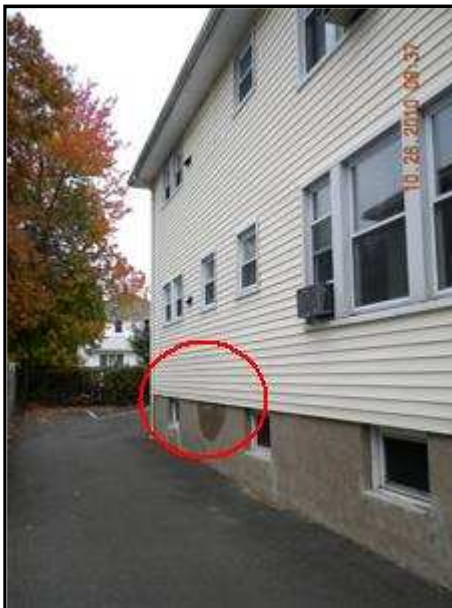
9.0 Picture 4

- 🏠 (2) Moisture stains present on exterior foundation walls up near the siding. Unable to determine the cause of dampness. Possible causes include leak at the kitchen sink, leaking steam radiators and roof or siding leakage. It had rained the night before the inspection. By the time we were done inspecting all three properties the moisture dampness was almost dry.

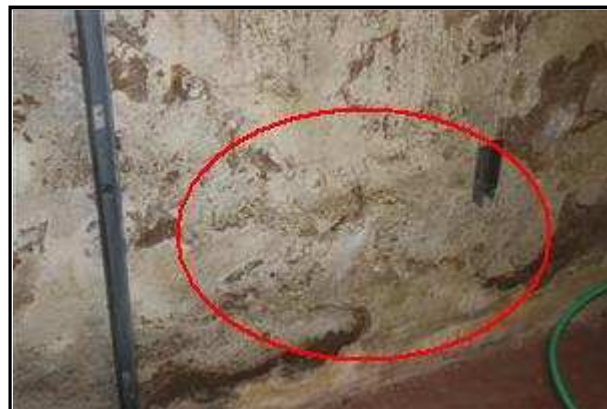
9.0 Picture 10

- 🏠 (4) Parging is cracked and loose on foundation interior at or below local grade. Parging tends to deteriorate quicker due to prolonged exposure to moisture. Repair parging to prevent excessive flaking.

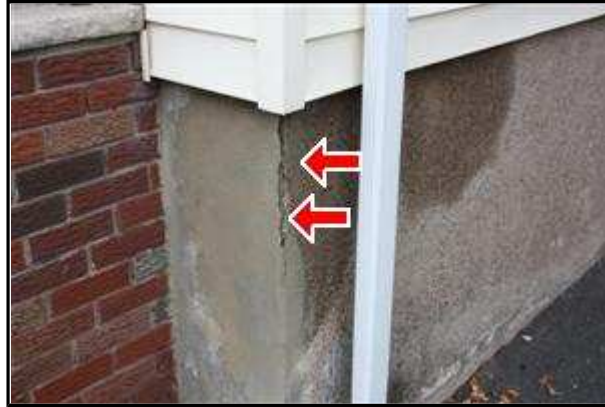
9.0 Picture 11

- 🏠 (5) Loose parging is cracked and loose around foundation exterior. Loose parging tends to deteriorate quicker due to exposure to moisture and thermal expansion. Repair parging to prevent excessive flaking.

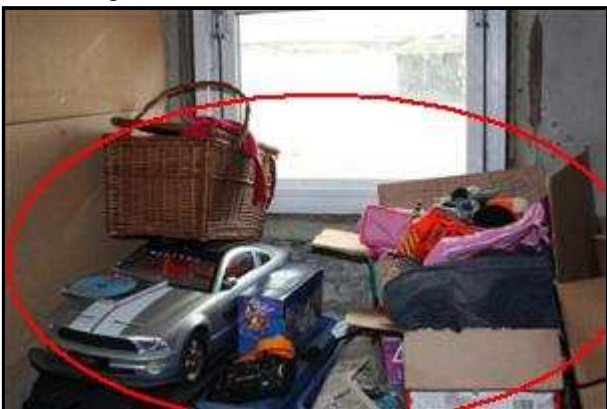
9.10 Picture 1

- 🏠 Note: The basement had stored items at time of inspection, unable to completely inspect foundations, floors, walls, ceilings, windows and/or outlets.

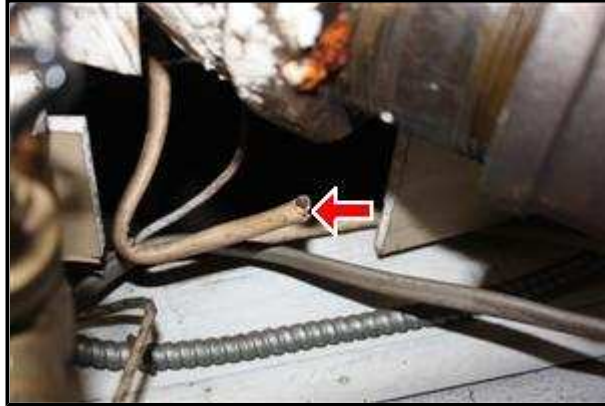
9.14 Picture 1

Open electrically active connections and wire ends present. Active joints and ends should be terminated in a junction box. An electrical safety hazard is present until repaired.

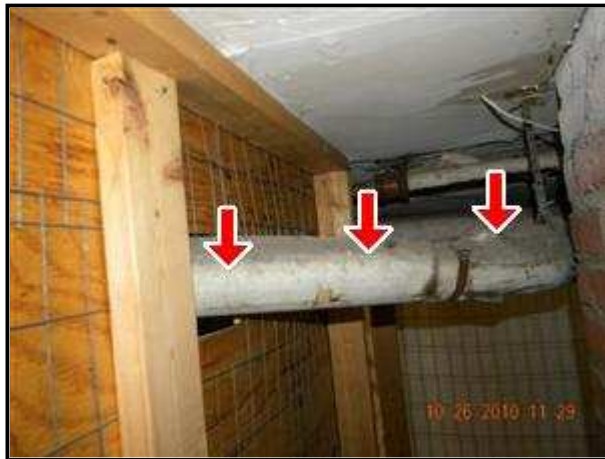
9.18 Picture 1

Suspected asbestos present on steam piping. Asbestos appears friable (crumbling). Asbestos is a health and safety concern. Recommend consulting with a qualified asbestos removal company for removal. To learn more about asbestos and living with asbestos fiber products in your home I recommend reviewing information at the Environmental Protection Agency's (EPA) web site: <http://www.epa.gov/asbestos/>
