Inspection Report

Single Family Sample

Property Address:
Inspection Address
Inspection Town, NJ Inspection Zip

All In One Home Inspection LLC

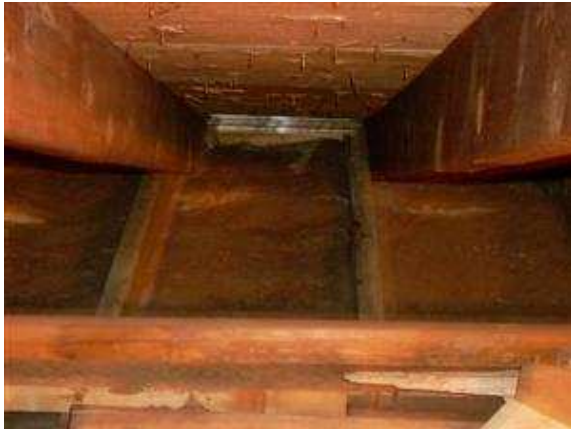
1.7 Picture 1

Fiberglass (Batts) insulation is old and has settled, and less than six inches in thickness remains. Heat loss can occur more on this home than one that is properly insulated. Repair or replace as needed.

Fiberglass (Batts) insulation is is old and has settled, and less than six inches in thickness remains. Heat loss can occur more on this home than one that is properly insulated. Repair or replace as needed.

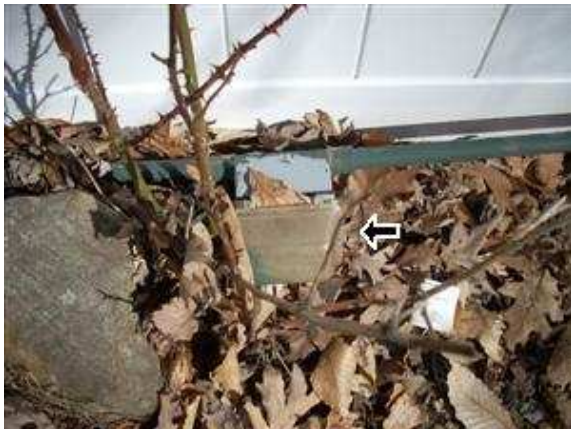
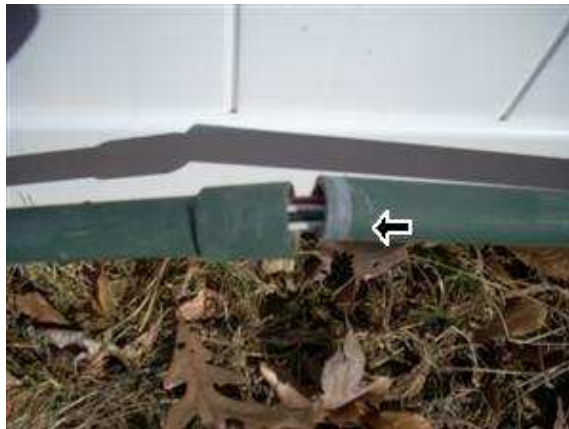
2.7 Picture 1

Exterior outlet by sump pump is open and facing into the dirt. Corrosion is present. PVC conduit for this outlet is broken as well. Conduit ideally should be buried at least 18" or firmly attached to the fence for protection.

Exterior outlet by sump pump is open and facing into the dirt. Corrosion is present. PVC conduit for this outlet is broken as well. Conduit ideally should be buried at least 18" or firmly attached to the fence for protection.

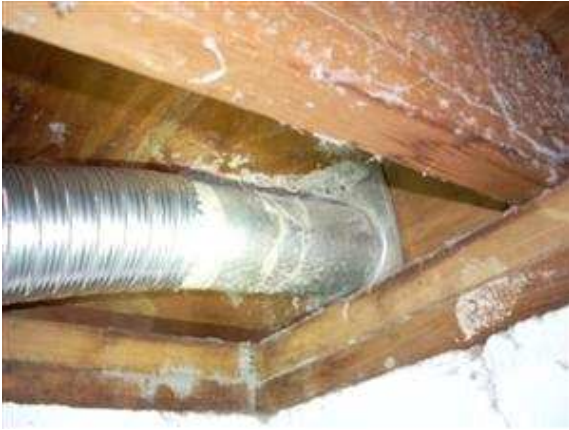
4.14 Picture 1

The dryer vent piping is leaking in the basement. Allowing lint to be released in the air is not healthy in closed rooms, crawlspaces or basements. I recommend repair as needed.

The dryer vent piping is leaking in the basement. Allowing lint to be released in the air is not healthy in closed rooms, crawlspaces or basements. I recommend repair as needed.

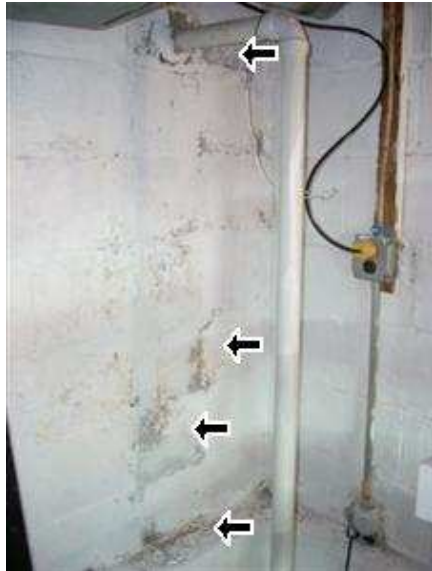
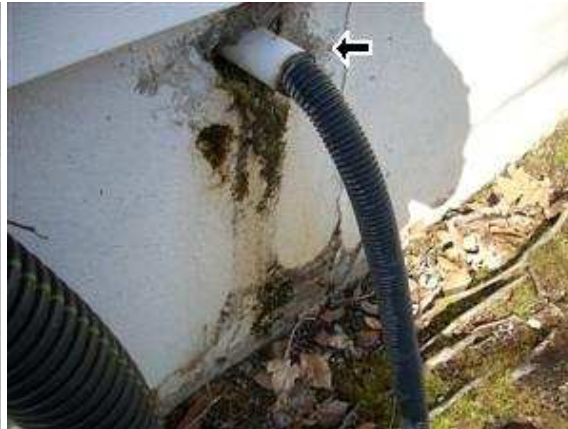
7.0 Picture 1

- 🏠 Visible signs of water intrusion and mold in the basement are present from water. It appears to be originating from a leak where the sump discharge passes through the foundation. It is recommend to repair leak and caulk opening.

Visible signs of water intrusion and mold in the basement are present from water. It appears to be originating from a leak where the sump discharge passes through the foundation. It is recommend to repair leak and caulk opening.

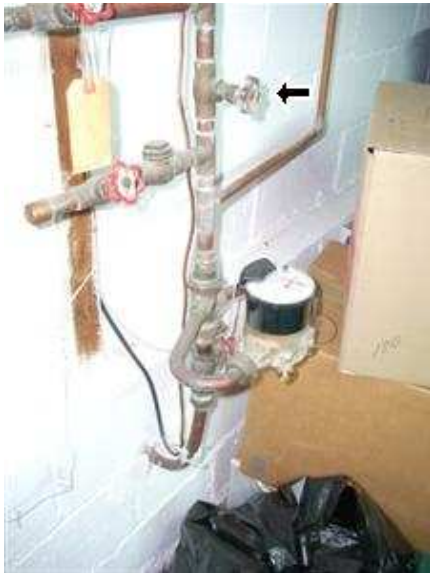
8.3 Picture 1

The main shut off are the knobs located in the basement on the front wall. One is corroded stuck and will likely need replacement. This is for your information.

The main shut off are the knobs located in the basement on the front wall. One is corroded stuck and will likely need replacement. This is for your information.

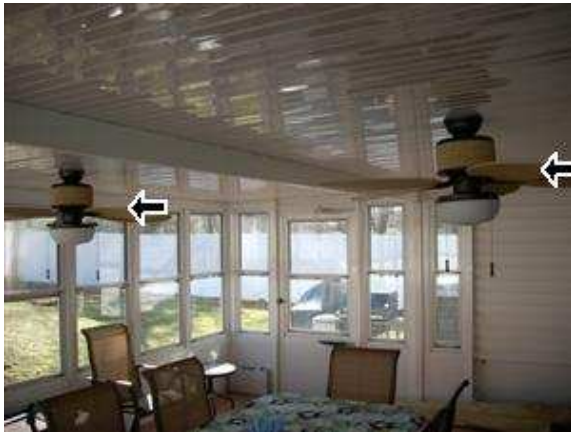
9.3 Picture 1

Ceiling fan/light combos are below head height. While replacement might not be practical, this a safety issue that should be noted.

Ceiling fan/light combos are below head height. While replacement might not be practical, this a safety issue that should be noted.

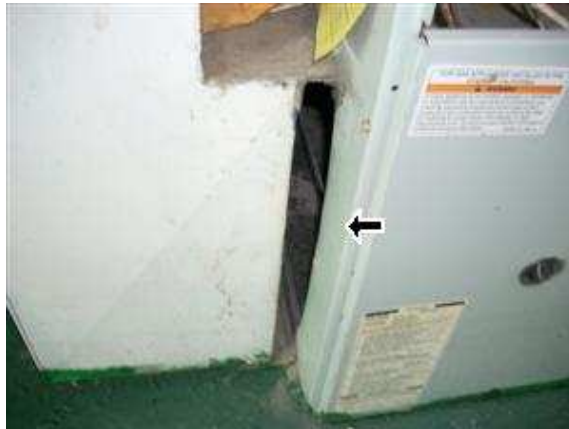
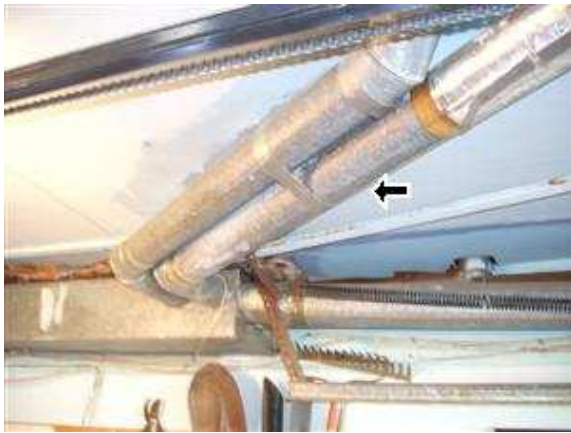
10.3 Picture 1

Ducts in garage are not insulated, which can lead to increased heating costs. Furnace cabinet has visible dirt accumulation and is missing it's disposable filter. A complete duct cleaning is recommended and insulation of all exposed ducts in non heated spaces. One vent in living room on the front wall was not functional. Cause not determined.

Ducts in garage are not insulated, which can lead to increased heating costs. Furnace cabinet has visible dirt accumulation and is missing it's disposable filter. A complete duct cleaning is recommended and insulation of all exposed ducts in non heated spaces. One vent in living room on the front wall was not functional. Cause not determined.
