Inspection Report

Town House Sample

Property Address:
Inspection Address
Inspection Town, NJ Inspection Zip

All In One Home Inspection LLC

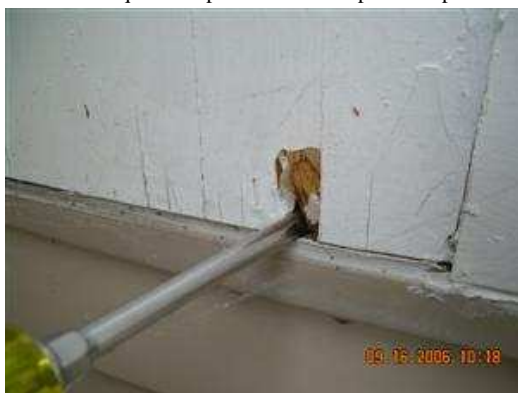
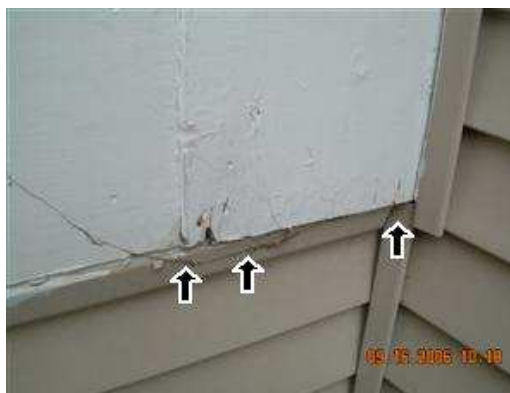
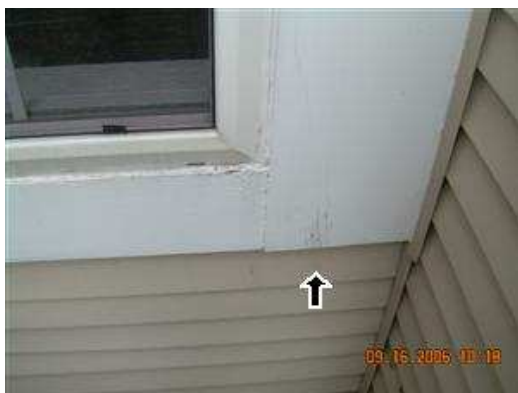
2.0 Picture 1

The Wood trim at the rear of home deteriorated along bottom edge of both windows. Caulking in disrepair. Further deterioration can occur if not corrected. A qualified person should repair or replace as needed.

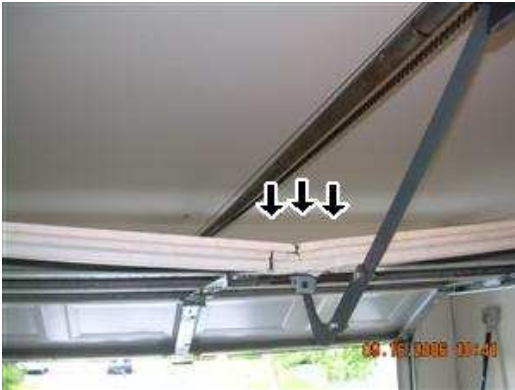
3.3 Picture 1

📌 The bottom garage door panel at the front of home is damaged . A qualified person should repair or replace as needed.

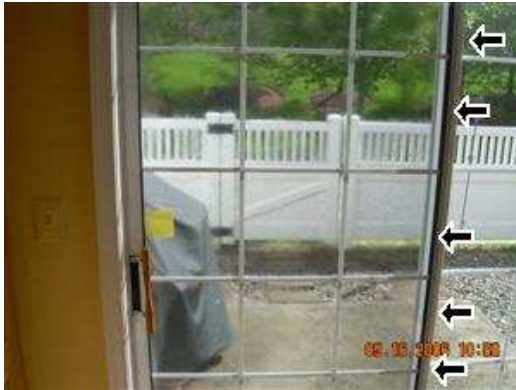
4.3 Picture 1

Sliding glass door has condensation between panes. Seal broken. Replace.

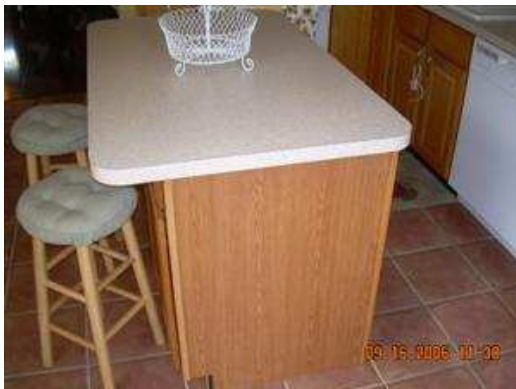
4.4 Picture 1

Center island cabinets not secured to floor. Listing agent stated this was to facilitate moving to side wall as needed.

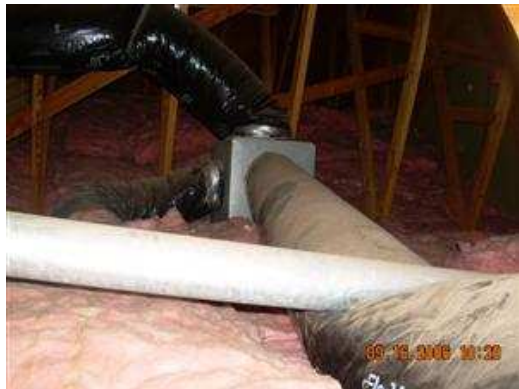
10.3 Picture 1

The insulated duct pipe is damaged in the attic. Ceiling vents in 2nd floor had no discernable air flow when testing both AC and heating systems. I recommend service repair to the crushed duct to restore air flow.
