# Inspection Report

Inspection Date: 6/1/2010

## Town House Sample Report

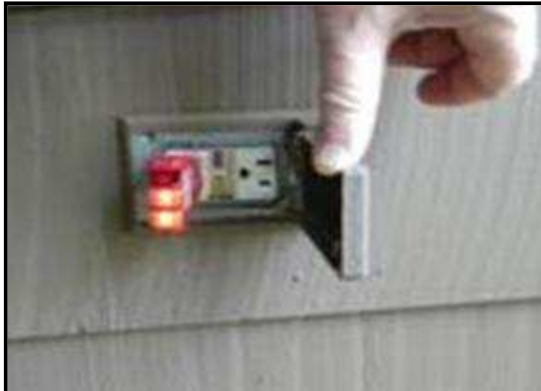
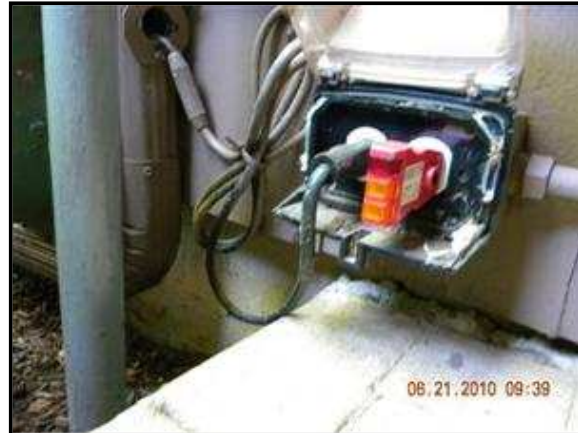
1.3 Picture 1

(1) The GFCI failed to trip when tested. This is considered a safety hazard until repaired. Recommend replacement by a licensed electrician.

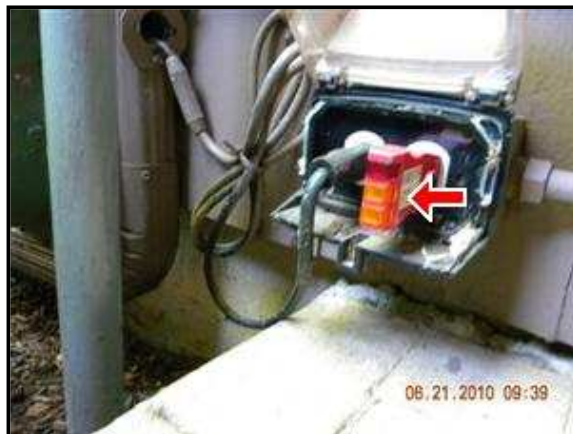
1.3 Picture 3

(2) No power at exterior outlet when tested. All circuit breakers are on at the main electric panel. The exterior outlets may be controlled by an interior/exterior switch, consult with the homeowner. Otherwise, recommend repair of the outlet by a licensed electrician.

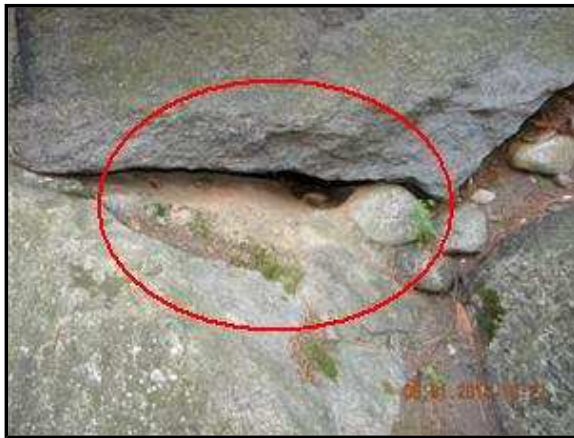
1.12 Picture 1

Vermin living in retaining wall in garden area are digging holes through garden bed that can upset the health of plants, retaining wall drainage and installed appliances. Recommend relocating vermin.

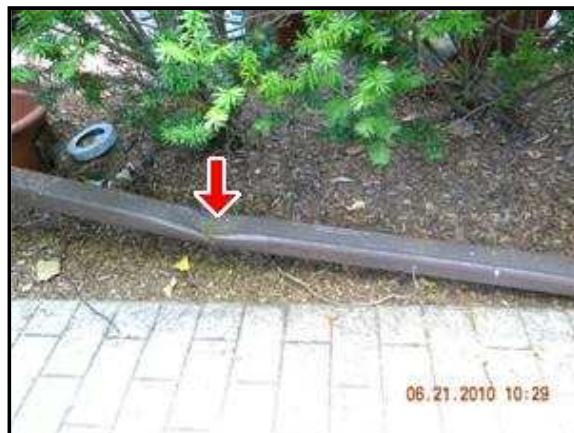
2.5 Picture 1

Gutters may overflow and drain/splash against foundation in rain storms. Puddling water against foundation may leak into basement causing moisture damage. Leader repair is recommended.

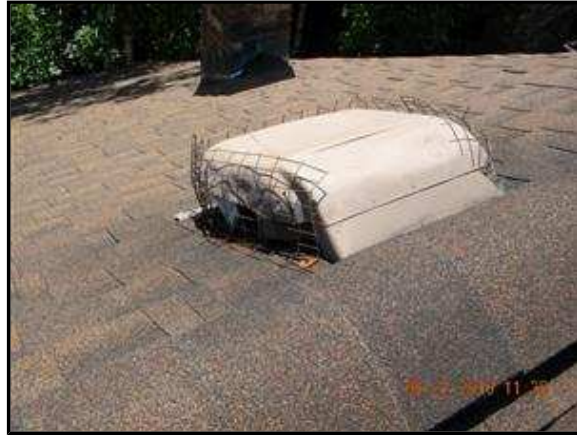
2.6 Picture 1

Active bees nests observed in vents. Exterminate bees for safety.

Vents have screen mesh added to help fight the ingress of vermin to attic spaces.

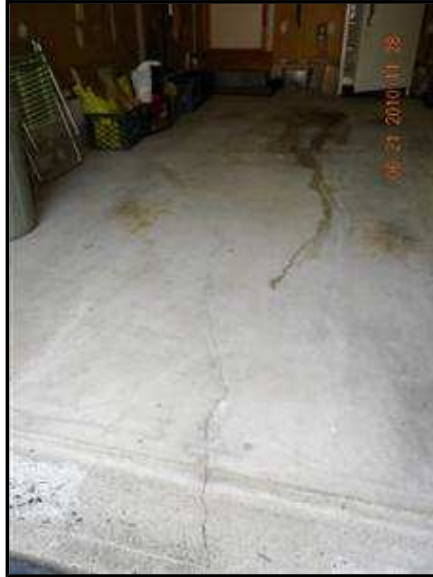
3.2 Picture 1

Note: The concrete floor of garage is cracked in areas from expansion/contraction or slight movement. I could not tell if the cracking is old or recent. I recommend patching or sealing cracks with an appropriate sealant or mortar.

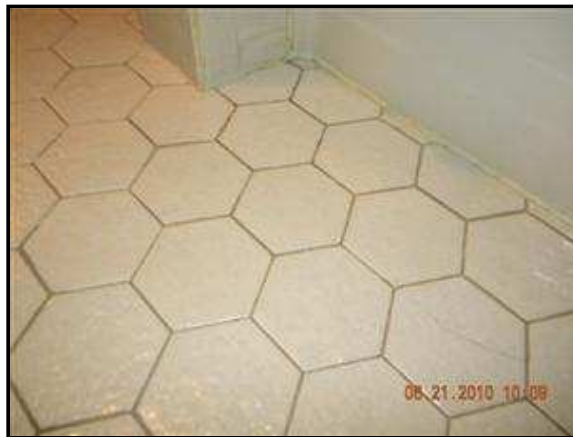
4.2.A Picture 1

The bathroom floor has cracked floor tile, loose floor tile & loose grout between tile. Moisture may penetrate flooring and damage the interior spaces of the flooring cavity. The floor is in need of evaluation and repair by a qualified contractor.

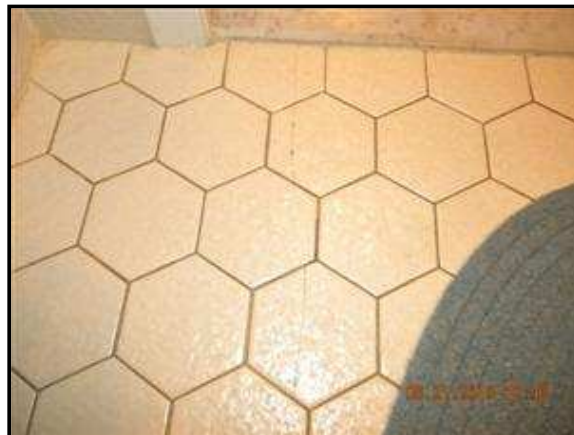
4.2.C Picture 1

The bathroom floor has cracked floor tile, loose floor tile & loose grout between tile. Moisture may penetrate flooring and damage the interior spaces of the flooring cavity. The floor is in need of evaluation and repair by a qualified contractor.

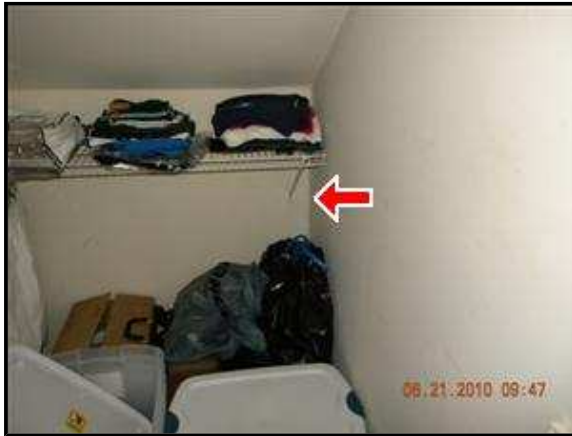
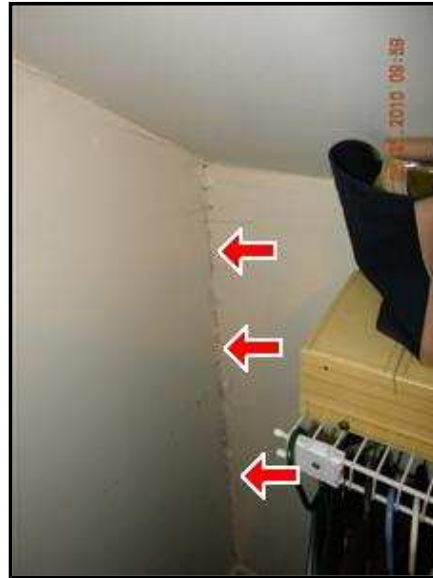
5.5.A Picture 1

Tape on seams in the corners of wall is torn. The tape in corners may have become damaged from slight localized movement. I recommend tape, spackle and paint repairs by a qualified contractor.

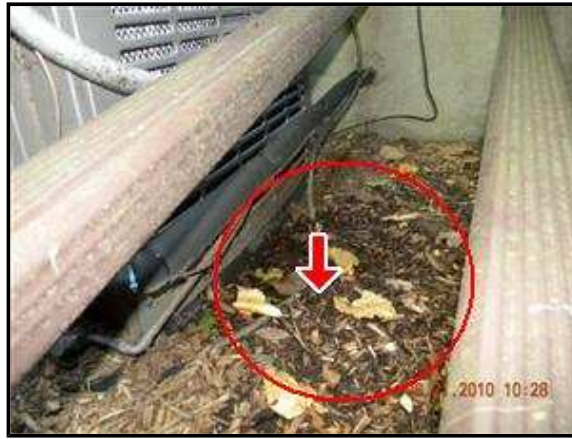
10.3 Picture 3

(3) The condensate pump discharges outside against the foundation. Moisture build up against the foundation on a continual basis can result in moisture leakage into the basement area of the home. Recommend discharging condensate a downspout leader, a wall mounted drain for a washer or to a slop sink.

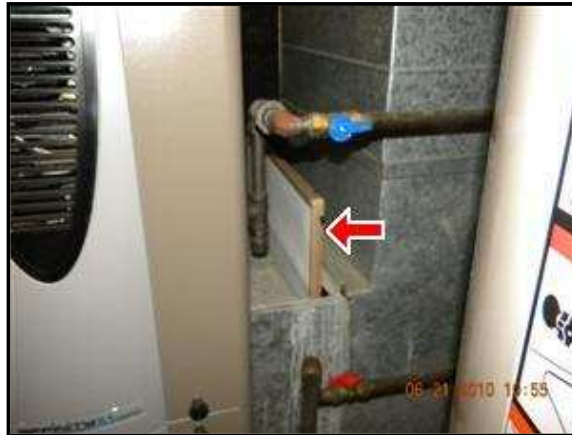
10.4 Picture 1

After you first move in, recommend inspecting every two weeks during heating or cooling season. If filter does not appear dirty then wait longer to check for dust build up. You will eventually figure out how often to change filter. If you can see dust on the filter, it is probably worth changing or cleaning. A totally clogged filter will cause the HVAC system to run inefficiently.
