# Inspection Report

## Town House Sample Report

**All In One Home Inspection LLC**

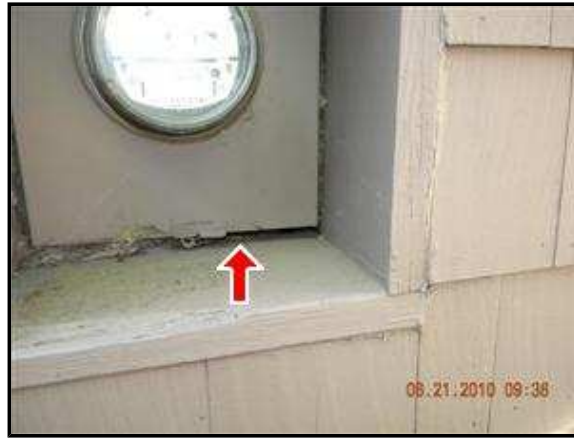
1.0 Picture 1

The holes for wires and piping to pass through siding should be sealed and plugged to prevent the ingress of moisture, insects or vermin.

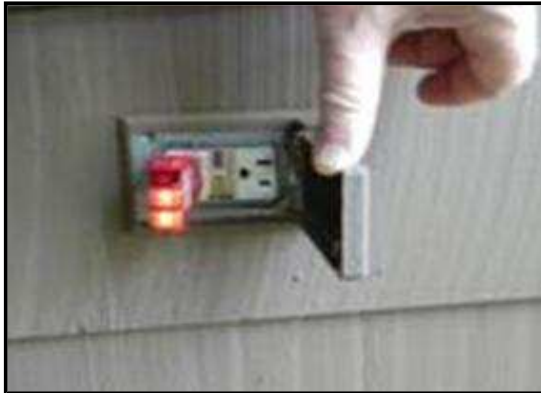
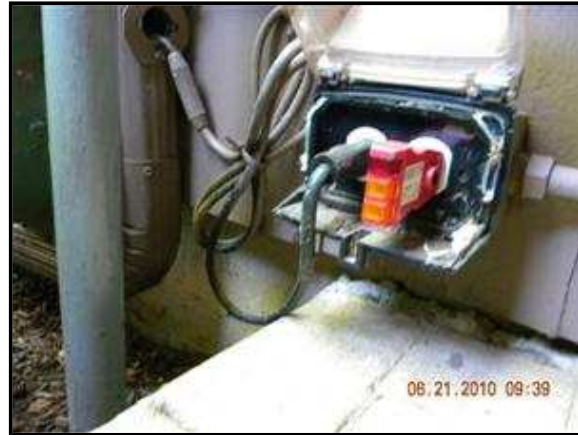
1.3 Picture 1

(1) The GFCI failed to trip when tested. This is considered a safety hazard until repaired. Recommend replacement by a licensed electrician.

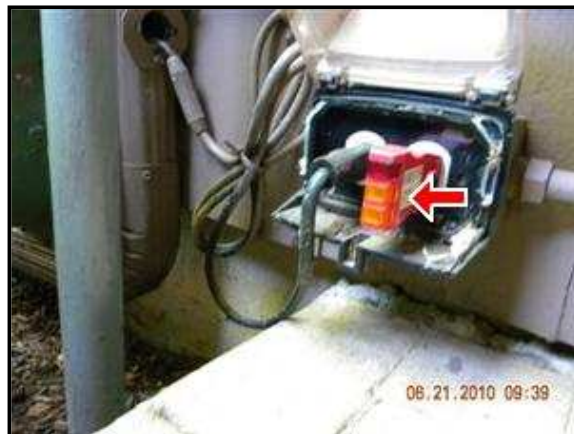
1.3 Picture 3

(2) No power at exterior outlet when tested. All circuit breakers are on at the main electric panel. The exterior outlets may be controlled by an interior/exterior switch, consult with the homeowner. Otherwise, recommend repair of the outlet by a licensed electrician.

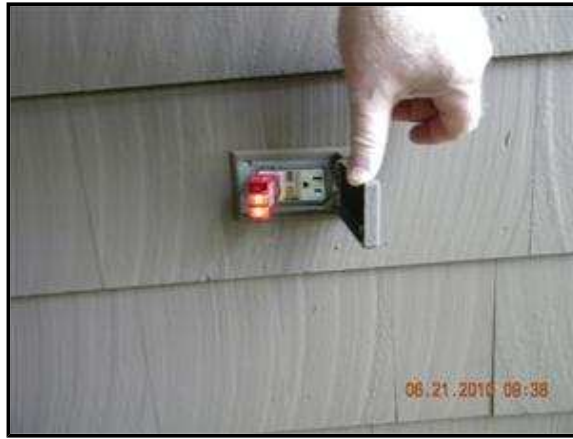
1.3 Picture 4

(3) The exterior outlet is loose. An electrical shock and fire hazard is present until repaired. Repair recommended by a licensed electrician.

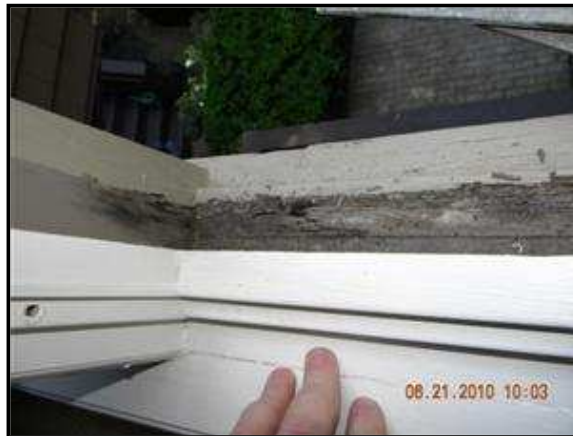
1.5 Picture 1

(1) Upstairs Back Bedroom - The wood frame around the windows are rotted. Wood frames need repair to prevent further accelerated deterioration and leakage into homes interior spaces. Evaluation and repair recommended by a qualified contractor.

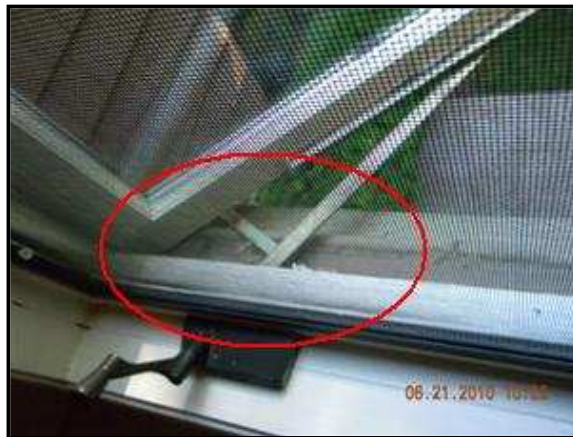
1.5 Picture 2

(2) Upstairs Back Bedroom - An active carpenter ant nest is present in the window frames. I recommend treatment for the control of carpenter ants.

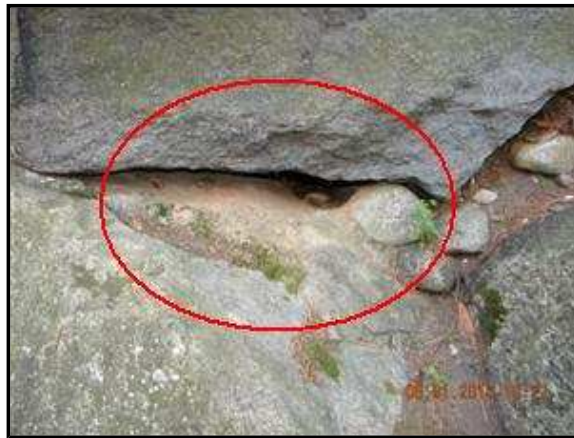
1.12 Picture 1

Vermin living in retaining wall in garden area are digging holes through garden bed that can upset the health of plants, retaining wall drainage and installed appliances. Recommend relocating vermin.

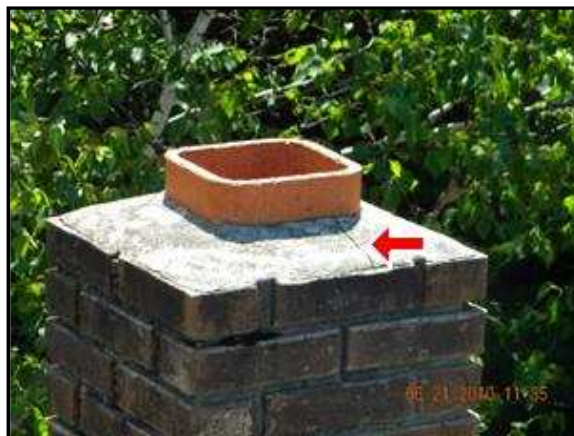
## 2.3 Picture 1

The concrete chimney cap is cracked. The cracked chimney cap may let moisture enter the cavity between the chimney wall and flue pipe. Moisture in the chimney can damage bricks, block, mortar and flue pipe. I recommend patching cracks in cap or replacing cement cap to prevent deterioration of chimney.

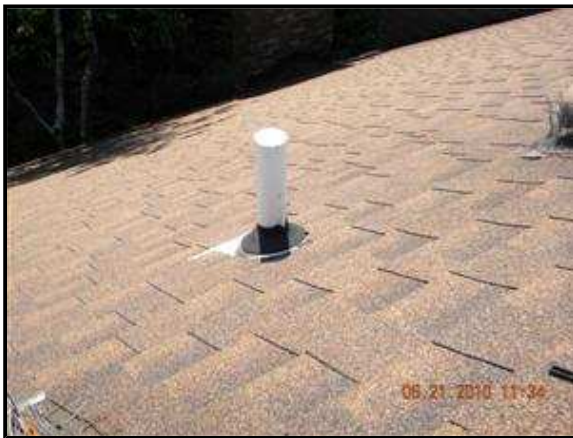
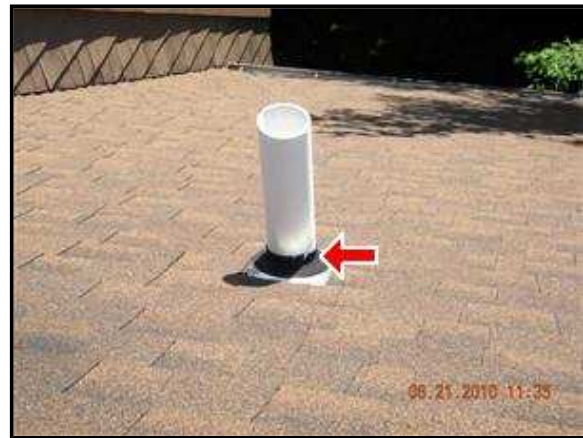
2.4 Picture 1

The flashing boot around the plumbing stack is cracked and has holes. The flashing around the plumbing vent needs repair or replacement by a qualified roofing contractor to prevent leakage to attic and interior spaces of home.

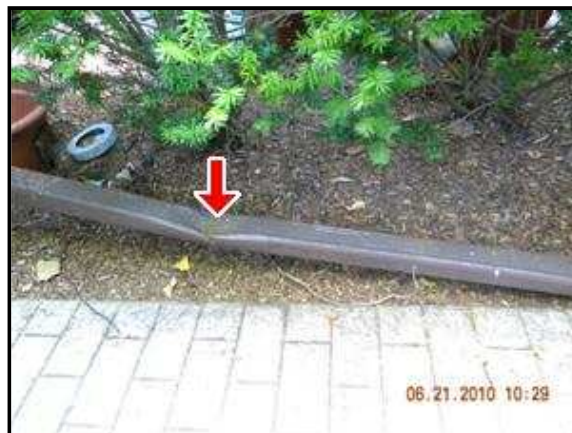
2.5 Picture 1

Gutters may overflow and drain/splash against foundation in rain storms. Puddling water against foundation may leak into basement causing moisture damage. Leader repair is recommended.

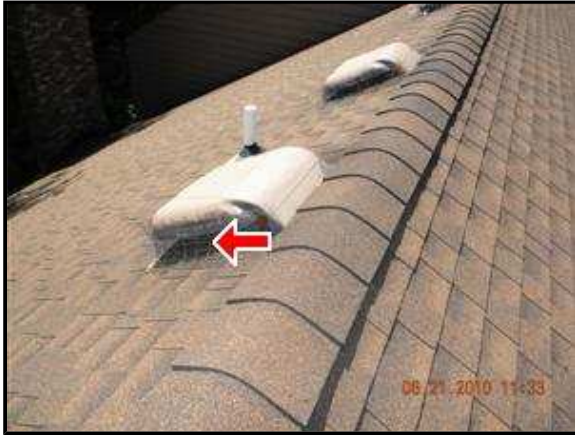
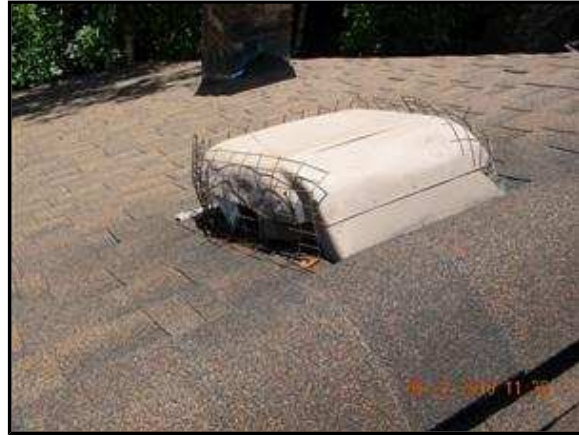
2.6 Picture 1

Active bees nests observed in vents. Exterminate bees for safety.

Vents have screen mesh added to help fight the ingress of vermin to attic spaces.

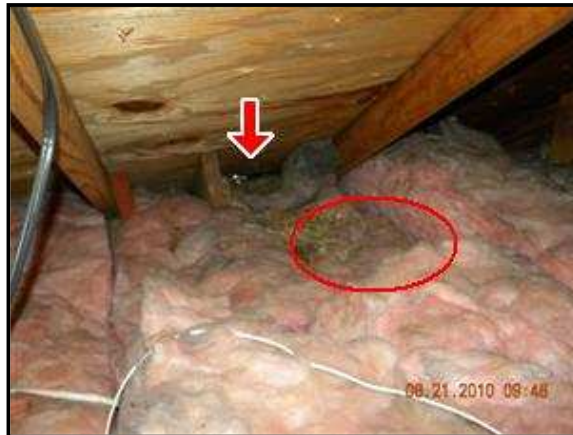
2.8 Picture 1

Debris that looks like bird nesting behavior present. Presence of nest debris suggest that the attic space has openings to allow the entry of birds. Patch the holes that are allowing the entry of birds or other vermin.

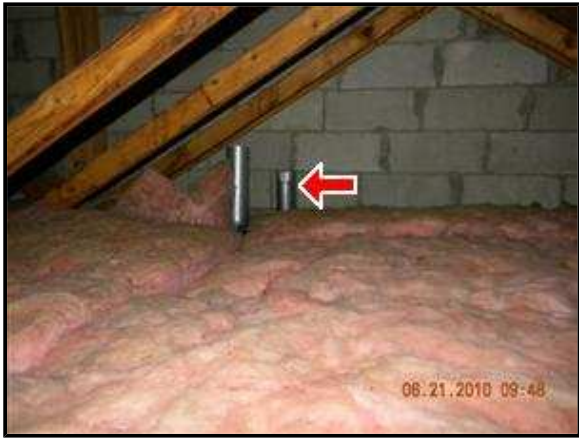
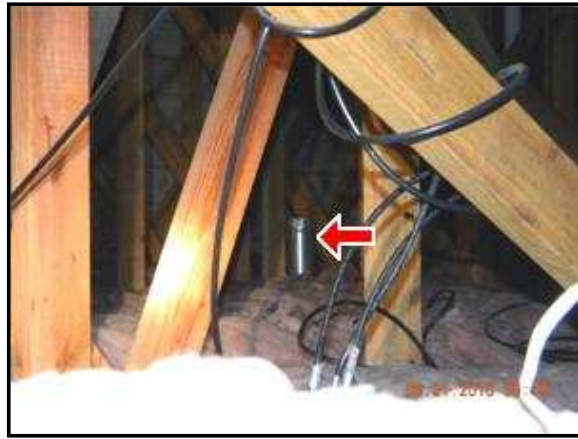
2.11 Picture 1

The bathroom exhaust vents discharge into the attic space. The fan should ideally vent to the exterior to avoid build up of humidity, condensation and mold in the attic space. Evaluation and repair recommended by a qualified contractor.

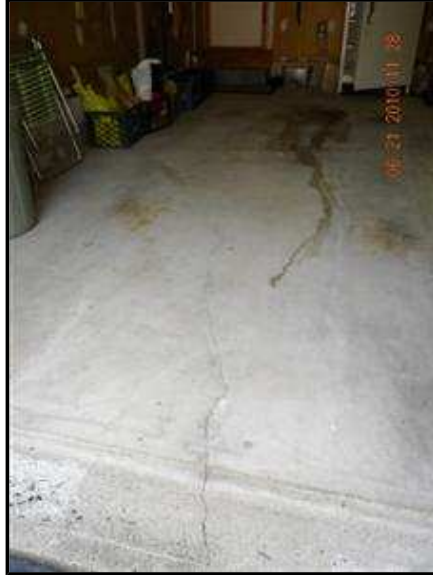
3.2 Picture 1

Note: The concrete floor of garage is cracked in areas from expansion/contraction or slight movement. I could not tell if the cracking is old or recent. I recommend patching or sealing cracks with an appropriate sealant or mortar.

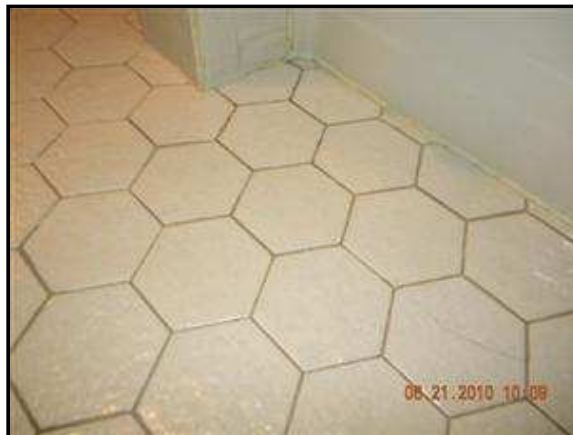
4.2.A Picture 1

The bathroom floor has cracked floor tile, loose floor tile & loose grout between tile. Moisture may penetrate flooring and damage the interior spaces of the flooring cavity. The floor is in need of evaluation and repair by a qualified contractor.

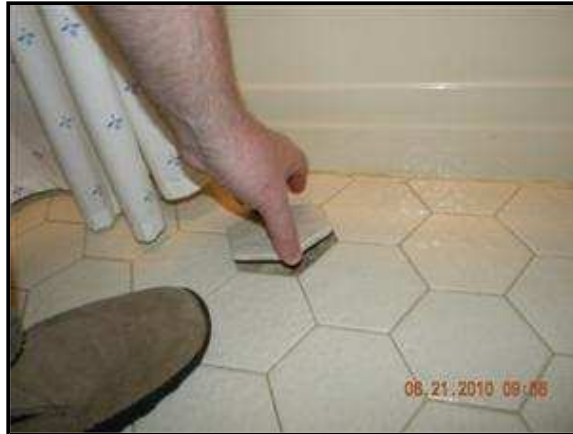
4.2.B Picture 1

The bathroom floor has cracked floor tile, loose floor tile & loose grout between tile. Moisture may penetrate flooring and damage the interior spaces of the flooring cavity. The floor is in need of evaluation and repair by a qualified contractor.

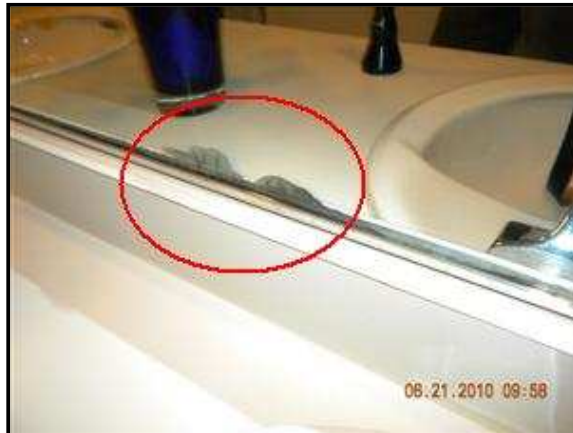
4.3.B Picture 1

The mirror reflective coating is damaged. Repair or replacement by a qualified contractor.

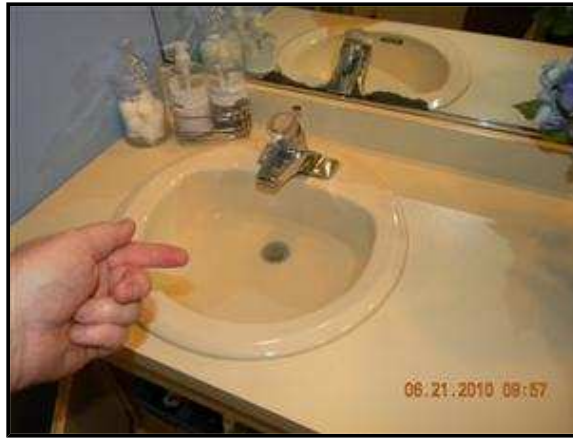
4.7.B Picture 1

The sink is draining slowly. The sink drain needs cleaning or repair.

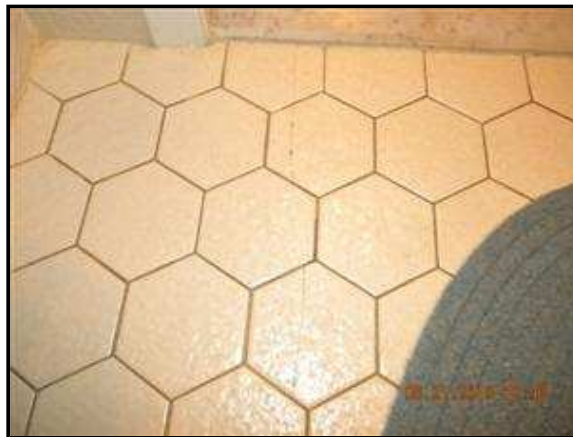
4.2.C Picture 1

The bathroom floor has cracked floor tile, loose floor tile & loose grout between tile. Moisture may penetrate flooring and damage the interior spaces of the flooring cavity. The floor is in need of evaluation and repair by a qualified contractor.

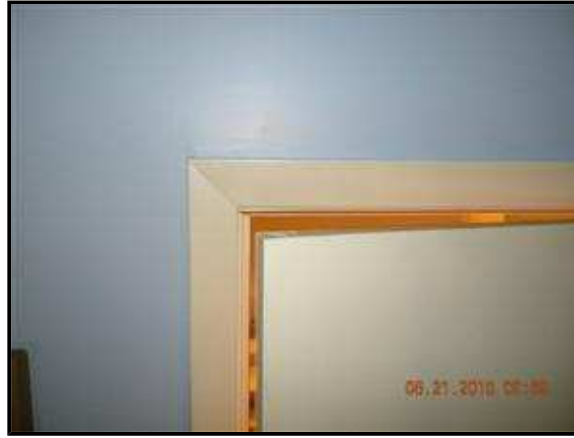
5.4.A Picture 1

The door is binding on frame. The door needs adjustment or repair to work properly.

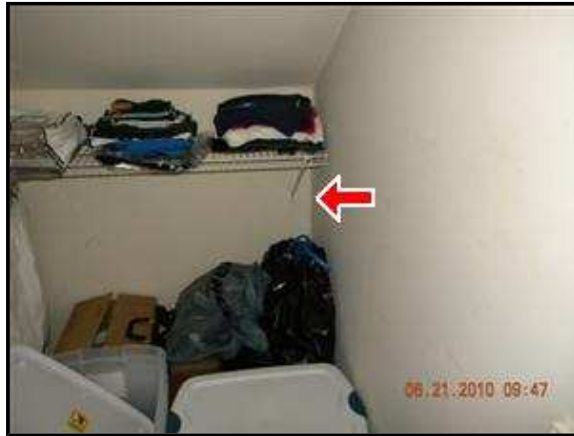
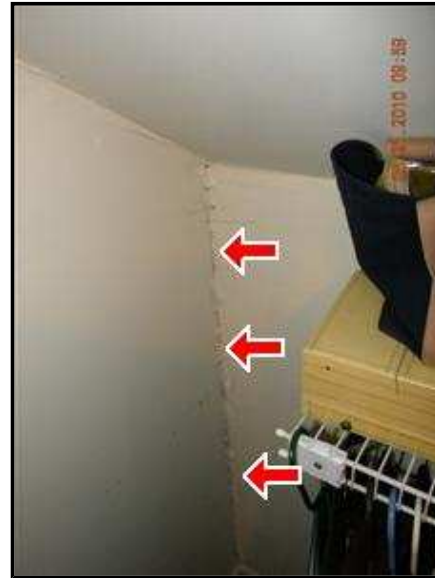
5.5.A Picture 1

Tape on seams in the corners of wall is torn. The tape in corners may have become damaged from slight localized movement. I recommend tape, spackle and paint repairs by a qualified contractor.

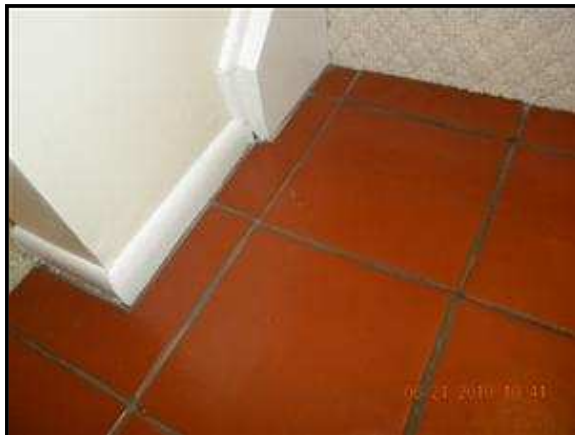
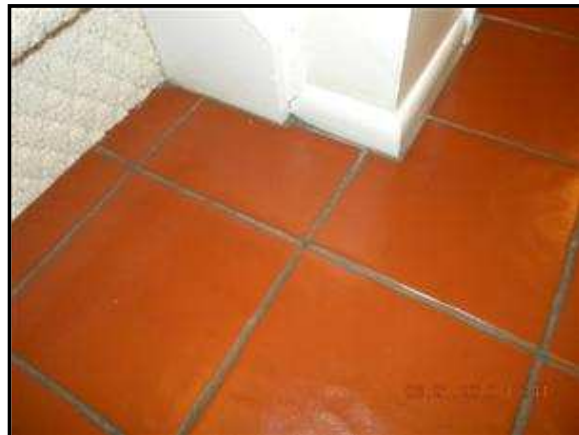
5.2.D Picture 1

Floor tiles are cracked, split, damaged and missing. Some tiles are loose and constitute a tripping and slipping hazard. Recommend repair or replacement.

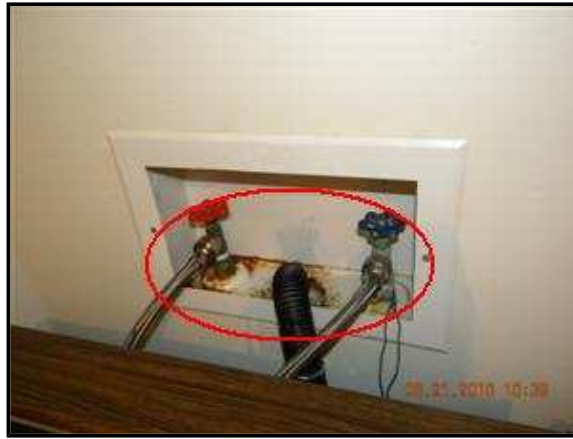
7.6 Picture 1

The wall mounted drain assembly is corroded and rusted. The wall mounted drain assembly should be repaired or replaced to prevent further rust corrosion that would lead to eventual leakage to interior spaces of home. Evaluation and repair recommended by a licensed plumber.

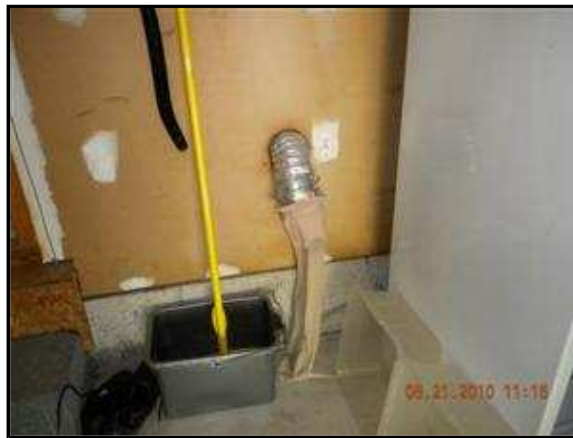
7.7 Picture 1

The dryer vents to the interior of the garage. Build up of humidity, condensation, lint and mold possible in garage area. Recommend venting the dryer outside.

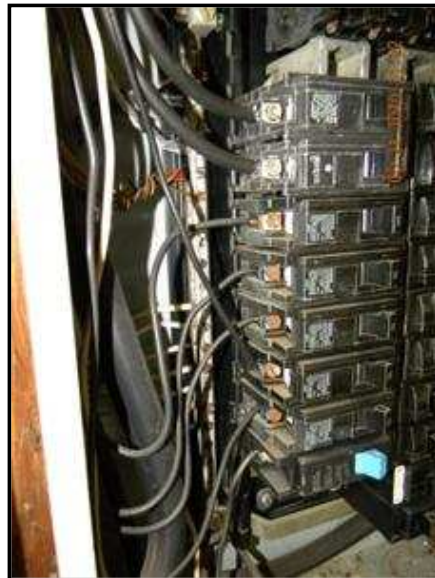
8.1 Picture 1

Corrosion is present on the circuit breakers and wire connections. The moisture source is typically leakage from outside at the mast head, service wire entrance at the meter box or the meter box enclosure cover. Repair of the moisture leakage source and clean up of the corrosion in the enclosure is recommended by a licensed electrician.

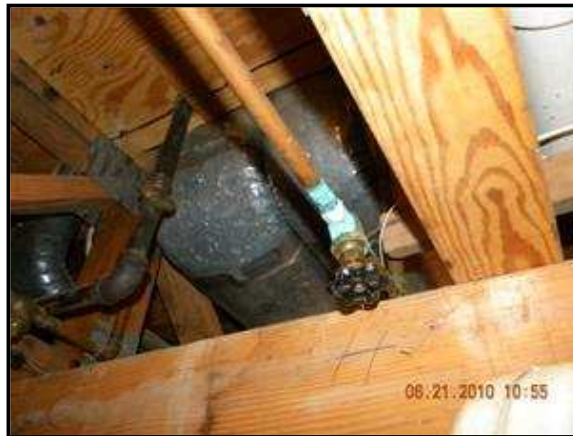
9.3 Picture 1

Corrosion present at pipe joints and fittings from prior chronic intermittent leakage. Repair recommended to prevent an untimely plumbing leak. Recommend evaluation and repair by a licensed plumber.

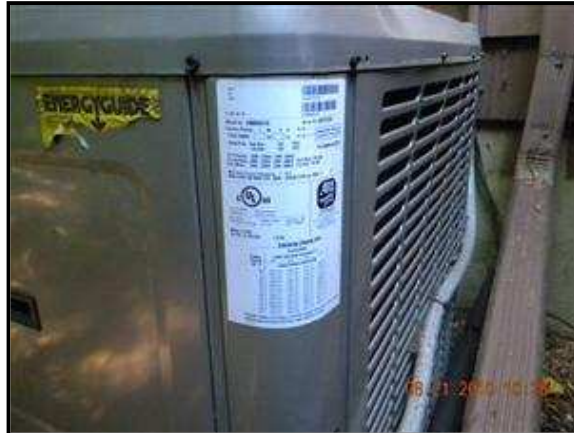
10.3 Picture 1

(1) Note: AC condensers that have reached the age of 15 years and are still in operation are considered to be at the end of their design lives. Not all Hot AC condenser units reach the age of 15 years, many fail as they near this age. Consider replacing older AC condensers prior to their failure. AC condensers left in service beyond 15 years are not generally a problem, but may fail at an inconvenient moment and cost more to replace in an emergency than when replaced at your leisure.

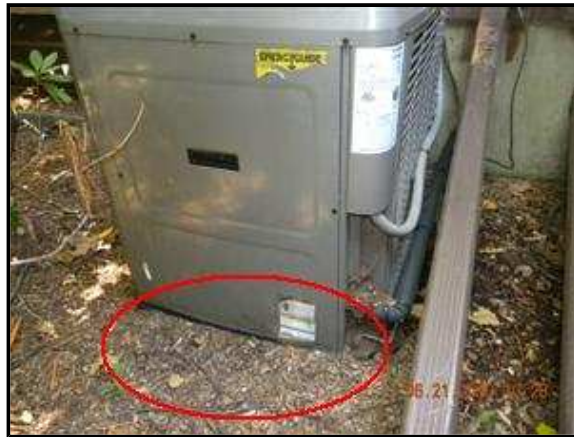
10.3 Picture 2

(2) Debris from the garden and yard cover the base of the AC condenser. Debris will trap moisture against metallic surfaces to promote rust and corrosion. Debris in cooling fins will reduce cooling efficiency. I recommend placing the AC condenser(s) on a pad and regrading garden surfaces to keep condensers free of garden and yard debris.

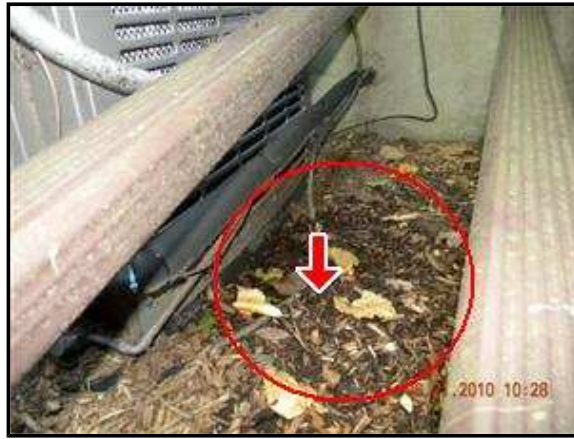
10.3 Picture 3

(3) The condensate pump discharges outside against the foundation. Moisture build up against the foundation on a continual basis can result in moisture leakage into the basement area of the home. Recommend discharging condensate a downspout leader, a wall mounted drain for a washer or to a slop sink.

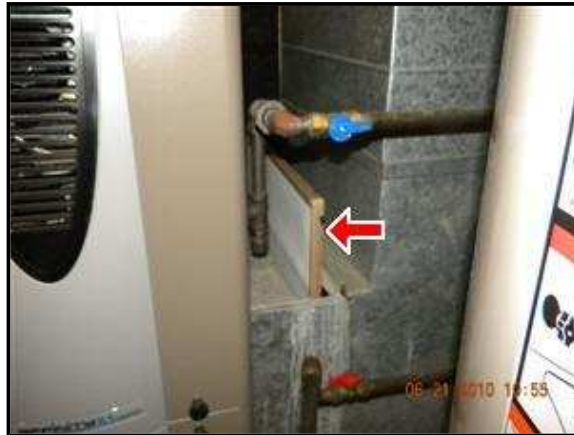
10.4 Picture 1

After you first move in, recommend inspecting every two weeks during heating or cooling season. If filter does not appear dirty then wait longer to check for dust build up. You will eventually figure out how often to change filter. If you can see dust on the filter, it is probably worth changing or cleaning. A totally clogged filter will cause the HVAC system to run inefficiently.

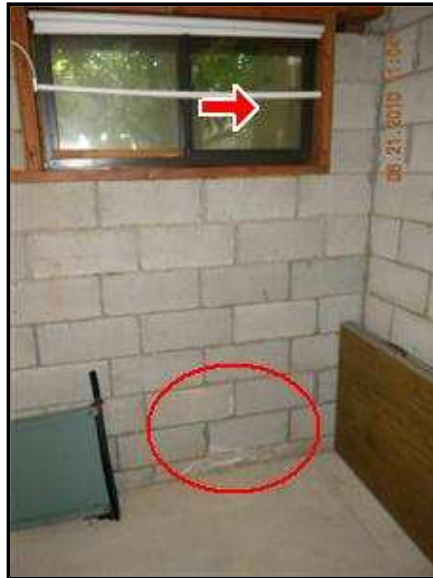
11.0 Picture 1

Note: The condensation discharge for the AC system is in the garden bed outside the basement foundation area may be responsible for the efflorescence.

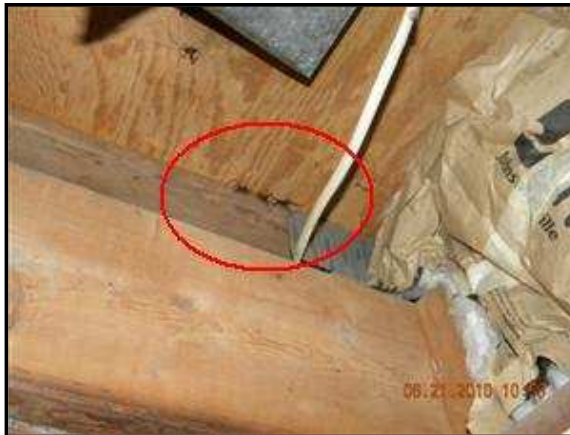
11.0 Picture 2

(2) Crickets present near electrical panel. Crickets can sometimes be found in basement areas where high levels of moisture and humidity are present. Recommend moisture control of basement area and extermination of crickets.

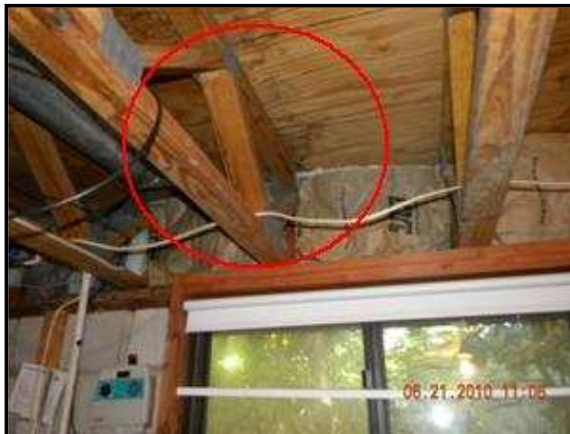
11.0 Picture 3

(3) Leakage stains from past moisture leakage on subflooring under the living room windows that the homeowner disclosed were recently replaced.

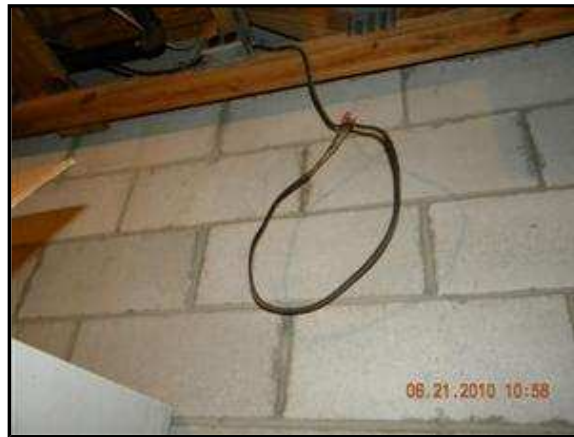
11.13 Picture 1

Open electrically active connections and wire ends present. Active joints and ends should be terminated in a junction box. An electrical safety hazard is present until repaired.
