Inspection Report

Single Family Sample Report

All In One Home Inspection LLC

Joseph W Fleming III - Home Inspector License 24GI00045600

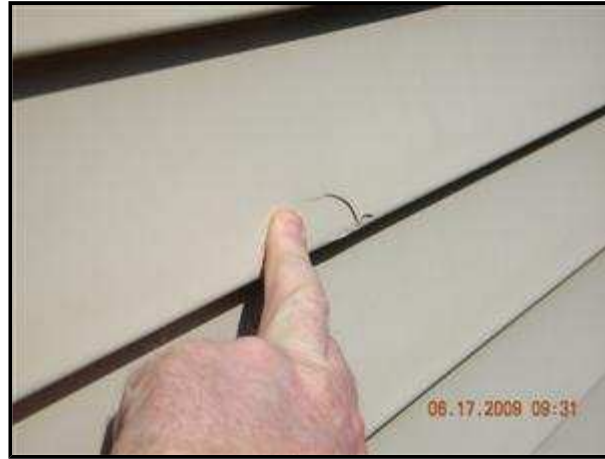
1.0 Picture 1

Deck Stair Area - Siding damaged. I recommend repair in order to prevent insects, vegetation and moisture from entering behind veneer. Consult with a qualified contractor.

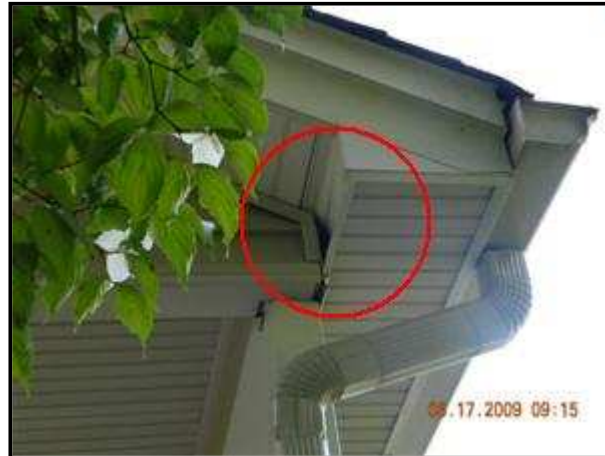
1.1 Picture 1

A gap between the eave board and soffits exists. The gap should be sealed to prevent vermin, moisture and insects from getting past the siding to enter the soffit and attic spaces.

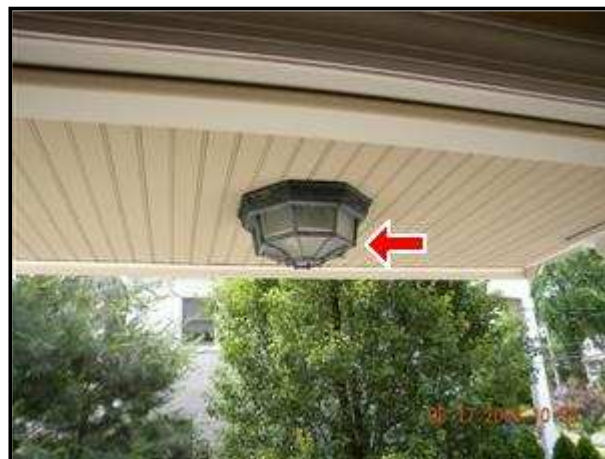
1.3 Picture 1

(1) The exterior light does not illuminate. The bulb may be burned out, the switch broken or the lamp light sockets broken. Replace bulbs and try to operate lamp, otherwise repair recommended by a licensed electrician.

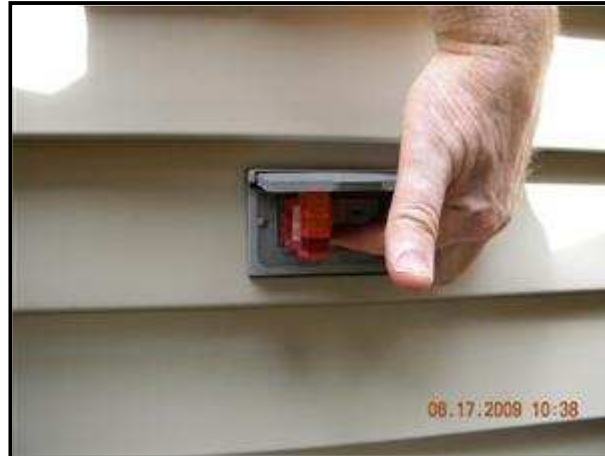
1.3 Picture 2

(2) Deck Area - The exterior GFCI is tripped in the off position and will not reset easily. This is considered a safety hazard until repaired. I recommend replacement of the GFCI outlet and a follow up test to ensure their intended safe operation.

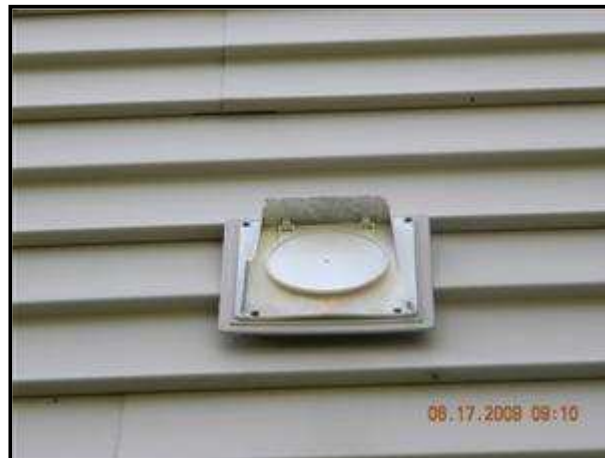
1.4 Picture 1

Dryer vent cap damaged. The damaged cap may leak allowing rain water to leak into the dryer and interior spaces of the home. Replacement of the dryer vent cap is recommended.

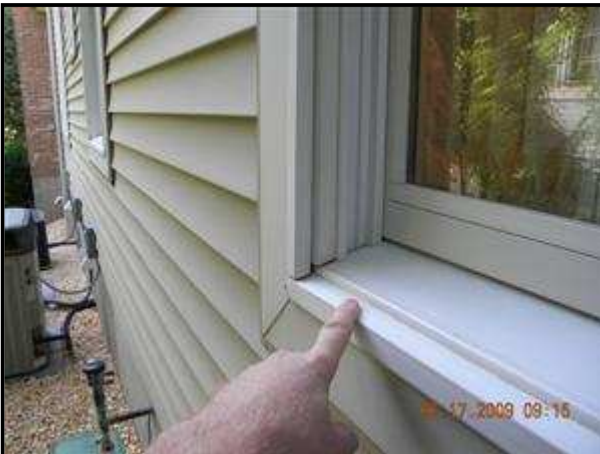
1.5 Picture 1

Screens missing from windows. Replace to prevent the ingress of insects and vermin when windows are open.

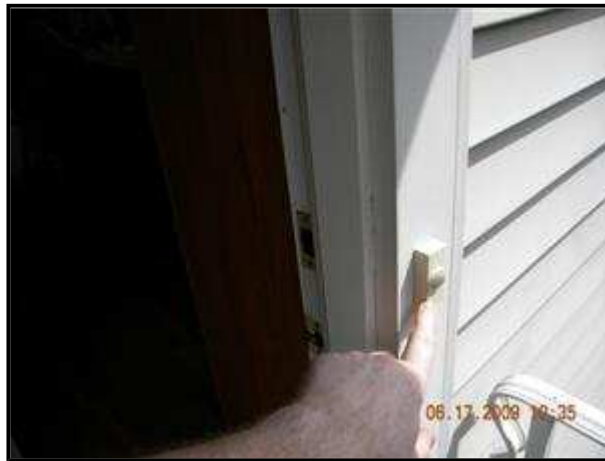
1.6 Picture 1

Side Door - Door bell inoperative. Door bell needs repair.

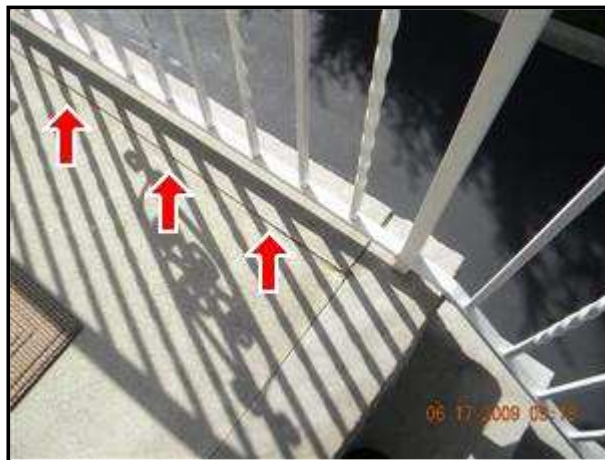
1.7 Picture 1

(1) Side Steps - The steps have loose and cracked mortar between concrete slabs on the landing. The cracks will be prone to further damage from thermal expansion/contraction and moisture/ice expansion in winter. Recommend re-pointing the slabs on the landing to prevent continued accelerated damage to the steps.

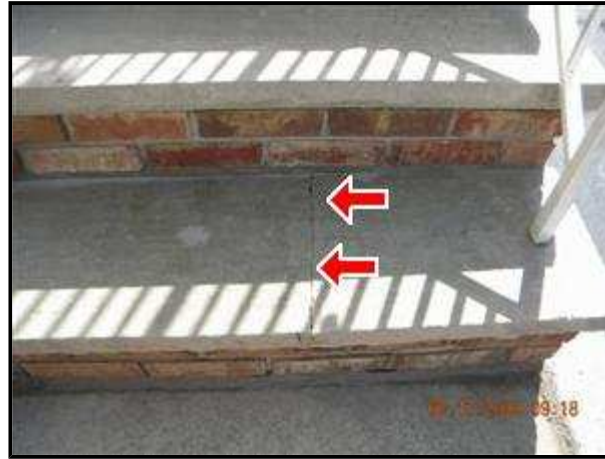
1.7 Picture 2

(2) Side Steps - Step treads are cracked. The cracks will be prone to further damage from thermal expansion/contraction and moisture/ice expansion in winter. Recommend sealing, patching or replacing step treads to prevent further moisture and ice damage to step, brick and mortar.

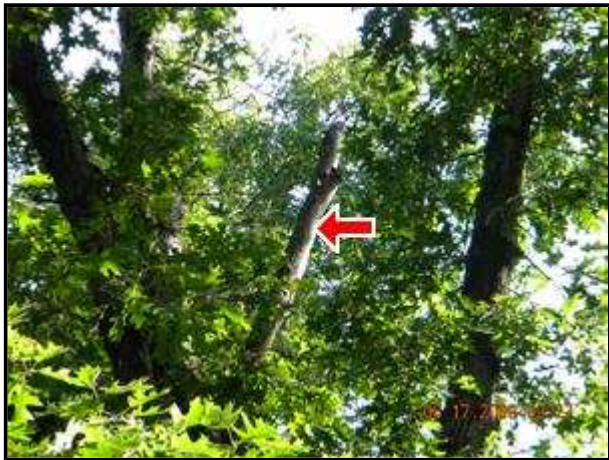
1.11 Picture 1

(1) Dead branches from trees are a hazard to persons working or playing in yard. Recommend tree pruning for dead branches by a qualified tree contractor.

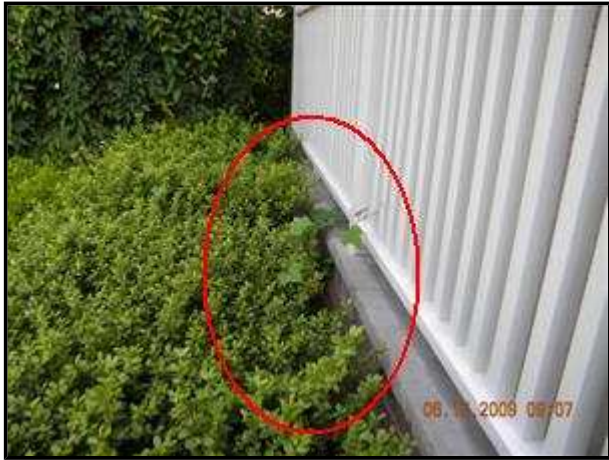
1.11 Picture 4

(2) Vegetation should be kept 4 to 6 inches away from foundation and siding. Vegetation can cause moisture

build up against siding and/or mechanical damage. Recommend cutting vegetation back or removal.

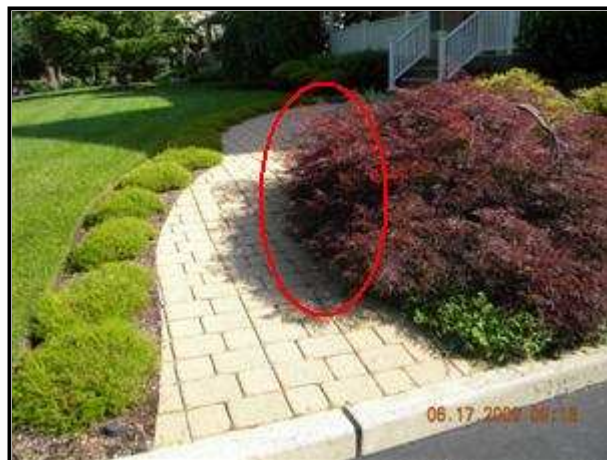
1.11 Picture 7

(3) Walkways are overgrown with bushes and shrubs from garden. Cutback or remove vegetation to allow use of walkways.

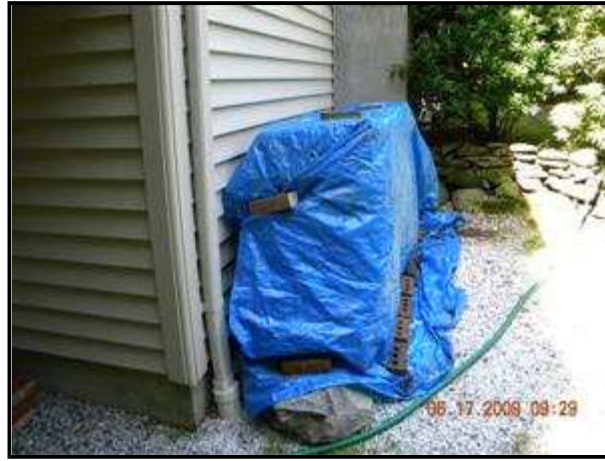
1.11 Picture 8

(4) A wood pile is present that may attract wood destroying insects near home. I recommend removal of wood pile to help prevent the attraction of wood destroying insects.

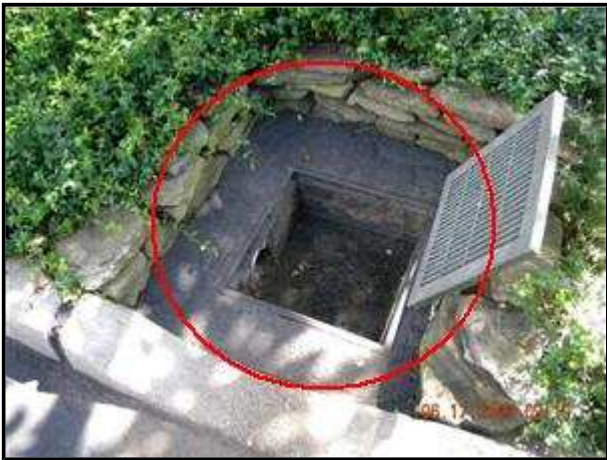
1.12 Picture 1

It could not be determined at time of inspection where the drain pipe for the surface drain in the driveway leads to. I could not determine if the drain was functional at time of inspection. The drain appears to be full of soil and may be clogged. The drain may require repair or cleaning by a qualified landscaper or drainage contractor to keep water from puddling at the end of the driveway. Evaluation and repair recommended by a qualified landscaper.

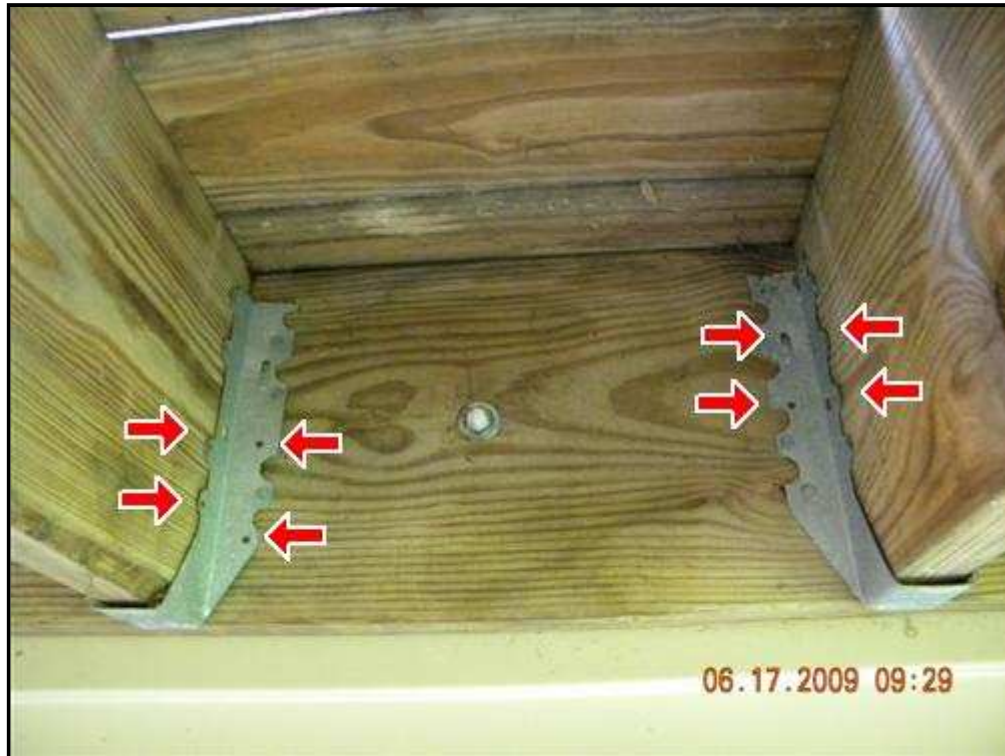
1.14 Picture 1

(1) Joist hangers under deck are missing nails. For maximum joist hanger strength and to meet manufacturers installation requirements there should be a nail in every fastener hole. I recommend consulting with the joist hanger manufacture for the correct nail size and installation requirements. This is considered a safety issue until corrected or repaired.

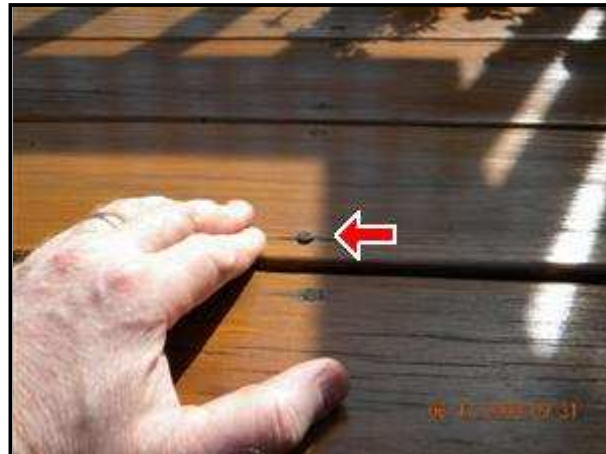
1.14 Picture 3

(2) Top of Stairs - Deck fasteners are protruding up from deck planks making for a tripping hazard. Protruding deck fasteners are also a hazard for bare feet. Refasten deck screws to secure deck planks and for safety.

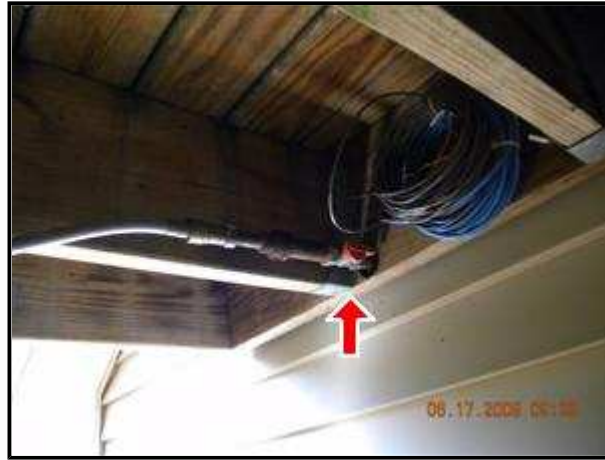
1.15 Picture 1

(1) Note: Gas cut off for barbecue is located under the deck.

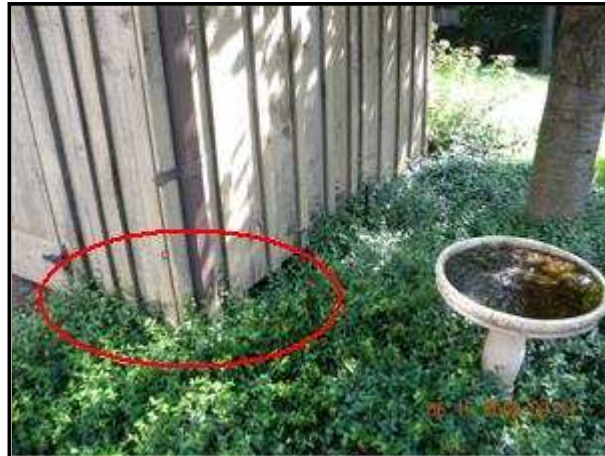
1.15 Picture 2

(2) Vegetation should be kept 4 to 6 inches away from foundation and siding. Vegetation can cause moisture build up against siding and/or mechanical damage. Recommend cutting vegetation back or removal.

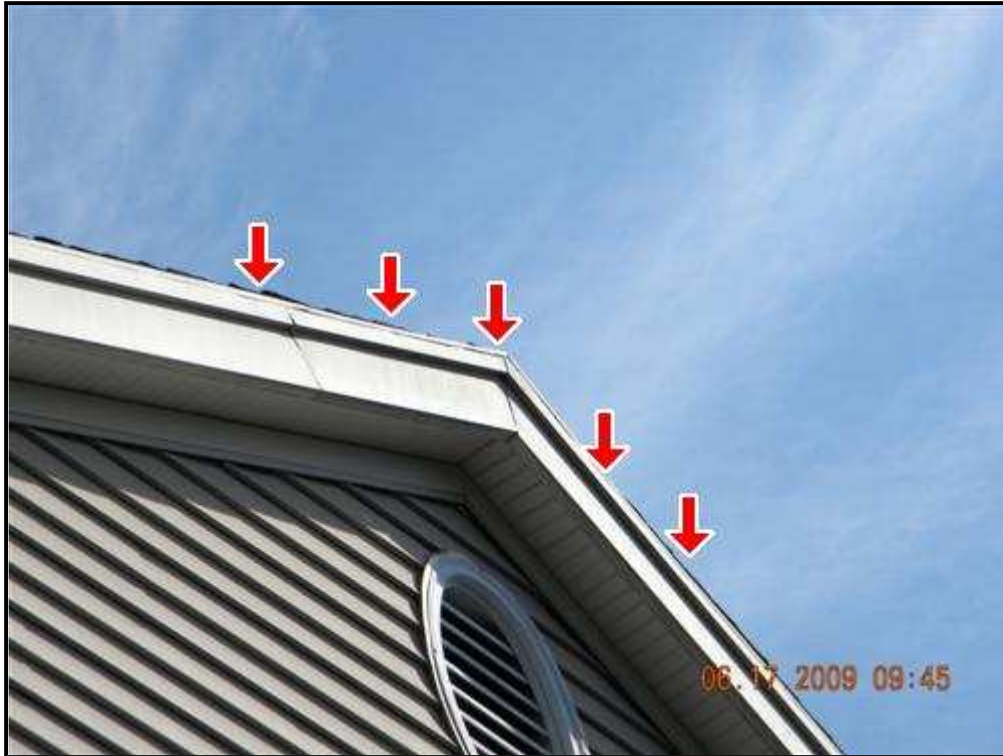
2.0 Picture 1

The roofing shingles do not extend over the edge of flashing and siding the traditional 1/2" to 1". Instead of dripping off the edge of the roofing shingle, the moisture may penetrate the gap between the flashing and shingle to get trapped behind roofing shingles and run down inside the siding. Moisture behind the roofing shingles may leak and cause moisture damage to roof sheathing, rafters, attic spaces and interior spaces. Recommend caulking exposed seam. Consult with a roofing contractor to evaluate and make repairs.

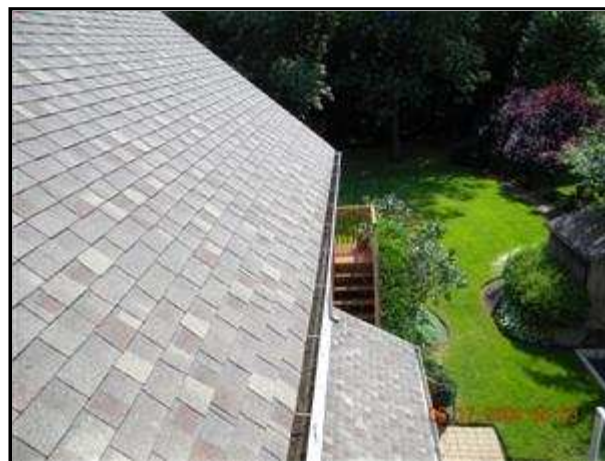
2.4 Picture 1

(1) The gutters are full of debris in areas and needs to be cleaned. Debris in gutters are blocking downspouts, causing gutter overflows and rain splatter onto siding and foundation. Cleaning of gutters is recommended to prevent unwanted water damage to exterior and interior of home. Consider installing gutter guards to help prevent build up of debris in gutters.

This particular gutter appears to collect and drain AC condensate. The gutter will remain wet all summer as condensate drains through to the back yard and drain area. I recommend keeping gutters clean to prevent unwanted rotting debris and resulting odors from occurring in gutters and downspouts.

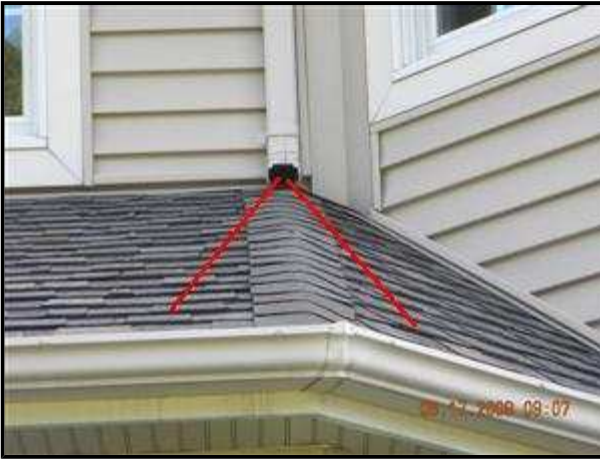
2.4 Picture 2

(2) Runoff water from another gutter and downspout drains across a lower roof surface. Runoff water will erode roof surface which will lead to premature roofing failure and leakage. The moisture from the clogged upper gutters is slowly seeping out keeping the lower roofing moist below the downspouts. Recommend adding leaders across lower roof surface to guide rain water to the lower gutter.

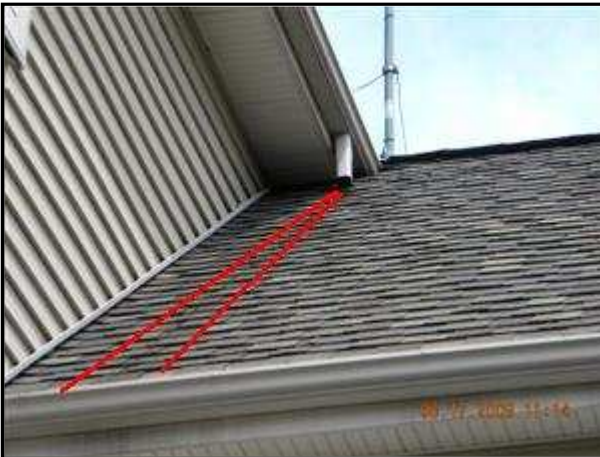
2.4 Picture 6

(3) The attic AC condensate drain is piped to a nearby gutter which causes moisture to continually drain across roof surface. Continual presence of moisture on a roof surface can eventually erode roof surfaces and saturate the roof surface with moisture, which may eventually lead to leakage. I recommend reconnecting the condensate drain to an interior house drain or add leaders across the roof surface to drain moisture to a lower gutter.

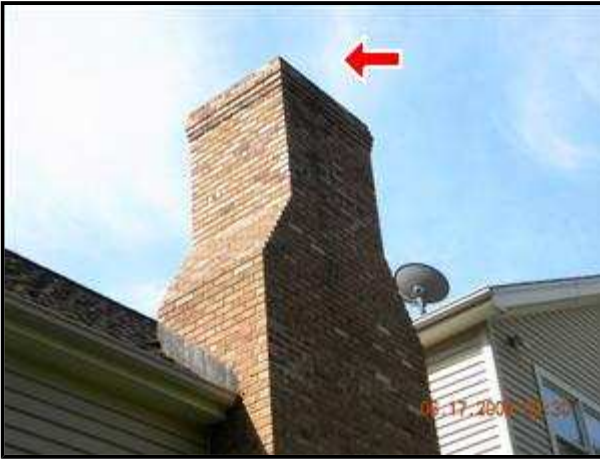
2.6 Picture 1

Consider installing a flue cap to prevent the ingress of moisture, debris and vermin.

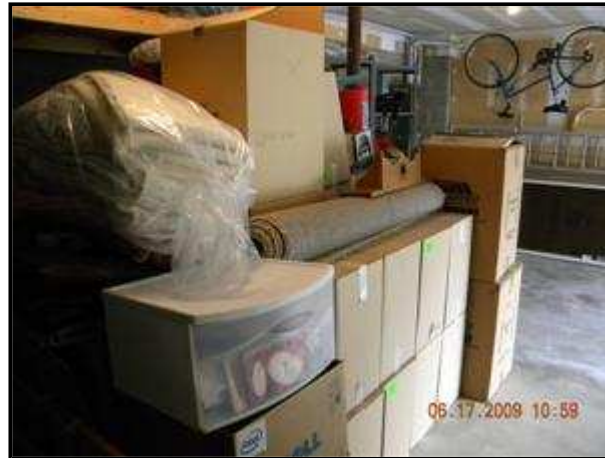
3.2 Picture 1

Note: Garage had stored items at time of inspection, unable to completely inspect foundations, floors, walls, ceilings, windows and/or outlets.

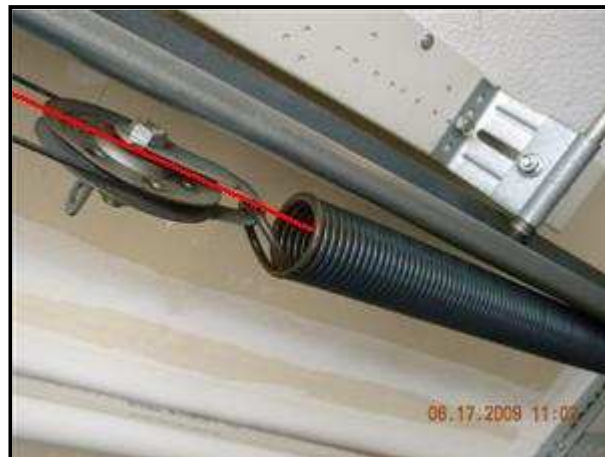
3.3 Picture 1

(1) A safety wire passing through the center of the door spring is missing. The safety wire keeps the spring from injuring those operating the door should the spring break. Recommend the installation of a safety wire.

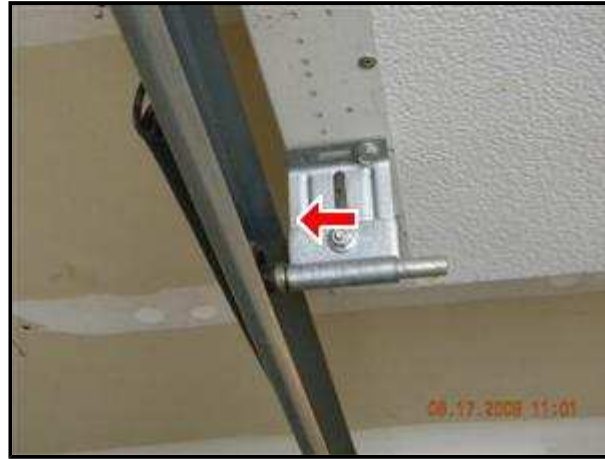
3.3 Picture 2

(2) The hinge plates chafe on the garage door rails. The hinges need adjustment to prevent chaffing or rubbing on rails. Recommend repair by a qualified garage door contractor.

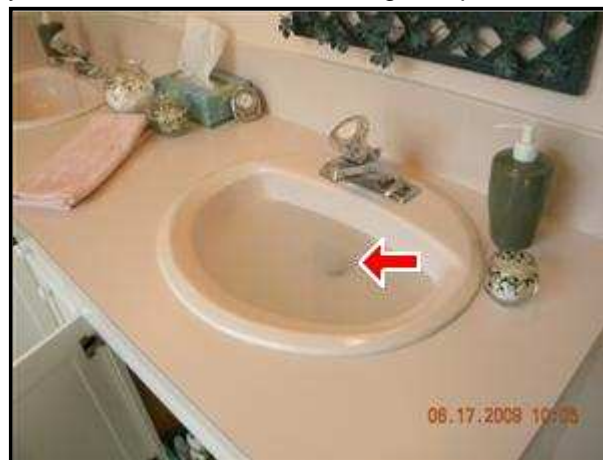
4.7.A Picture 1

(1) The sink is draining slowly. The sink drain needs cleaning or repair.

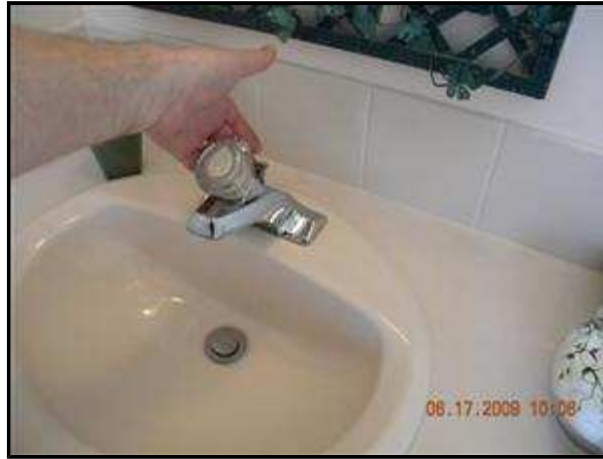
4.7.A Picture 2

(2) The sink stopper is missing or not working. Replacement or repair is needed to make sink work as intended.

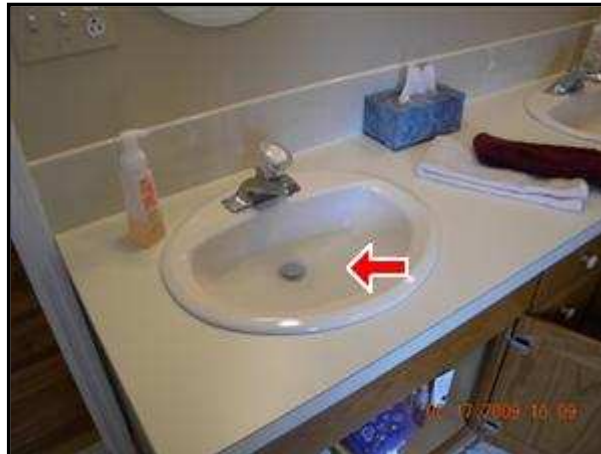
4.7.B Picture 1

The sink is draining slowly. The sink drain needs cleaning or repair.

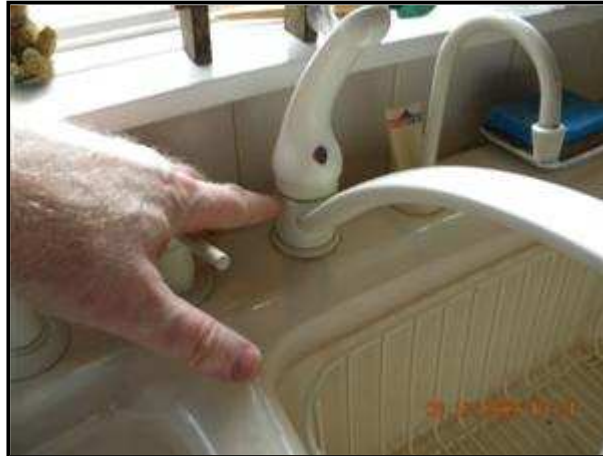
6.6 Picture 1

The lever on faucet leaks at the sink. Repairs are needed to stop leaking water from damaging the cabinet bottom or to eliminate moisture that may contribute to fungi growth. I recommend repair as necessary by a qualified person or plumber.

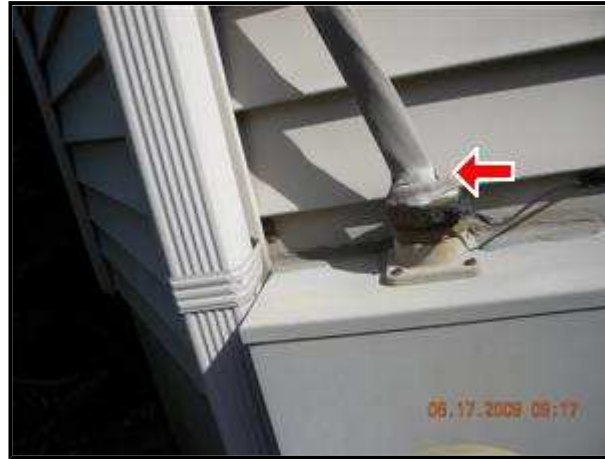
8.0 Picture 1

Cracked or missing caulking where service wire enters the electric meter box, service wire needs to be caulked at cable gland to prevent moisture ingress into meter box and elsewhere. Repair recommended by a licensed electrician.

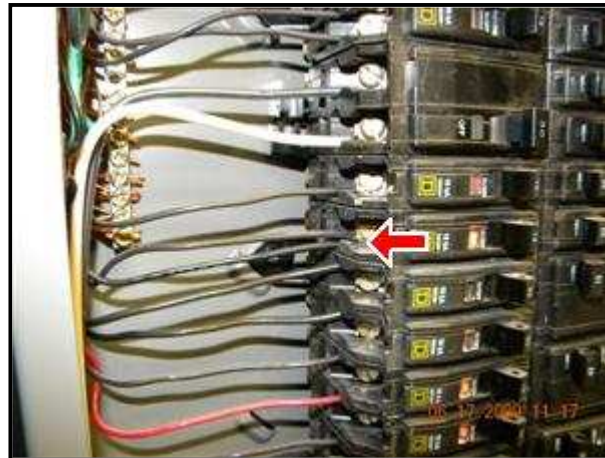
8.2 Picture 1

Double tap wiring of breakers is present. Recommended practice is one wire per circuit breaker to prevent the connections and breaker from overheating. Consult with an electrician for evaluation and repair.

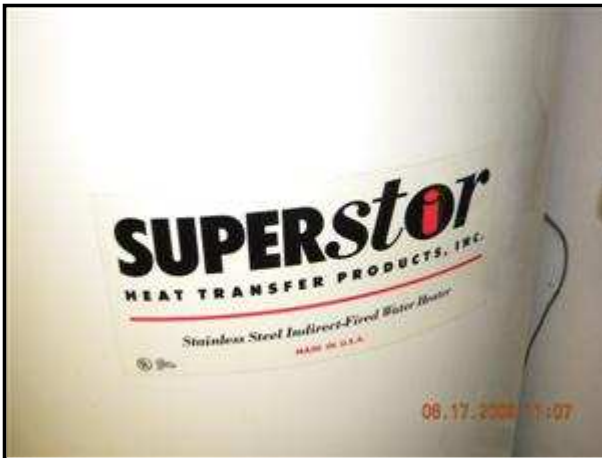
9.4 Picture 1

(1) Note: Hot Water Heaters that have reached the age of 12 years and are still in operation are considered to be at the end of their design lives. Not all Hot Water Heaters reach the age of 12 years, many fail as they near this age. Consider replacing older Hot Water Heaters prior to their failure and eventual leakage. Hot Water Heaters left in service beyond 12 years should be monitored for leakage continually until they are replaced. Budget for a new Hot Water Heater in the near future.

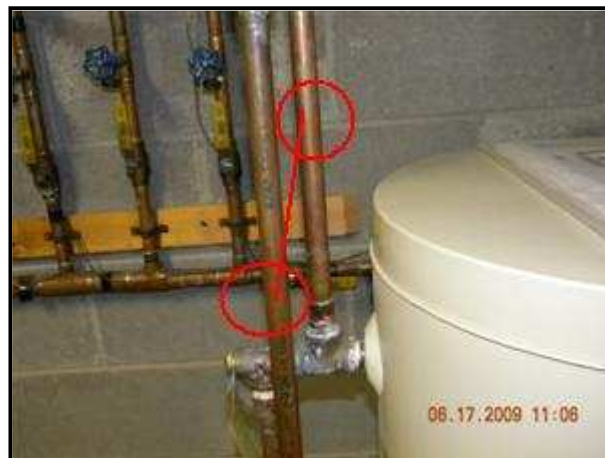
9.4 Picture 3

(2) The "bonding" wire for the hot to cold water pipes at the hot water is disconnected or missing. If the bond wire is not reattached an electrical shock hazard may become present on all the hot water piping in the home if the hot water piping were to come in contact with active electrical wiring. I recommend the installation of a bond wire by a licensed electrician.

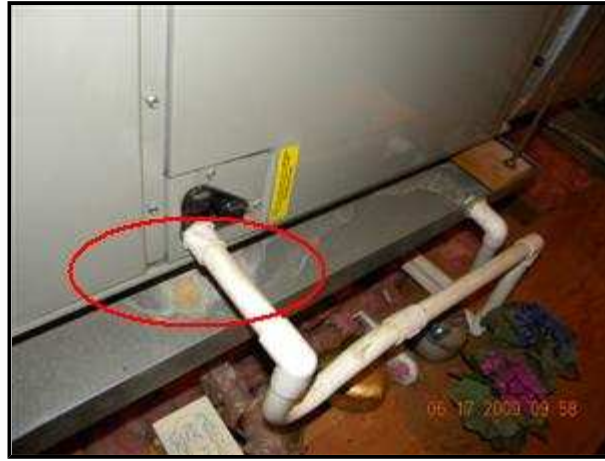
10.3 Picture 1

Attic - The primary drip pan located inside the AC evaporator cabinet shows signs of leaking AC condensate water into the secondary drip pan. Failure to repair the primary evaporator drip pan may eventually lead to the secondary drip pan clogging and leaking AC condensation water into the interior spaces of home. Recommend evaluation and repair by a qualified HVAC technician.

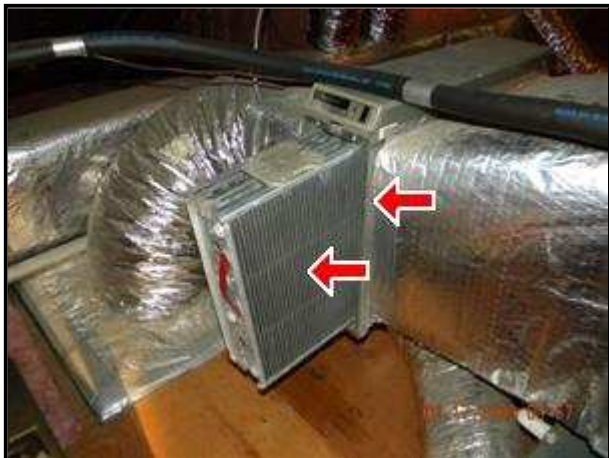
10.7 Picture 1 Electrostatic and Washable Filters

It appears that disposable filters could be used in the hallway ceiling instead of washable filters in the attic HVAC cabinets.

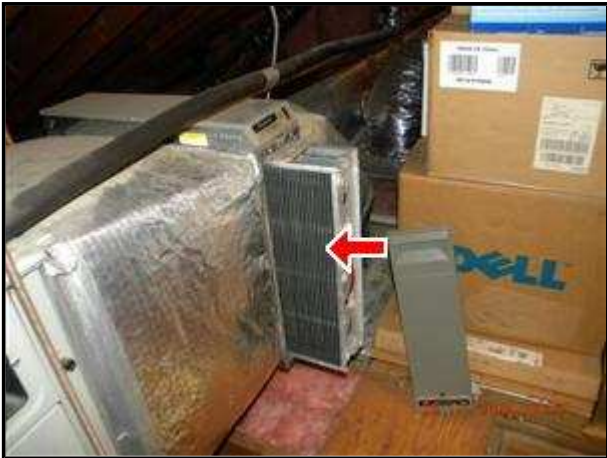
10.7 Picture 6

(2) The electrostatic air filter in the attic appears inoperative. The filter power did not appear to be turned on. I recommend repair by a qualified HVAC contractor to make operable.

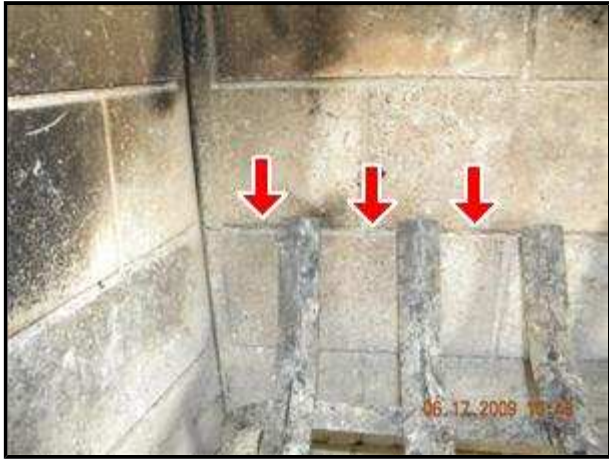
10.8 Picture 1

Fire brick in factory built fireplace appears to be cracked. I recommend repairing or replacing fire brick to prevent fire hazards from embers and uncontrolled hot flue gases. Consult with the fireplace manufacturer for the suitable fire brick panel replacement. Evaluation and repair by a qualified chimney inspector is recommended.

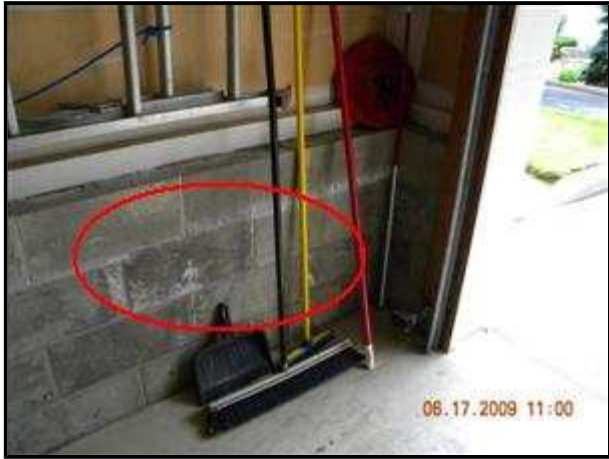
11.0 Picture 1

(1) White efflorescence (powder substance) on block wall indicates moisture is in contact with the masonry. This does not necessarily indicate that intrusion will occur. I recommend checking the gutters and the downspout drain lines for proper operation. Also, a water proofing paint could be applied to the interior side of the block if necessary. Efflorescence is found on many homes without water intrusion occurring inside the home. But, it should alert you to the possibility that future steps may be needed.

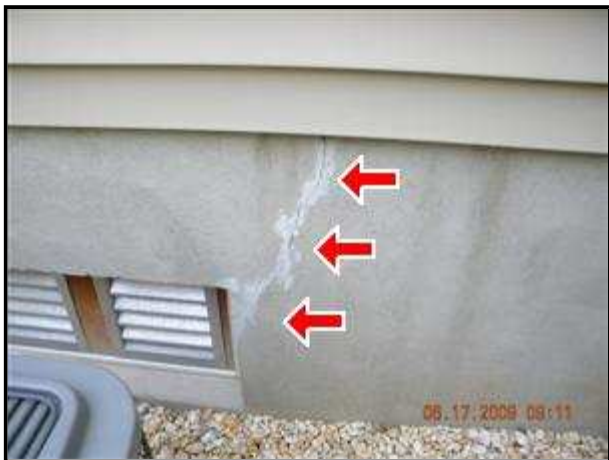
11.0 Picture 3

(2) Foundation cracks present. The cracks do not appear to effect the structural integrity of the home but should be patched to prevent the ingress of insects and moisture.

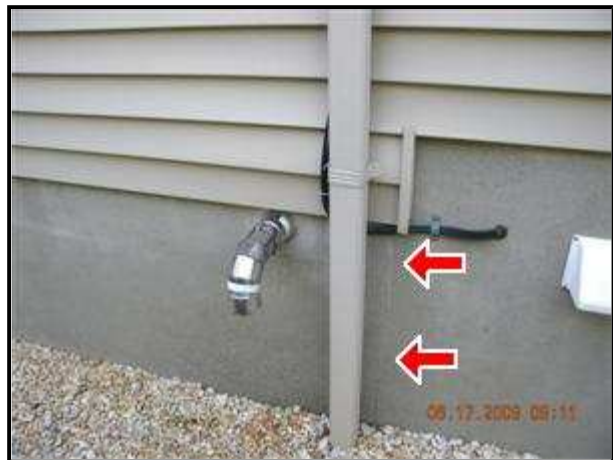
11.0 Picture 4

11.0 FOUNDATIONS (Report signs of abnormal or harmful water penetration into the building or signs of abnormal or harmful condensation on building components.)
