Home Inspection Report

Commercial Sample Report

All In One Home Inspection LLC

Joseph W Fleming III, PE, ACI - Home Inspector License 24GI00045600

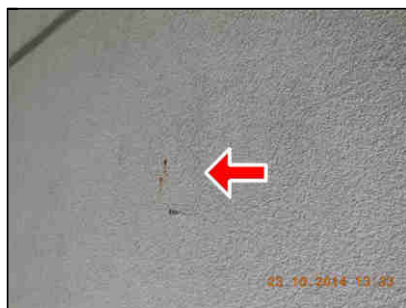
1.0 Item 1(Picture)

(1) EIFS siding has gaps and cracks at window frames, door frames, lamp fixtures and wall penetrations. Caulk and seal gaps to help prevent damage causing moisture from entering past the siding.

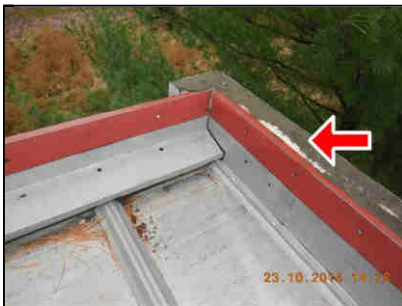
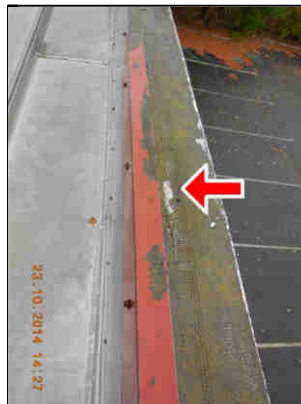
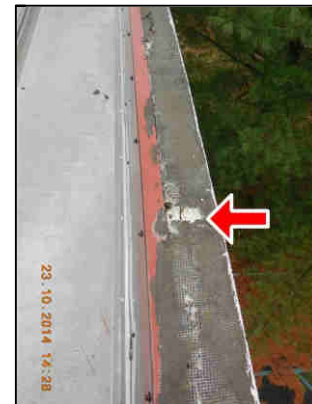
(2) The EIFS siding has open gaps at the top of the front wall that allows moisture to penetrate behind the siding to damage interior spaces. Repair recommended by a qualified contractor to help prevent moisture damage.

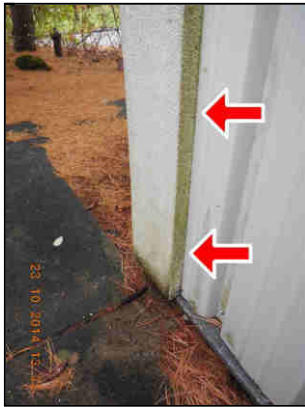
1.0 Item 16(Picture)

(3) The gaps and cracks where the EIFS siding meets the door and window frames caulked to prevent the ingress of damage causing moisture behind siding. Moisture behind siding can lead to corrosion of structural components and mold build up behind the siding. Repair recommended by a qualified contractor.

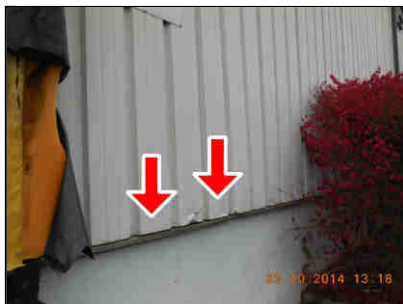
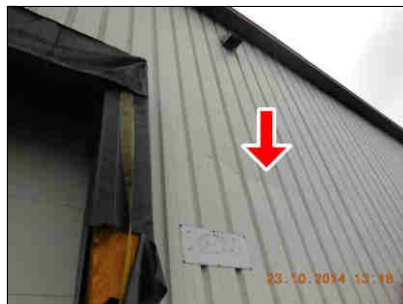
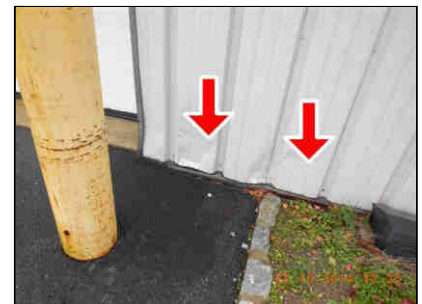
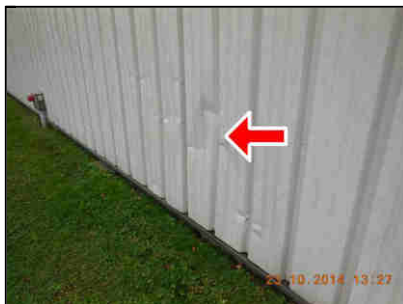
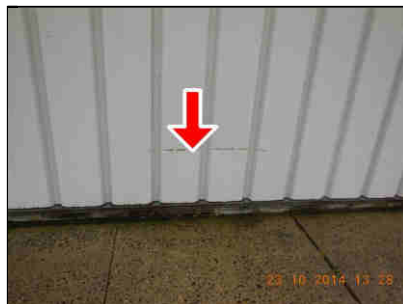
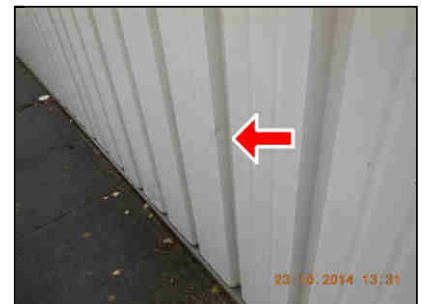
(4) The siding is dented and damaged from mechanical abrasion. Damaged and bent siding panels have been weakened. Repair recommended by a qualified contractor for safety.

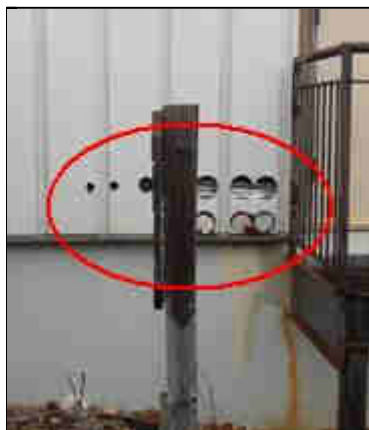
1.0 Item 26(Picture)

(5) Holes in the siding need repair to help prevent the ingress of insects, vermin and moisture.

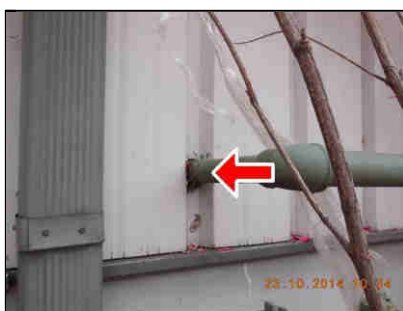
1.0 Item 28(Picture)

(6) The holes for wires and piping to pass through siding should be sealed and plugged to prevent the ingress of moisture, insects or vermin.

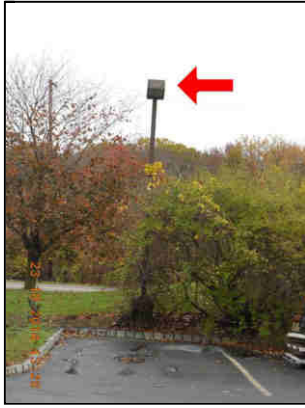
1.3 Item 1(Picture)

(2) Parking Lot Lights - Exterior lights do not illuminate. The bulbs may be burned out, the switches broken or the lamp light sockets broken. Replace bulbs and try to operate lamp, otherwise repair recommended by a licensed electrician.

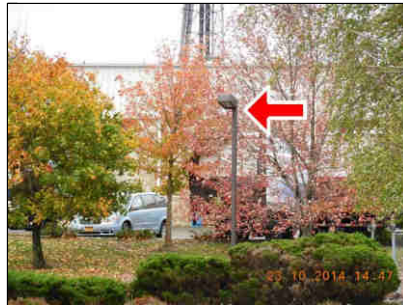
1.3 Item 4(Picture)

- 🏠 (3) The exterior GFCI has power on but does not trip when tested. This is a safety issue until repaired. I recommend evaluation and replacement by a licensed electrician.

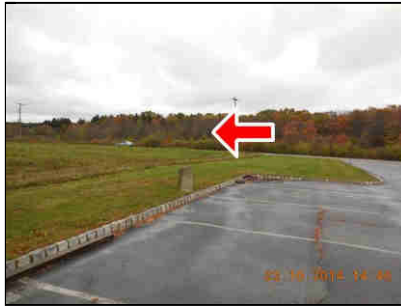
1.3 Item 8(Picture)

- 🏠 (6) Light posts are missing from the cement piers around the parking lot. The lights should be replaced or wire ends secured by a qualified contractor.

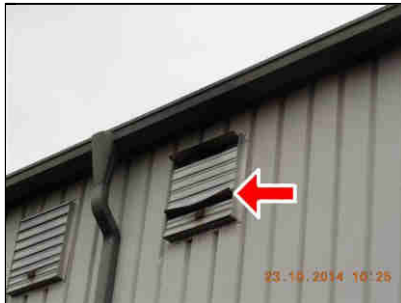
1.4 Item 1(Picture)

- 🏠 The exhaust vent louvers are damaged. The louvers may not operate properly. Moisture, vermin and insect ingress past the vent opening is possible unless repaired or replaced by a qualified person or contractor.

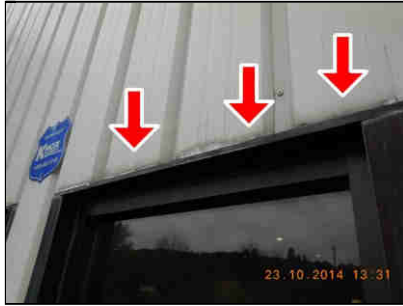
1.5 Item 1(Picture)

- 🏠 (1) The caulk between the window frame and siding is deteriorated. Signs of moisture leakage is present at the base of the door. Repair recommended to prevent the ingress of moisture and insects.

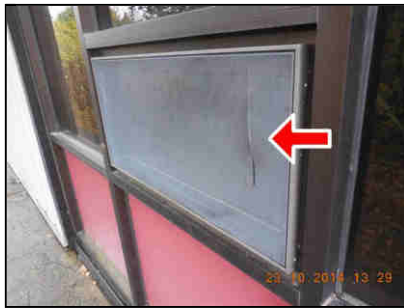
1.5 Item 2(Picture)

(2) Window screens are torn or damaged on a number of windows. Recommend repair or replacement to prevent the ingress of insects and vermin.

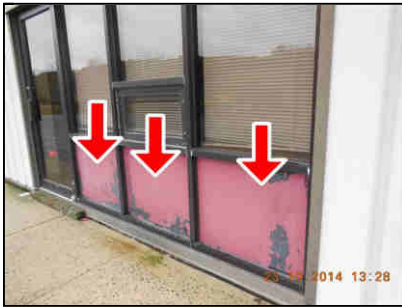
1.5 Item 6(Picture)

(3) Gaskets and seals around window panels have gaps and cracks. The window seals need repair or replacement to help prevent moisture leakage to interior spaces of the building.

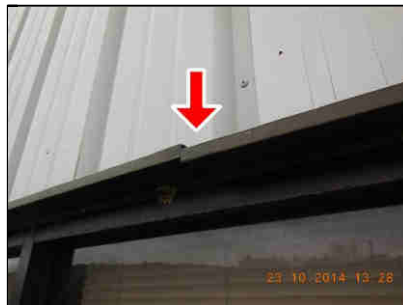
1.5 Item 10(Picture)

- 🏠 (4) Window flashings are damaged. Flashings need repair by a qualified contractor to help prevent moisture leakage past gaps.

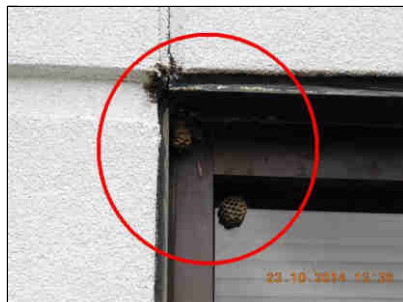
1.5 Item 11(Picture)

- 🏠 (5) Remove bee nests from windows for safety around the building.

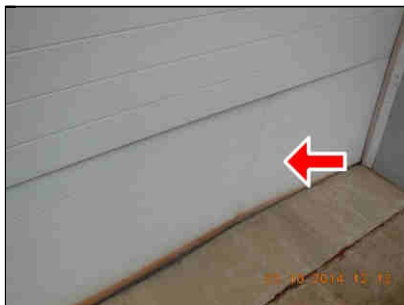
1.6 Item 1(Picture)

- 🏠 (1) Loading dock doors and insulation have damage from an impacts, such as a truck trailers pressing against the door. Door panels and insulation in need of replacement by a qualified contractor.

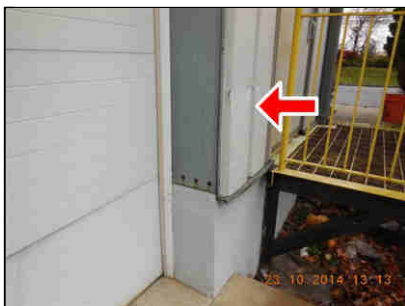
1.6 Item 2(Picture)

- 🏠 (2) Door frame trim is damaged from mechanical abrasion. Repair recommended by a qualified contractor.

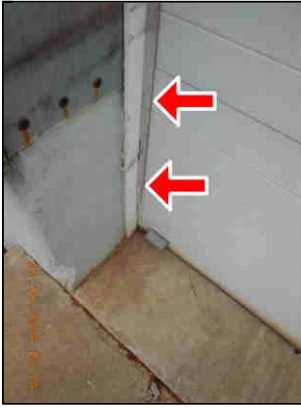
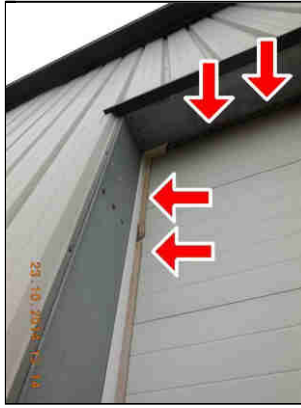
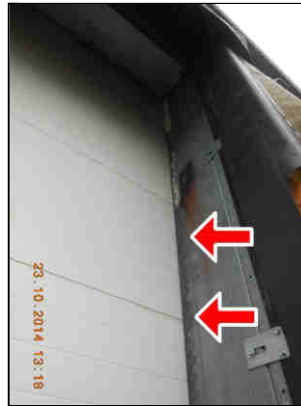
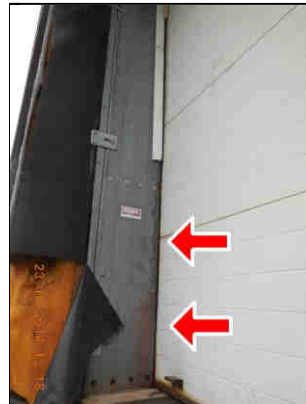
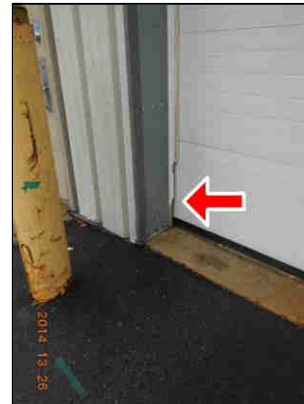
- 🏠 (3) The garage door seals are damaged and torn. The door seals are in need of replacement by a qualified garage door contractor to help prevent the ingress of moisture, insects and vermin into the interior spaces of the building.

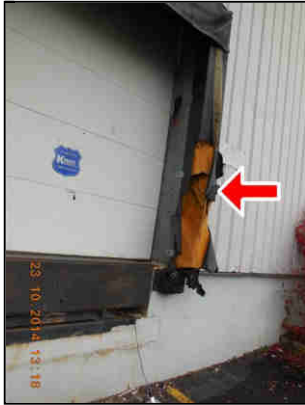
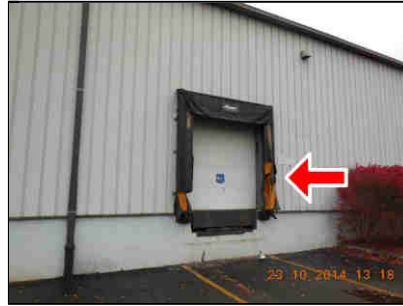
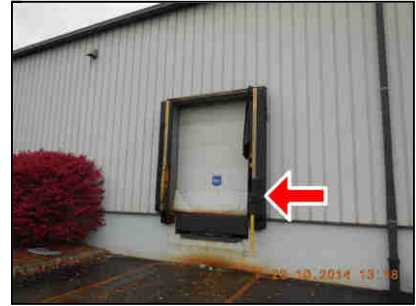
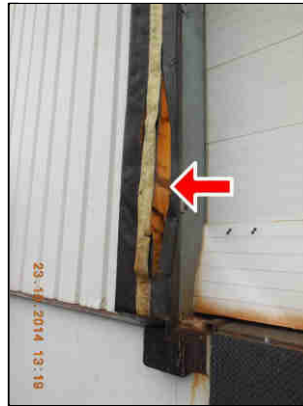
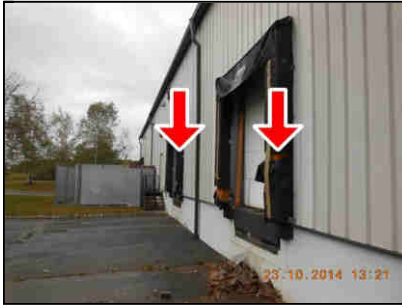
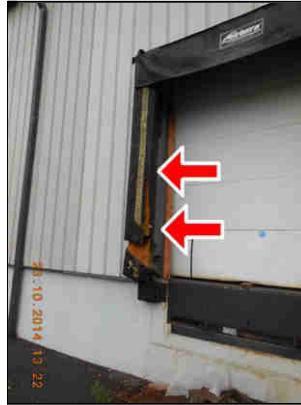
(4) Door bumpers/weather seals are damaged and torn. The door bumpers in need of repair by a qualified contractor.

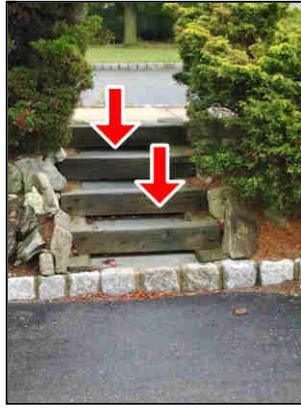
1.7 Item 1(Picture)

The step treads have settled between the railroad ties. Slipping and tripping hazards are present. The steps are in need of repair for safety.

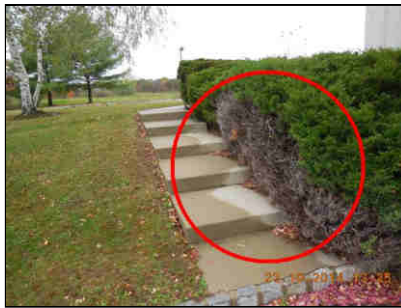
1.8 Item 1(Picture)

The walkway is impeded by dense vegetation. Recommend cutting back or removing overgrown shrubs to allow easy passage of walks.

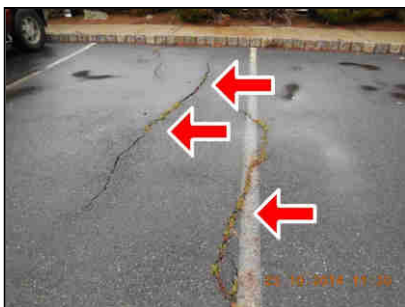
1.9 Item 1(Picture)

(1) The driveway is cracked all over. The use of an appropriate crack sealer and applying a seal coat may preserve the driveway longer. If no repairs are made soon the driveway will experience accelerated deterioration from moisture penetration in cracked areas.

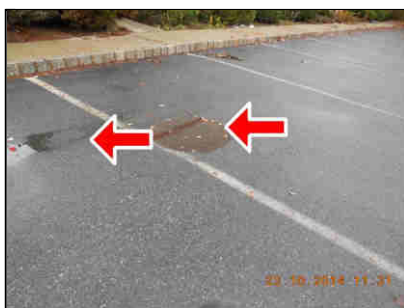
1.9 Item 10(Picture)

- 🏠 (2) There appears to be neutral pitch and pockets in the driveway and parking area that cause puddling of rain water. Rain may puddle and form ice in cold weather leading to slipping and falling hazards. Regrade or re-pitch driveway to help carry rain water away from the building.

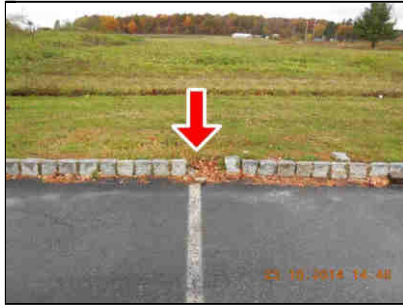
1.9 Item 13(Picture)

- 🏠 (3) Curbing is damaged in several areas. Repair recommended by a qualified contractor to help eliminate driving hazards.

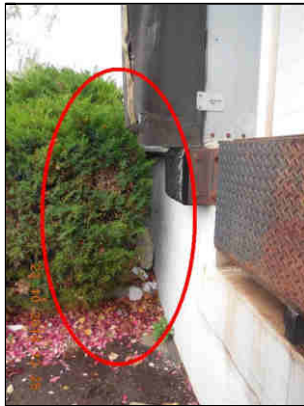
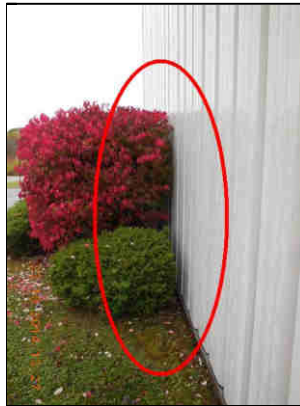
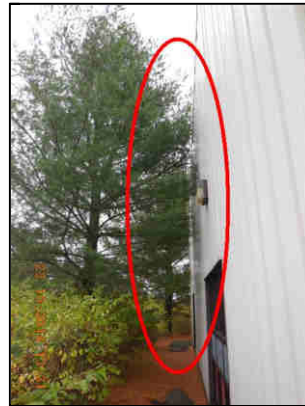
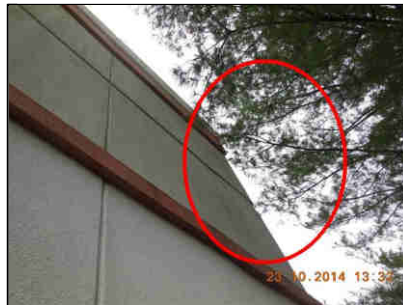
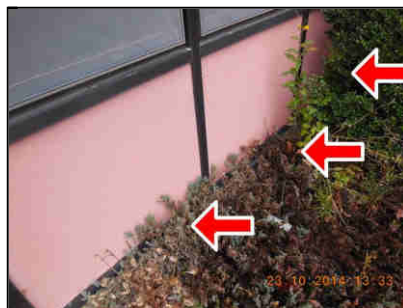
Vegetation should be kept 4 to 6 inches away from foundation and siding. Vegetation can cause moisture build up against siding and/or mechanical damage. Recommend cutting vegetation back or removal.

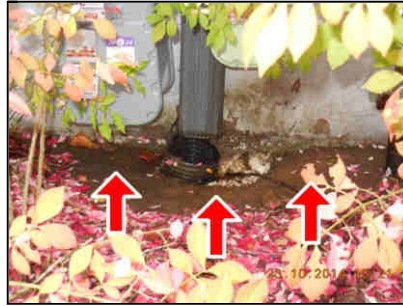
1.11 Item 1(Picture)

(1) Several areas have a neutral or negative grade towards foundation. Rain water in these areas will run along foundation, pocket and/or puddle against foundation, potentially causing leakage past walls. I recommend regrading and improving drainage by a qualified irrigation and landscaping contractor to carry rain water away from siding and foundation.

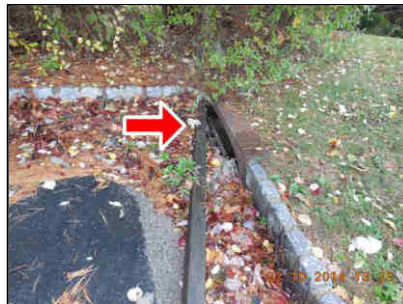
1.11 Item 2(Picture)

(2) Storm drain grates are located around the parking lot. The storm drain grate must be kept clean to promote easy run off of rain water.

Note: The town may have an easement to maintain the drainage pipe that appears to run through the yard. Review the survey and consult with homeowner and town.

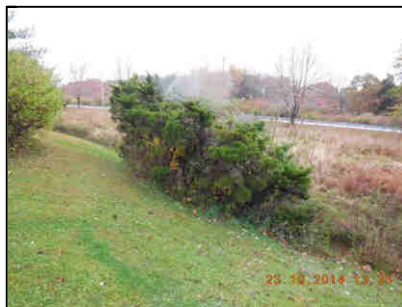
1.11 Item 3(Picture)

(3) Note: The town may have an easement to maintain the drainage holding pond that appears to run along the edge of the yard. Review the survey and consult with homeowner and town.

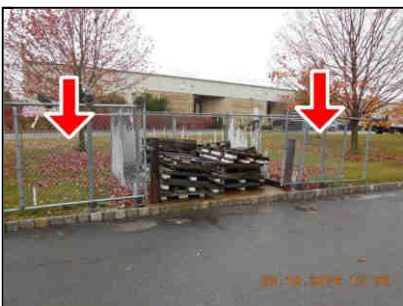
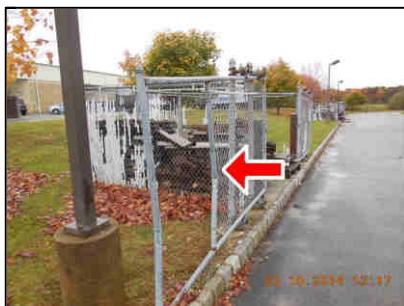
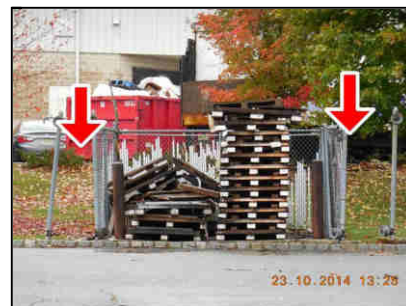
The fencing gates are damaged. The gates are in need of repair to swing closed and latch for security. Recommend repair or replacement by a qualified fence contractor.

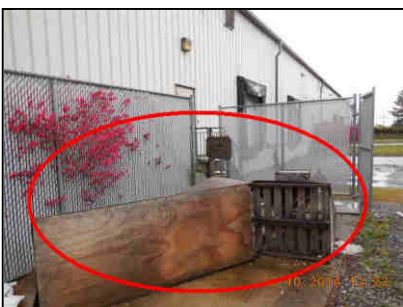
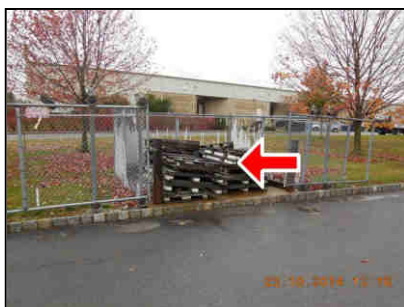
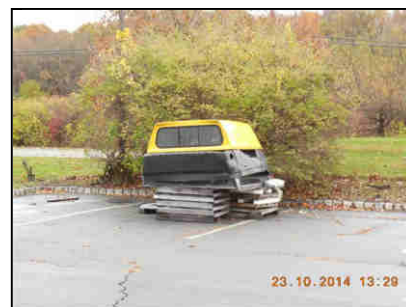
Debris located around the lots and grounds should be removed for safety and ease of maintenance.

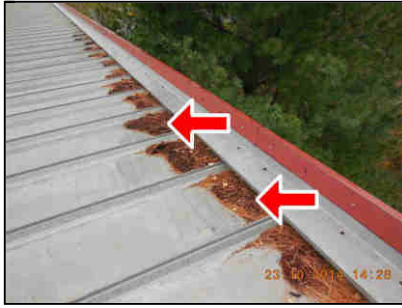
2.0 Item 1(Picture)

(1) Low angle of roof has trapped debris. Debris is trapping moisture against roof surface and clogging gutters causing undesired flow of rain water from roof. Clean debris to prevent moisture damage (leakage, rot and mold) and to allow the easy drainage of rain water. Cleaning the debris from the roof should be part of the annual lawn and garden maintenance and cleanup.

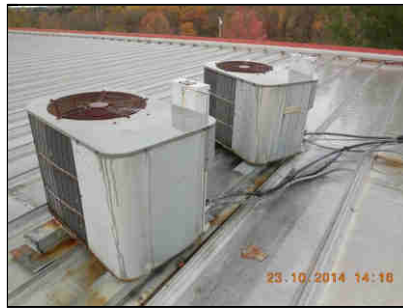
2.0 Item 3(Picture)

(2) Unused AC condensers are present on the roof. The condensers should be removed to help reduce maintenance of roof penetrations and mounting brackets.

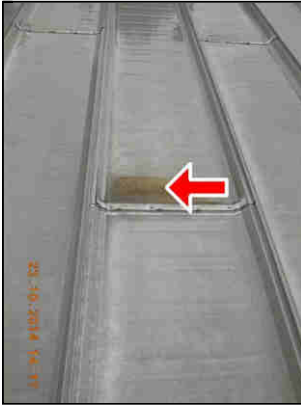
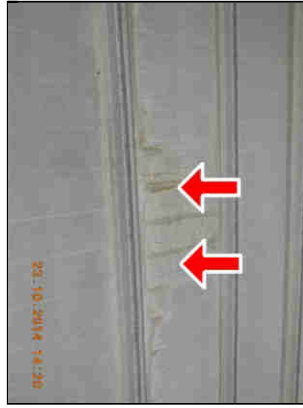
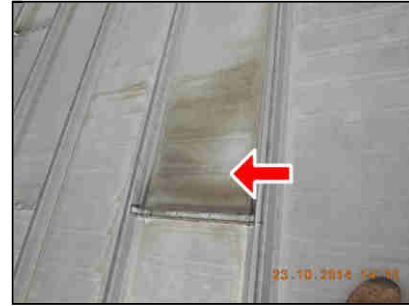
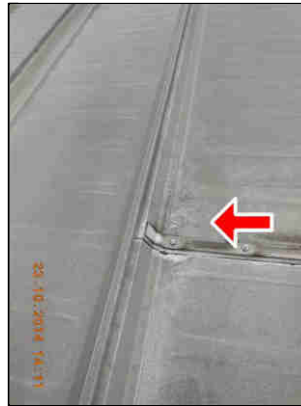
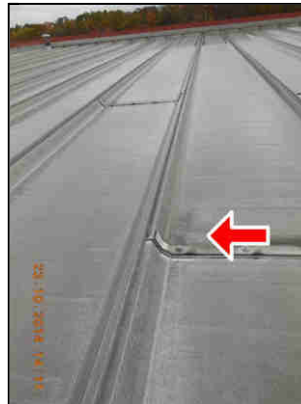
(3) Puddling noted at some of the roof panel seams. Stains noted on the underlying insulation towards the middle of the roof suggest periodic roof leakage from the seams and flashings.. The seams need repair by a qualified contractor to help prevent further leakage of the roof.

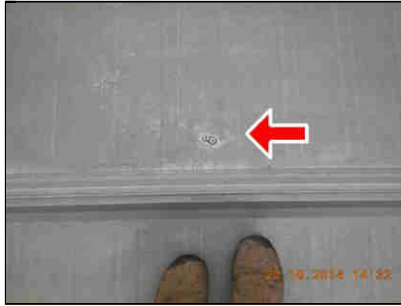
2.0 Item 9(Picture)

(4) Signs of hole repair noted in several locations. Repair may have been needed from mechanical damage to panels. The roof should be periodically visually inspected to insure that repaired areas are in good shape.

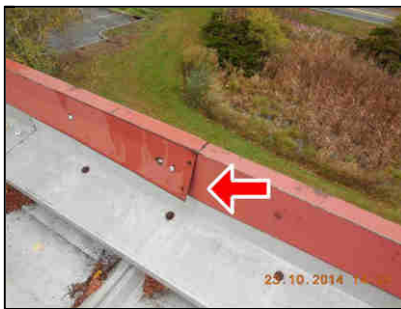
2.1 Item 1(Picture)

(1) The flashing at the edge of the roof has gaps that may allow moisture to penetrate behind siding and past roofing. Patch the flashing with caulk or asphalt or replace flashing to prevent leakage and damage to interior areas. Repair recommended by a qualified roofing contractor.

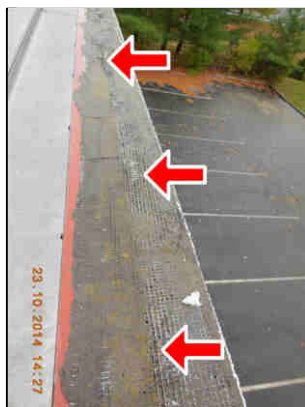
2.1 Item 3(Picture)

(2) Flashings are missing at the top of the exterior wall in front of the building. Moisture leakage behind the siding is possible where there are open gaps for moisture to pass. Repair recommended by a qualified contractor to help prevent moisture damage.

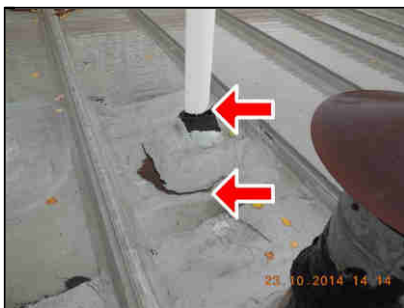
2.2 Item 1(Picture)

(1) The flashing boots around the plumbing vent pipes appear to be cracked and torn. The flashing boots may collect and seep moisture into the attic and interior spaces of home. Repair recommended by a qualified roofing contractor.

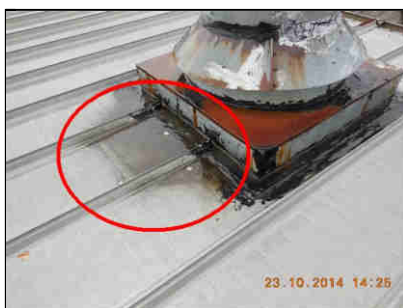
2.2 Item 3(Picture)

(2) Moisture is puddling behind roof vent flashings. Gaps and cracks in the asphalt patch around the vent may lead to moisture leakage. Flashings appear to need periodic re-coating with asphalt patch to help prevent leakage past the roof.

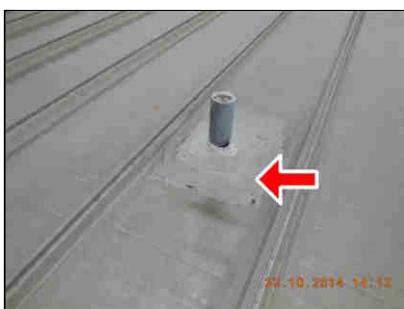
2.2 Item 4(Picture)

(3) The plumbing vent flashings are patched with asphalt probably because the original flashing rubber seal has failed. The asphalt patch has cracked and may leak moisture into interior spaces. I recommend repair by a qualified roofing contractor.

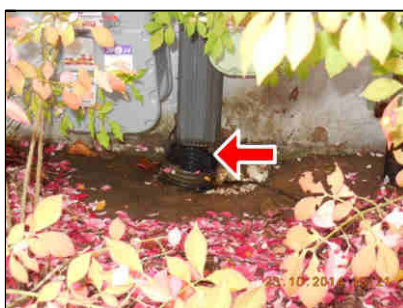
2.4 Item 2(Picture)

Leaders are disconnected from downspouts. Water may puddle against foundation during rain storms. Puddling water against foundation may leak into basement causing moisture damage. Downspout repair is recommended.

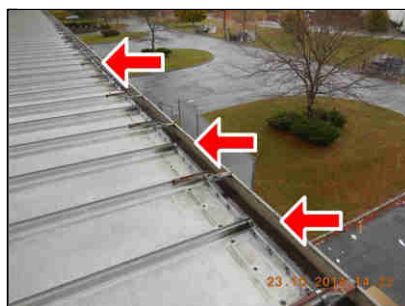
2.4 Item 3(Picture)

- 🏠 (3) The gutters are bowed and damaged in the middle. The gutters will not drain properly as they are no longer pitched towards the downspouts. Repair recommended in order to help the gutters drain completely during rain storms.

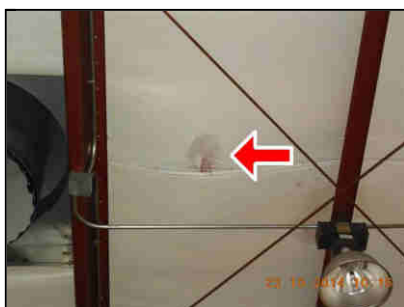
2.6 Item 19(Picture) Section
1

(2) Stains are present on the vapor barrier in several locations near vent flashings and roof seams. The ceilings appeared dry at time of inspection. Stains are a sign that further repair of the roof and flashings may be needed should leakage return.

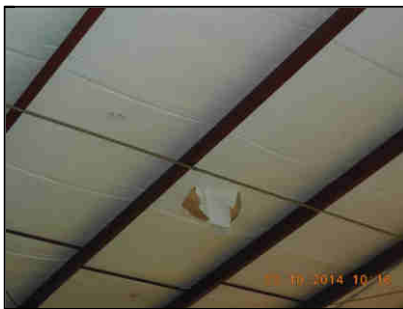
2.7 Item 1(Picture) Section 1

The insulation vapor barrier that helps prevent warm humid air inside the building from coming in contact with cold exterior walls is damaged. Moisture damage from condensation and mold buildup from perpetual dampness may occur unless repaired by a qualified contractor.

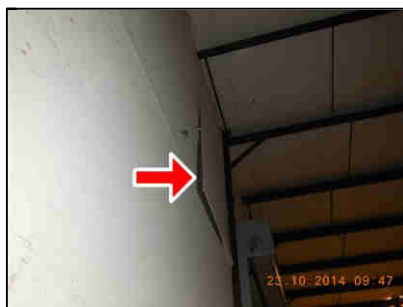
3.2.A Item 1(Picture)

(1) Sheetrock panels appear loose at the partition wall. The panels are in danger of falling and causing damage or injury. Repair recommended by a qualified contractor.

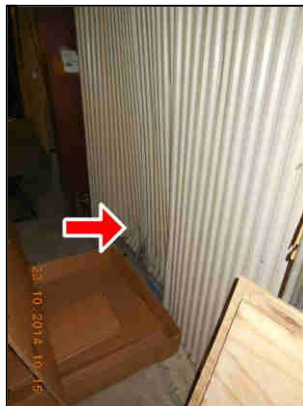
3.2.A Item 2(Picture)

(2) Protective wall paneling against the exterior wall is damaged pressing in on the insulation. Repair recommended by a qualified contractor.

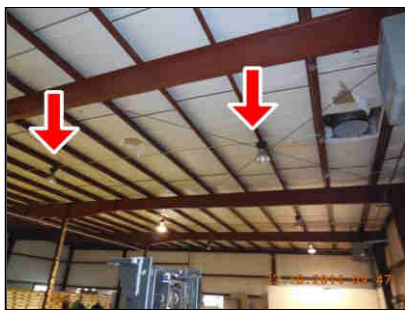
3.7.A Item 1(Picture)

(1) The lights were not working. Either the bulbs are burned out or the electrical circuits are in need of repair. Replace the bulbs, otherwise make repairs with a licensed electrician.

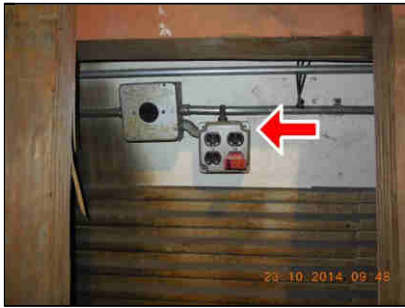
3.7.A Item 3(Picture)

(2) There are outlets, lights and junction boxes that are loose and without power around the walls and columns of building Section 1. The wiring throughout the room should be repaired or removed by a qualified contractor.

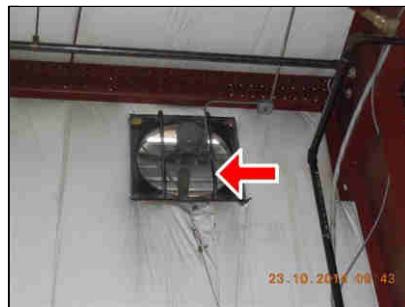
3.9.A Item 1(Picture)

(1) The vent fan is inoperative. Louver actuator parts block the fan from spinning. Repair recommended by a qualified contractor.

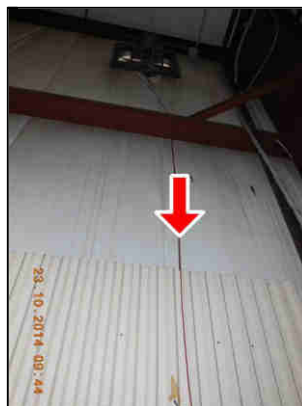
3.9.A Item 2(Picture)

(2) The fan louver spring that pressure actuates the louvers is broken. The louvers are manually opened by a long cable. Repair recommended by a qualified contractor.

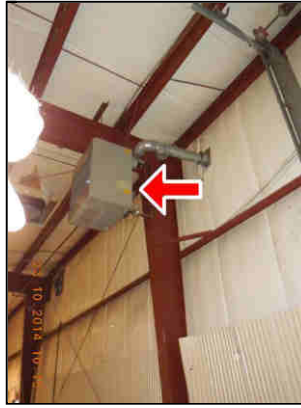
3.17.A Item 1(Picture)

The gas power space heater was inoperative at time of inspection. The space heater needs repair by a qualified contractor.

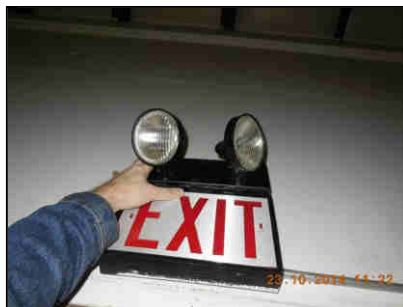
3.0.B Item 1(Picture)

(1) Emergency lights are inoperative throughout the building. Repair recommended by a qualified contractor.

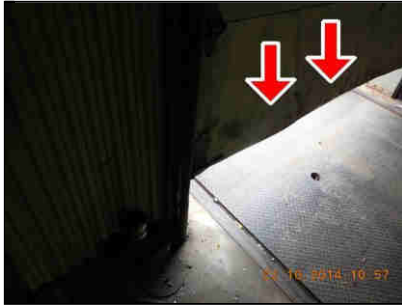
3.0.B Item 2(Picture)

(2) Loading dock doors and insulation have damage from an impacts, such as a truck trailers pressing against the door. Door panels and insulation in need of replacement by a qualified contractor.

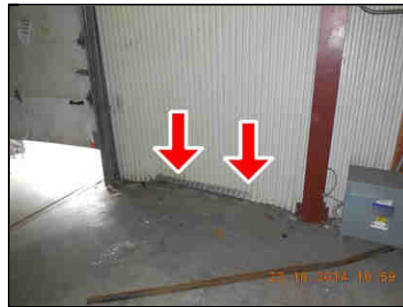
3.2.B Item 1(Picture)

(1) Protective wall paneling against the exterior wall is damaged pressing in on the insulation. Repair recommended by a qualified contractor.

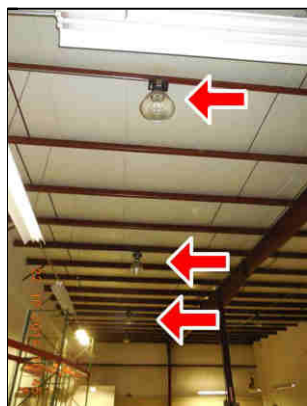
3.7.B Item 1(Picture)

(1) The lights were not working. Either the bulbs are burned out or the electrical circuits are in need of repair. Replace the bulbs, otherwise make repairs with a licensed electrician.

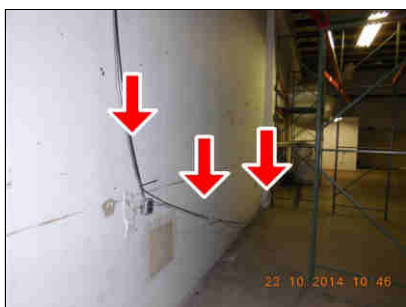
3.7.B Item 3(Picture)

(2) There are outlets, lights and junction boxes that are loose and without power around the walls and columns of building Section 2. The wiring throughout the room should be repaired or removed by a qualified contractor.

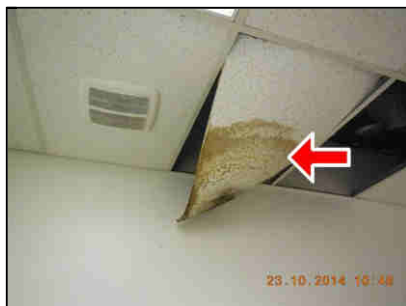
3.10.B Item 1(Picture)

The ceilings are damaged from a chronically leaking plumbing vent flashing. The flashing and ceiling in need of repair by a qualified contractor.

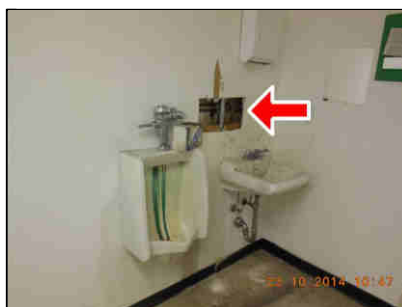
3.11.B Item 1(Picture)

The sheet rock walls are damaged. Repair recommended by a qualified contractor.

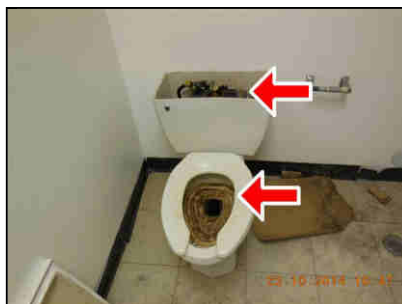
3.15.B Item 1(Picture)

(1) The toilet was inoperative at time of inspection. Repair recommended by a qualified contractor.

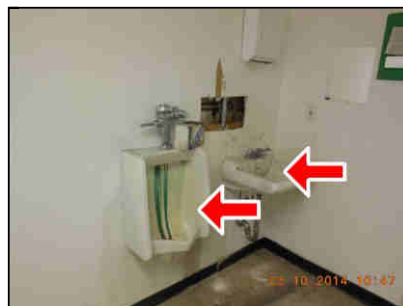
3.15.B Item 2(Picture)

(2) The sink and drain were inoperative at time of inspection. The sink and drain in need of repair by a qualified contractor.

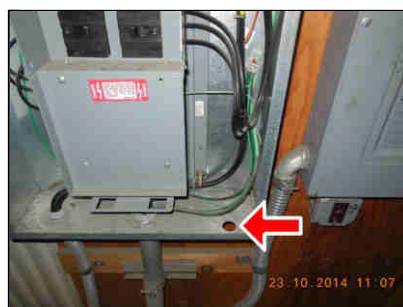
3.24.B Item 1(Picture)

Wiring knockout missing, the hole should be plugged for electrical and fire safety.

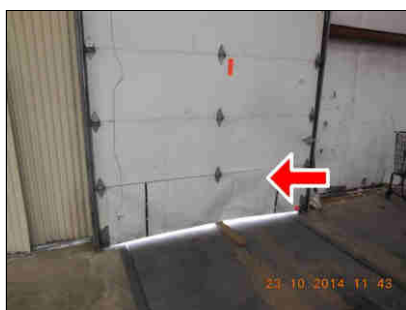
3.0.C Item 1(Picture)

The door springs are broken and the door is inoperative. Repair recommended by a qualified contractor.

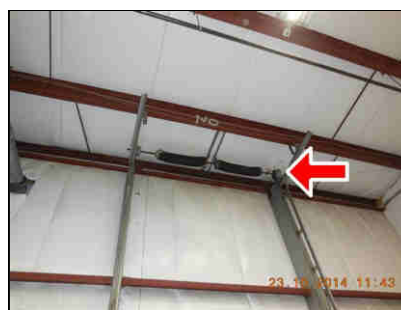
3.0.C Item 2(Picture)

Loading dock doors and insulation have damage from an impacts, such as a truck trailers pressing against the door. Door panels and insulation in need of replacement by a qualified contractor.

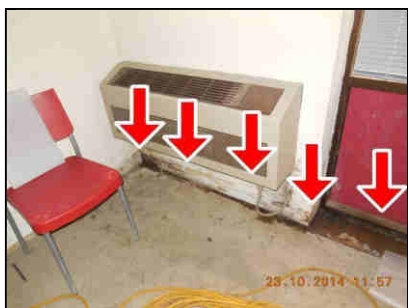
3.2.C Item 1(Picture)

(1) Walls are damaged from leakage past the wall mounted HVAC unit flashings. Caulking is cracked around the exterior flashing. Moisture is puddling and draining in past the siding. Repair recommended by a qualified contractor.

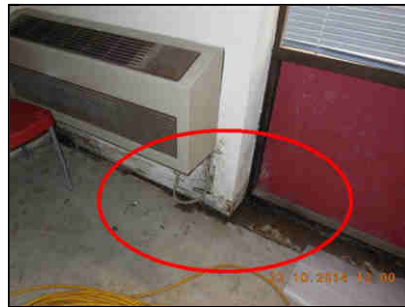
3.2.C Item 7(Picture)

(2) Mold deposits present on wall and baseboard surfaces in the office and office bathroom areas. We did not inspect, test or determine if this growth is or is not a health hazard. The underlying cause is moisture. Walls are in need of cleaning and repair by a qualified contractor.

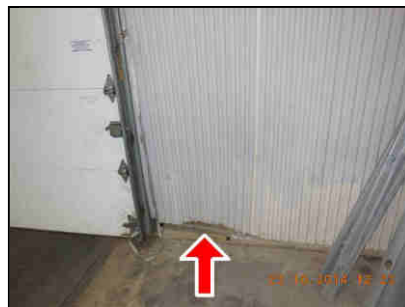
3.2.C Item 8(Picture)

(3) Protective wall paneling against the exterior wall is damaged pressing in on the insulation. Repair recommended by a qualified contractor.

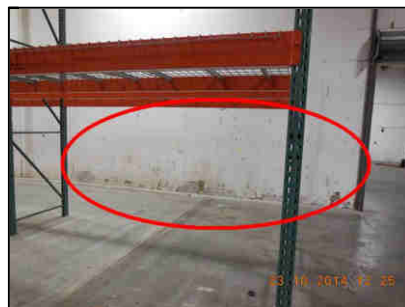
3.2.C Item 9(Picture)

(4) Sheetrock walls are damaged. Repair recommended by a qualified contractor.

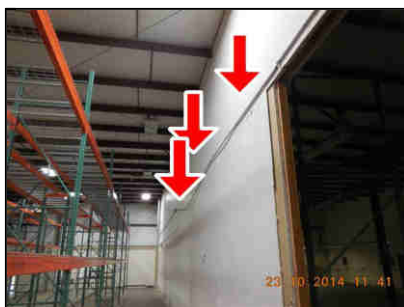
3.7.C Item 1(Picture)

There are outlets, lights and junction boxes that are loose and without power around the walls and columns of building Section 3. The wiring throughout the room should be repaired or removed by a qualified contractor.

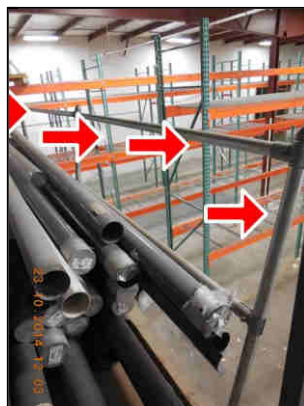
3.8.C Item 1(Picture)

Railings on the loft are loose and ready to collapse. Repair recommended by a qualified contractor for safety.

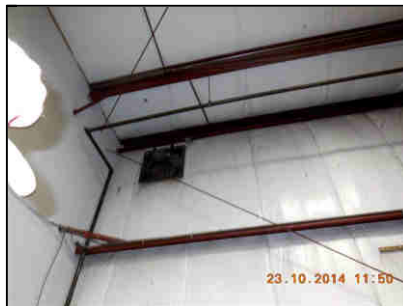
3.9.C Item 1(Picture)

The vent fan is inoperative. Repair recommended by a qualified contractor.

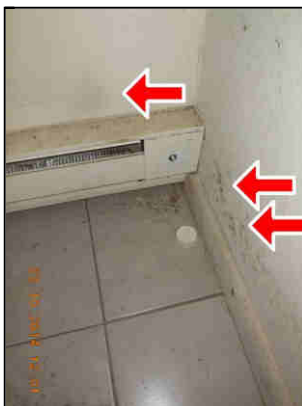
3.11.C Item 1
(Picture)**3.12.C FLOORS (REST ROOMS)**

Mold deposits present on wall and baseboard surfaces in the office and office bathroom areas. We did not inspect, test or determine if this growth is or is not a health hazard. The underlying cause is moisture. Walls are in need of cleaning and repair by a qualified contractor.

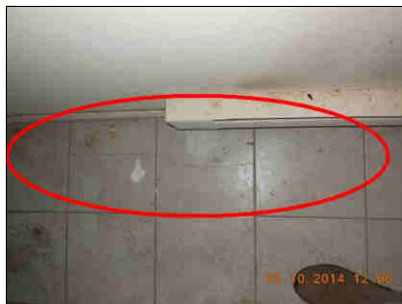
3.12.C Item 1(Picture)

Cracked floor tile noted. Repair recommended by a qualified contractor.

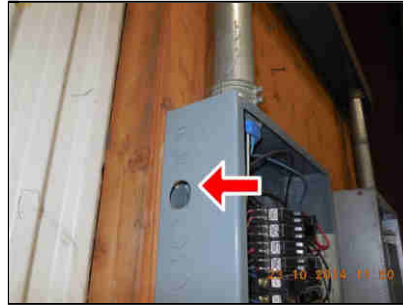
3.24.C Item 1(Picture)

(1) Wiring knockout missing, the hole should be plugged for electrical and fire safety.

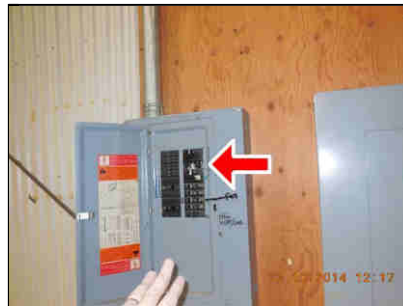
3.24.C Item 2(Picture)

(2) Holes present in front of panel where circuit breakers should be located. A safety hazard is present until repaired. Recommend installing circuit breaker blanks in holes.

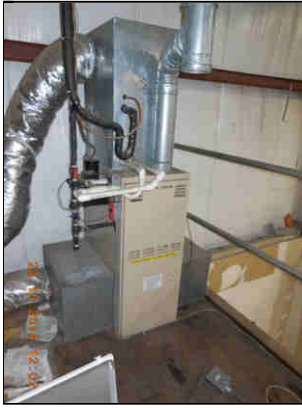
3.27.C Item 1
(Picture)

(1) The heating system over the office area has been abandoned. Gas is still connected and turned on to the furnace. The furnace should be removed and the gas line disconnected and plugged for safety.

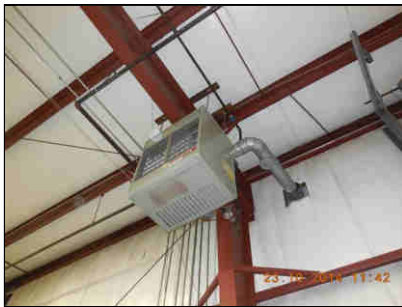
3.27.C Item 3(Picture)

(2) The gas power space heater was inoperative at time of inspection. The space heater needs repair by a qualified contractor.

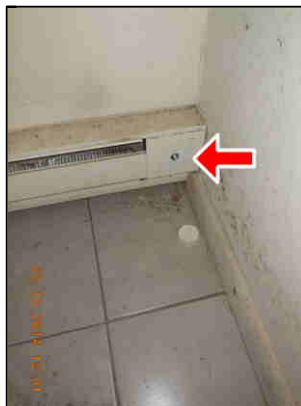
3.27.C Item 5
(Picture)

(3) The control knob for the electric baseboard heat is missing. The knob needs replacement to control the heat in the bathroom.

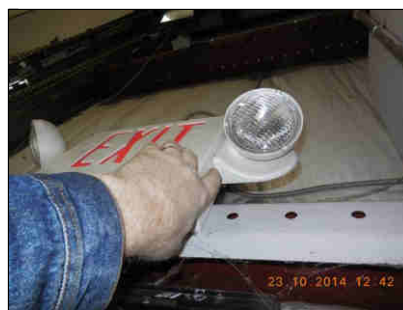
3.0.D Item 1(Picture)

(1) Emergency lights are inoperative throughout the building. Repair recommended by a qualified contractor.

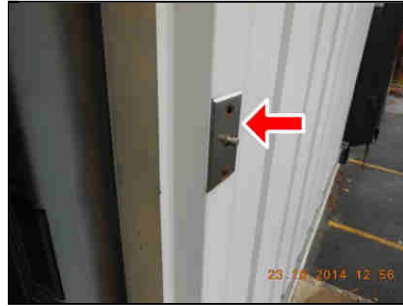
3.0.D Item 2(Picture)

(2) Door bell inoperative. Door bell needs repair.

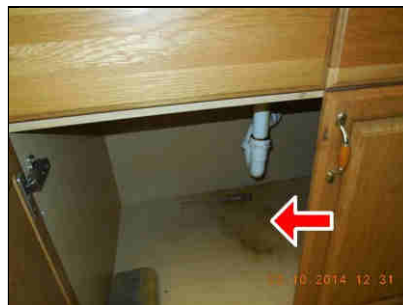
3.8.D Item 1(Picture)

The sink drain is corroded as if it has been leaking or is about to leak. Repair of drain recommend as a preventative action to help avoid damage to stored supplies, cabinets and interior spaces of home.

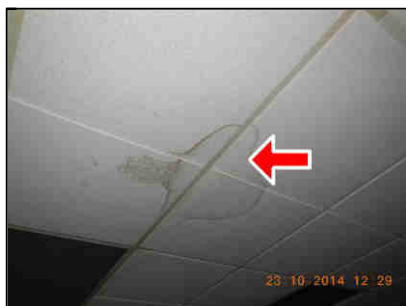
3.17.D Item 1(Picture)

Ceilings are damaged by moisture stains. The overlying AC unit shows signs of widespread chronic moisture leakage. Repair recommended by a qualified contractor.

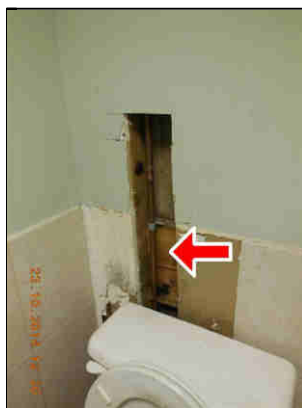
3.18.D Item 1
(Picture)**3.19.D FLOORS (S/O/S ROOMS)**

Holes in sheetrock walls need repair by a qualified contractor.

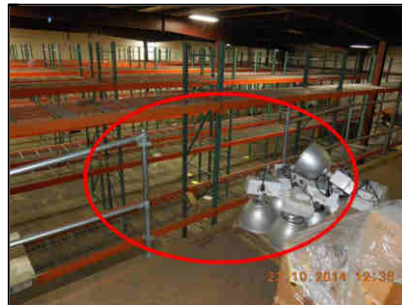
3.26.D Item 1(Picture)

(1) Gaps are present in the loft railing system. Repair recommended by a qualified contractor for safety.

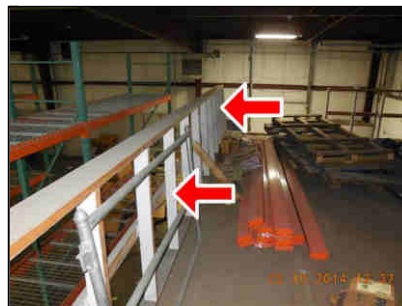
3.26.D Item 2(Picture)

(2) Loft railings are loose and on the verge of collapse. Repair recommended for safety.

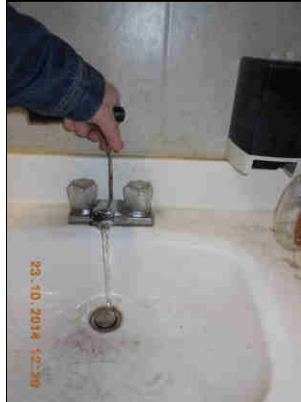
3.34.D Item 1
(Picture)

(1) The sink stopper is missing or not working. Replacement or repair is needed to make sink work as intended.

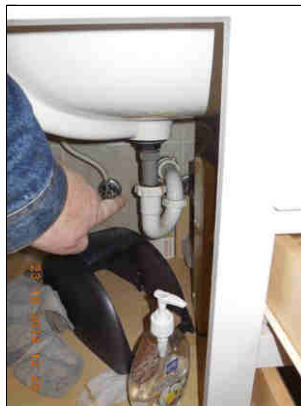
3.34.D Item 2
(Picture)

(2) The sink drain is corroded as if it has been leaking or is about to leak. Repair of drain recommend as a preventative action to help avoid damage to stored supplies, cabinets and interior spaces of home.

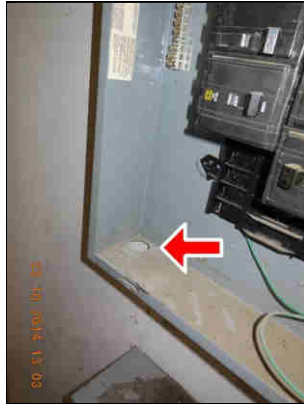
3.42.D Item 1
(Picture)

Wiring knockout missing, the hole should be plugged for electrical and fire safety.

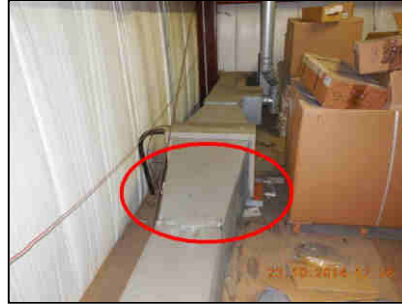
3.47.D Item 1(Picture)

(1) The condensate drain from the AC system appears to be leaking when the AC system is operated. The condensate drain is in need of repair by a qualified contractor.

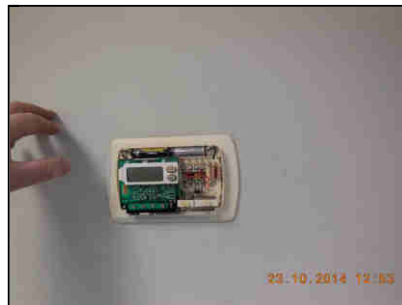
3.48.D Item 1(Picture)

The office thermostat was inoperative at time of inspection. Replacement recommended by a qualified contractor.

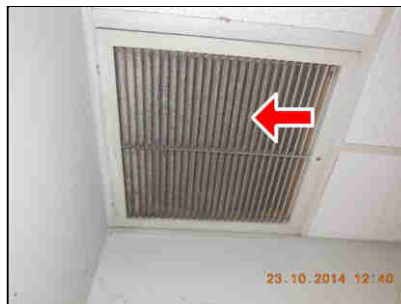
3.52.D Item 1(Picture)

The disposable filter is dirty. The filter needs to be replaced. Air filters in furnaces should be replaced somewhere between once a month and twice a year depending upon local conditions.

After you first move in, recommend inspecting every two weeks during heating or cooling season. If filter does not appear dirty then wait longer to check for dust build up. You will eventually figure

out how often to change filter. If you can see dust on the filter, it is probably worth changing or cleaning. A totally clogged filter will cause the HVAC system to run inefficiently.

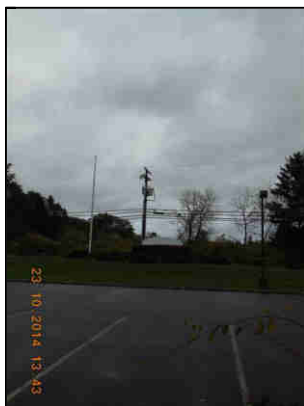
4.0 Item 1(Picture)

The conduit between the pole and the main panel has filled with moisture from an open end at the exterior. The moisture has been draining through the base of the main disconnect panel. The panel is severely rusted. The conduit and panel are in need of repair by a qualified electrical contractor for safety.

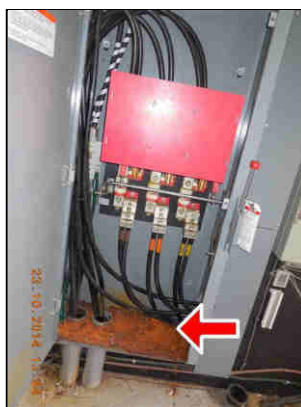
4.1 Item 1(Picture)

Rust is present in the bottom of the electrical panel. The moisture source is typically leakage from outside at the mast head, service wire entrance at the meter box or the meter box enclosure cover. Repair of the moisture leakage source and clean up of the corrosion in the enclosure is recommended by a licensed electrician.

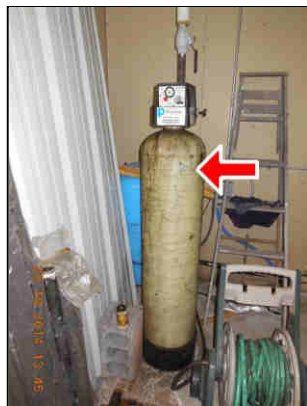
5.2 Item 1(Picture)

- 🏠 (2) A water filter is present. We did not inspect or check the operation of this accessory equipment. Water filtration systems are taken care of typically by the home owner or a qualified service contractor.

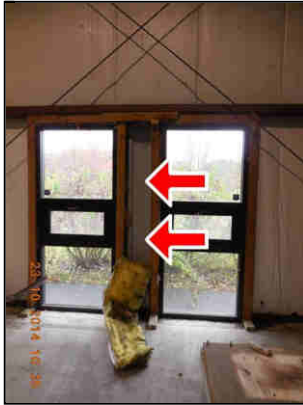
6.4 Item 1(Picture)
Section 1

Insulation and vapor barriers are damaged and torn in a number of places throughout the building. Repair recommended by a qualified contractor for heating efficiency and to help prevent condensation damage to insulation. Repair recommended by a qualified contractor.

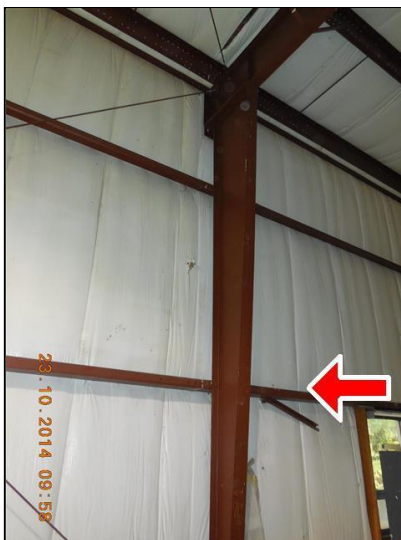
6.7 Item 1(Picture)

Braces along the siding are disconnected and loose. I recommend reattachment by a qualified contractor for the strength and security of the siding.

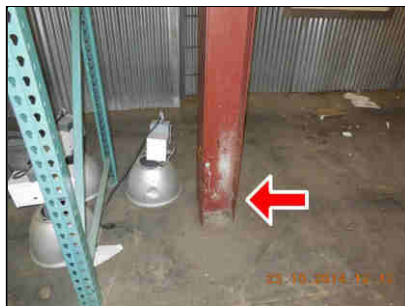
6.9 Item 1(Picture)

Steel columns ins Sections 2 and 3 of the building have been damaged from impacts such as a fork lift. The columns are weakened where bent and damaged. Damaged columns may be prone to buckling during high wind or snow loads. Evaluation recommended by a structural engineer along with any recommended repairs by a qualified contractor.
