# Home Inspection Report

Inspection Date: 4/18/2019

## Condo Sample Report

### All In One Home Inspection LLC

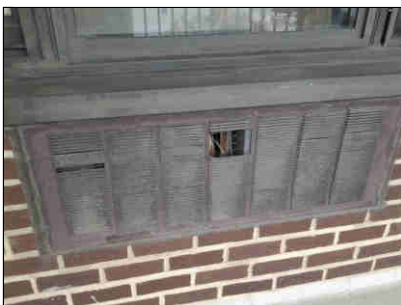
2.4 Item 1(Picture)

Vent grills on the balcony HVAC unit are damaged. The grill should be replaced by a qualified contractor to help prevent the ingress of insects, vermin and moisture to the interior spaces of the home.

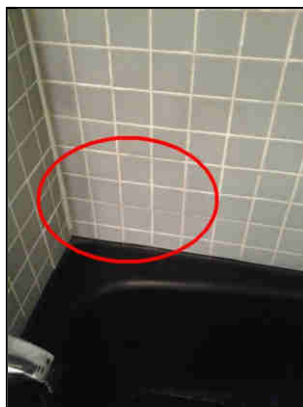
4.1.A Item 1(Picture)

The tile wall is deteriorated (loose tile present) and needs repair or replacement. The wall board and framing may need repair (not visible). I recommend tile repair or replacement using a qualified contractor.

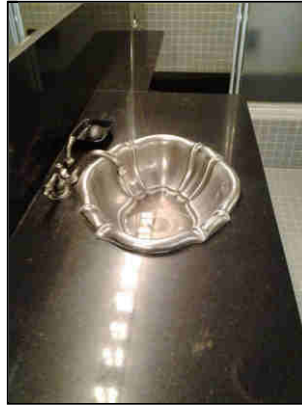
4.7.A Item 1(Picture)

- (1) The tub stopper is missing or not working. Recommend replacement or repair by a licensed plumber to make tub work as intended.
- (2) The tub is draining slowly. The tub drain needs cleaning or repair by a qualified person or licensed plumber.
- (3) The sink stopper is missing or not working. Replacement or repair recommended by a plumber.

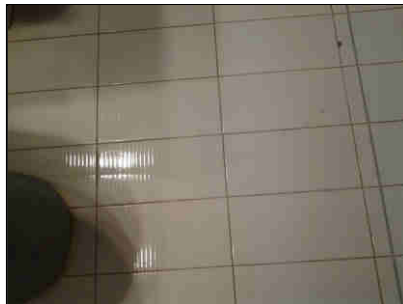
4.2.B Item 1(Picture)

The bathroom floor has cracked floor tile. Moisture may penetrate flooring and damage the interior spaces of the flooring cavity. The floor is in need of repair by a qualified contractor.

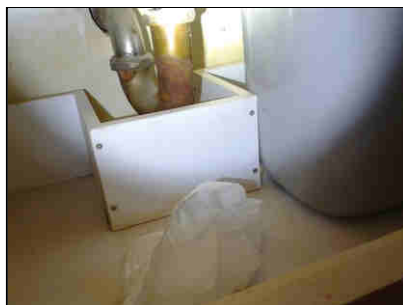
4.7.B Item 1(Picture)

(1) The sink drain is corroded as if it has been leaking or is about to leak. Repair of drain recommend as a preventative action to avoid damage to stored supplies, cabinets and interior spaces of home.

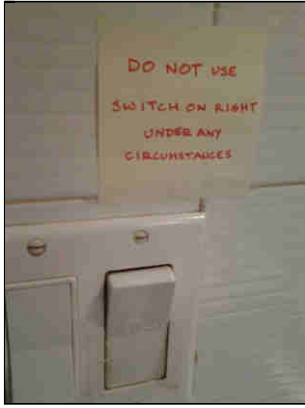
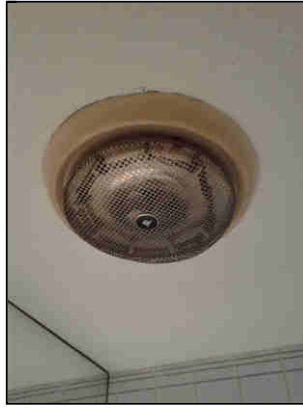
4.8.B Item 1(Picture)

(1) A switch was present with a warning sign not to operate. The spa and electric space heater were inoperative at time of inspection. Unable to determine if the switch was for either of these appliances. Repair recommended by a qualified contractor.

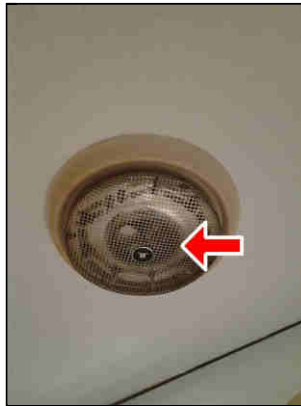
4.10.B Item 1(Picture)

The electric space heater was inoperative at time of inspection. Repair recommended by a qualified contractor.

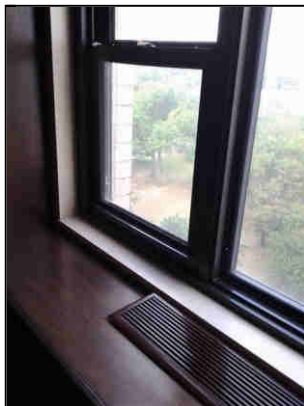
5.6.A Item 1(Picture)

(1) Screens are missing from about half the windows. Recommend replacement to prevent the ingress of insects and vermin.

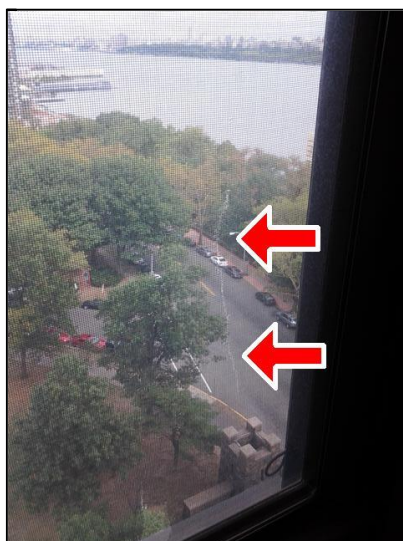
5.6.A Item 3(Picture)

(2) Screens in some windows are torn or deteriorated. Screens need replacement to prevent the ingress of insects.

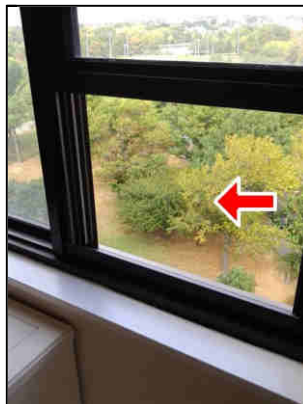
5.6.B Item 1(Picture)

Screens missing from windows. Recommend replacement to prevent the ingress of insects and vermin.

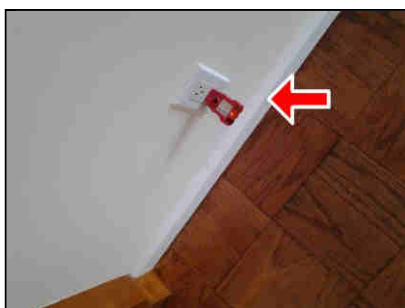
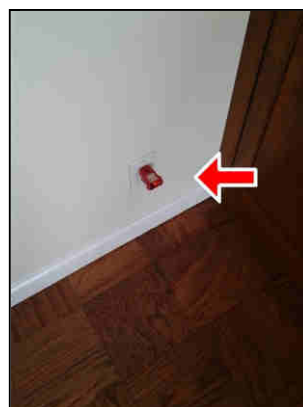
5.7.B Item 1(Picture)

Outlets with three prongs have open grounds, this electrical hazard presents a safety issue to the occupants of the home, repairs are recommended. A qualified licensed electrician should perform repairs that involve wiring.

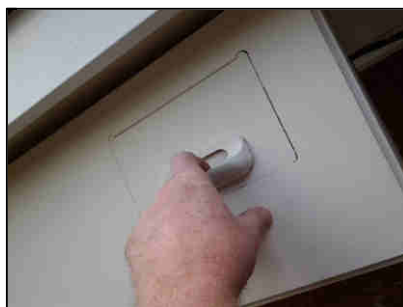
5.8.B Item 1(Picture)

Access door covers on the heating and cooling wall units are painted shut. The doors need repair for ease of access to the heating and cooling units.

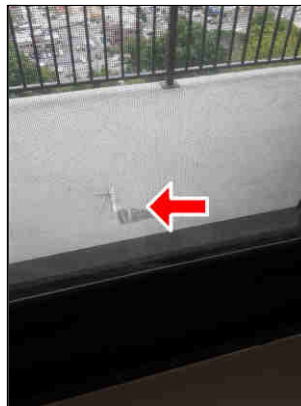
5.6.C Item 1(Picture)

(1) Screens in some windows are torn or deteriorated. Screens need replacement to prevent the ingress of insects.

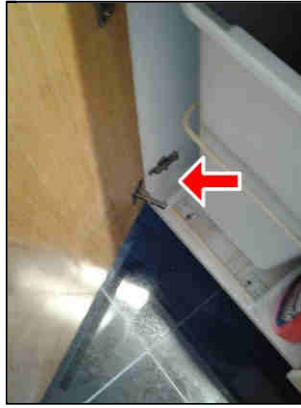
6.6 Item 1(Picture)

Cabinet hinge is damaged, the cabinet door not closing properly, hinge needs repair or replacement.

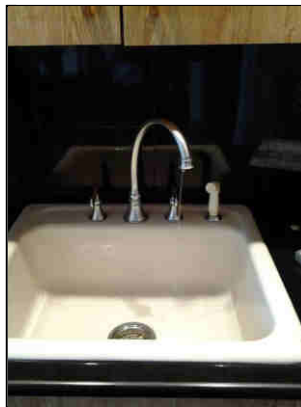
6.7 Item 1(Picture)

Low water pressure is present at the sink faucet. The low pressure may be attributed to mis-adjusted pressure regulators, cut-off valves not completely open, or malfunctioning sink faucet. Although the bathroom had adequate water pressure, it is also possible the supply to the kitchen area is low pressure. I recommend evaluation and repair by the building maintenance supervisor and/or a licensed plumber.

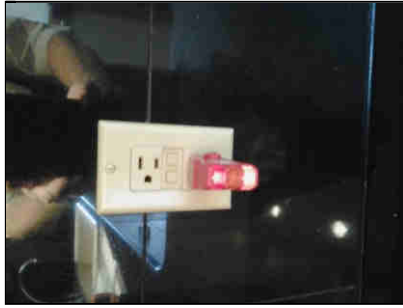
6.9 Item 1(Picture)

The GFCI (Ground Fault Circuit Interrupter) outlet is wired reverse polarity and will not "trip" when tested. Electrical issues are considered a hazard until repaired. A qualified licensed electrician should perform repairs that involve wiring.

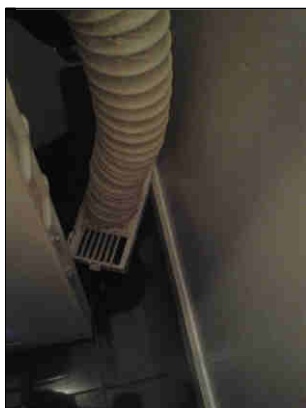
7.7 Item 1(Picture)

The dryer vents to the interior the laundry closet. Build up of humidity, condensation, lint and mold possible in closet area. Recommend venting the dryer outside.

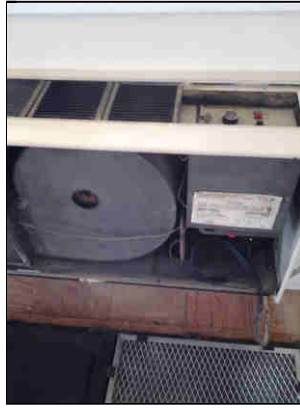
10.0 Item 1(Picture)

(1) The AC unit in the dining room makes noise as if something is about to break. Repair recommended by a qualified contractor.

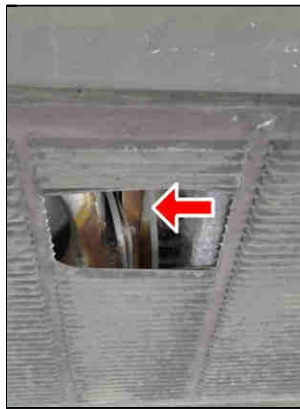
10.0 Item 2(Picture)

(2) The interior of the HVAC wall unit facing the balcony is rusted and weathered from constant exposure to the outside world. Repair recommended by a qualified contractor.

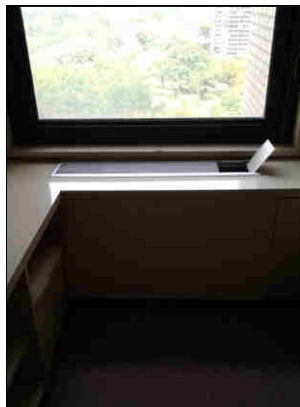
10.0 Item 3(Picture)

(3) The HVAC wall unit in the first bedroom is inoperative. Repair recommended by a qualified contractor.

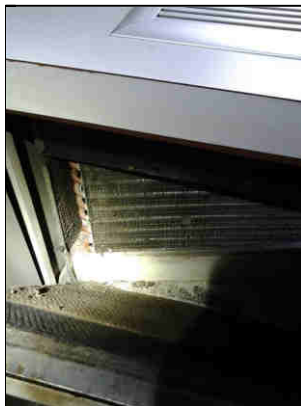
10.0 Item 4(Picture)

(4) The coils in the HVAC wall units are dirty and clogged with dust and mold. Cleaning recommended by a qualified contractor.
