Home Inspection Report

Inspection Date: 4/18/2019

Single Family Report

All In One Home Inspection LLC

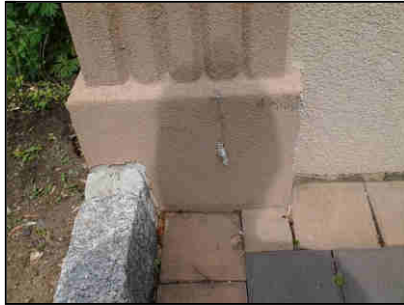
1.0 Item 1(Picture)

(2) EIFS siding has cracks and damage in several locations. Have a qualified contractor make repairs to help prevent damage causing moisture from entering past the siding

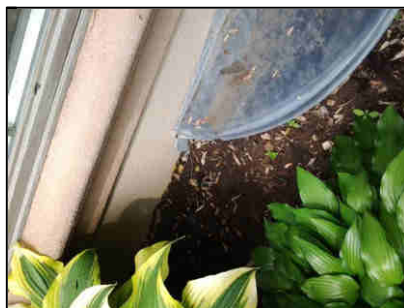
1.0 Item 4(Picture)

(3) EIFS siding should terminate 6" to 12" above grade level so it does not draw water up into wall. Water in the wall can lead to algae buildup on EIFS siding, mold buildup behind EIFS siding, and rot in wood siding and structural components. A lower trim piece called a drip screed is missing. The drip screed provides a finished edge, allows drainage and prevents water from being drawn up into wall. Evaluation and repair recommended by a qualified EIFS siding contractor.

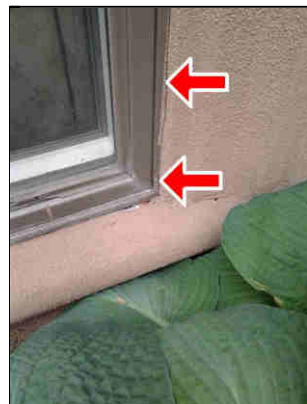
1.0 Item 6(Picture)

(4) EIFS siding has gaps and cracks at window frames, door frames, lamp fixtures and wall penetrations. Caulk and seal gaps to help prevent damage causing moisture from entering past the siding

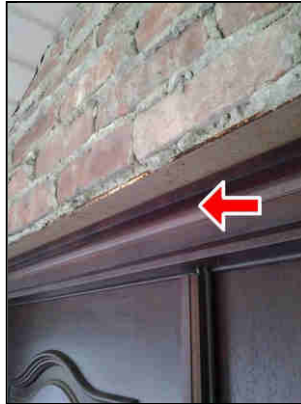
1.0 Item 8(Picture)

(5) The steel lintels over the entrance doors, exterior windows, garage door and under bay windows are bare metal and rusted. If allowed to rust the lintel can cause cracks in the brick veneer at the lintel ends. Recommend rust removal and painting to preserve lintels and prevent cracks in brick veneer siding.

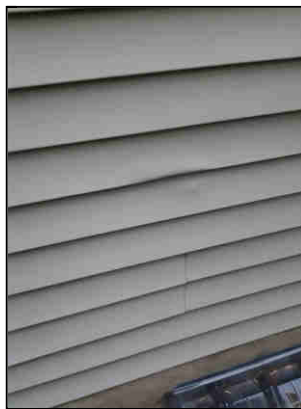
1.0 Item 9(Picture)

(6) Vinyl siding appears distorted as if it was exposed to heat. The damage may have occurred from a barbecue. Keep heat generating appliances away from home and siding. Evaluation and repair by a qualified siding contractor.

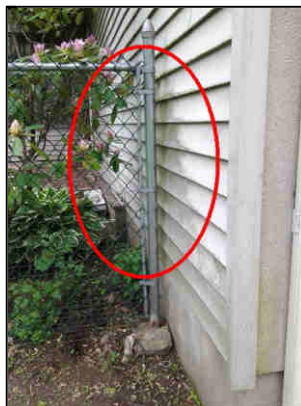
1.0 Item 10(Picture)

(7) The siding is covered with algae. This side of the home appears to be in the shade and the air seems to hold humidity for algae to form. Vegetation in this area is overgrown and should be cut back to help siding remain dry. I recommend monitoring and cleaning.

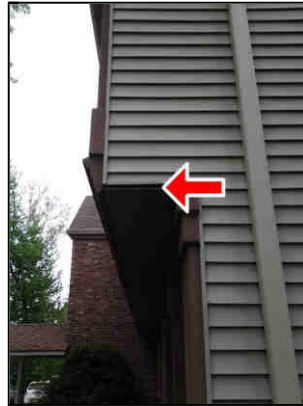
1.1 Item 1(Picture)

(1) A gap between the siding and soffits exists. The gap should be sealed to prevent vermin, moisture and insects from getting past the siding to enter the interior spaces of the home.

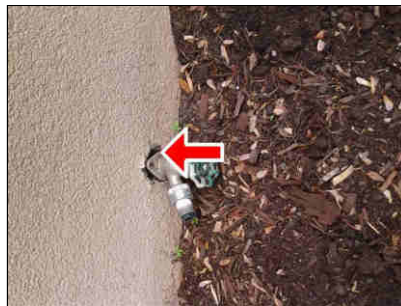
1.2 Item 1(Picture)

The hole where spigot water supply pipe passes through foundation should be caulked to prevent the ingress of vermin, insects and moisture.

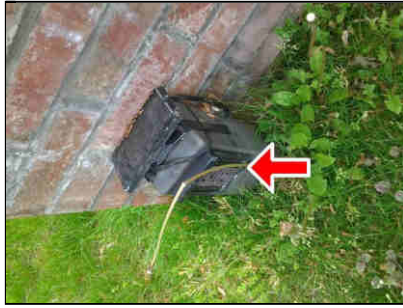
1.3 Item 1(Picture)

Outlet cover plate loose or broken, moisture penetrating outlet and electric box. Repair or replace outlet cover plate for safety.

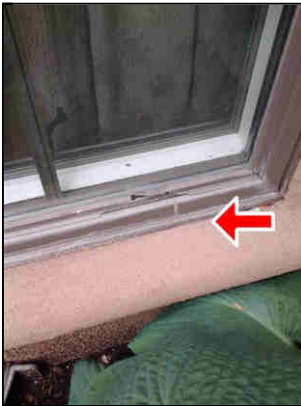
1.5 Item 1(Picture)

(1) The caulk between the window frame trim and siding is deteriorated. Unless repaired the gap between the frame and trim may let moisture and insects past siding to interior spaces. Repair recommended to prevent the ingress of moisture and insects.

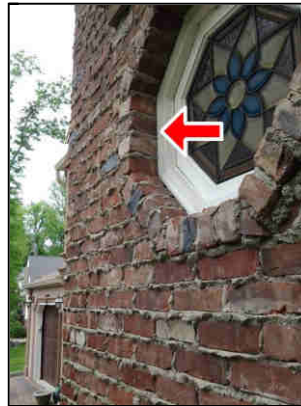
1.5 Item 6(Picture)

(2) Gaps between brick veneer and window frames/sills present. Caulk and seal cracks and gaps to prevent the ingress of moisture, vermin and insects to the interior spaces of the home.

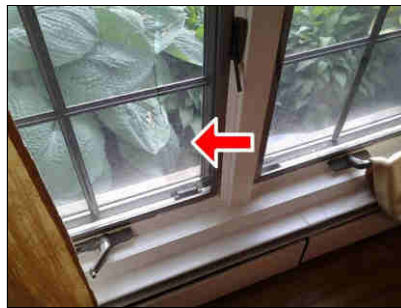
1.5 Item 7(Picture)

(3) Window screens torn in some windows. Replacement needed to prevent the ingress of insects.

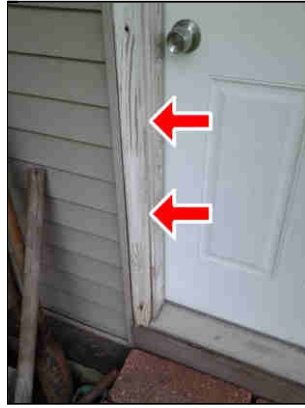
1.6 Item 1(Picture)

(1) The door trim/frame is peeling paint. Further deterioration of paint, wood and trim may occur if not repainted/repaired. I recommend a qualified contractor inspect and repair as needed.

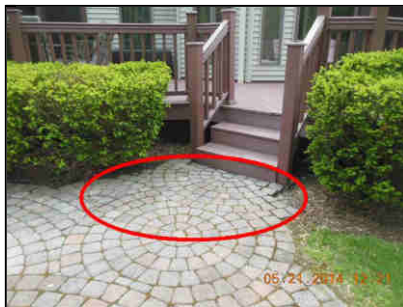
1.8 Item 1(Picture)

Backyard sidewalk block is uneven with gaps and settling at the edges. Trip hazards are present. Evaluation and repair by a qualified landscaper or qualified general contractor.

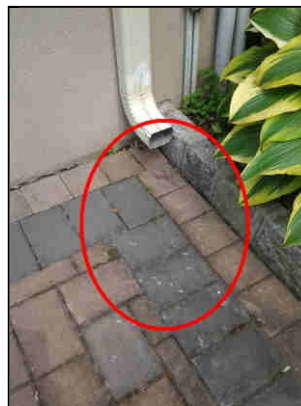
1.9 Item 1(Picture)

(1) Water from downspout discharges across driveway. Water on driveway can freeze in the winter causing slip and stumble hazards. Move downspout discharge point or install underground leaders to help prevent ice on driveway walk areas.

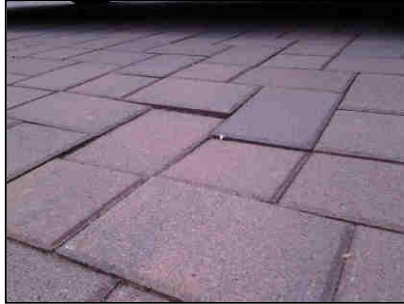
1.9 Item 2(Picture)

(2) Driveway block is uneven in front of the garage entrances. Trip hazards are present. Evaluation and repair by a qualified contractor.

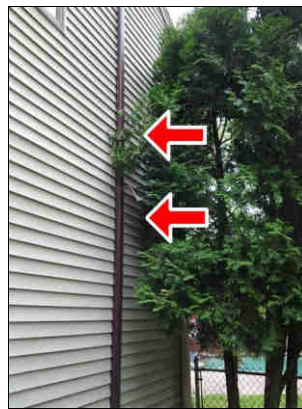
1.10 Item 1(Picture)

Vegetation should be kept 4 to 6 inches away from foundation and siding. Vegetation can cause moisture build up against siding and/or mechanical damage. Recommend cutting vegetation back or removal.

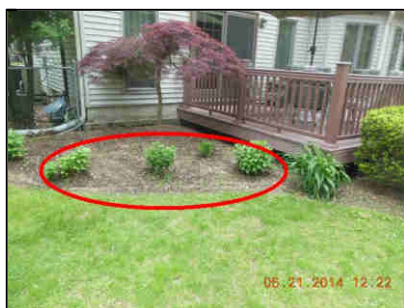
1.11 Item 1(Picture)

There appears to be neutral pitch of the earth in back of the home that may lead to puddling of rain water in the back yard area and against foundation, which can lead to moisture ingress into basement area. Regrading of the yard may be required to promote runoff and prevent rain from puddling in backyard area and against foundation. The addition of longer leaders to carry rain water away from foundation or underground leaders leading elsewhere would help carry rain water away from backyard and foundation area.

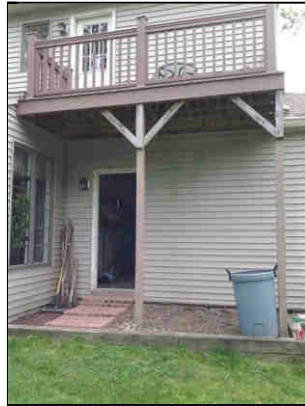
1.12 Item 1(Picture)

Dirt and debris should be removed from around balcony columns to expose tops of footings. Keeping column ends dry will prevent moisture buildup and rot of columns.

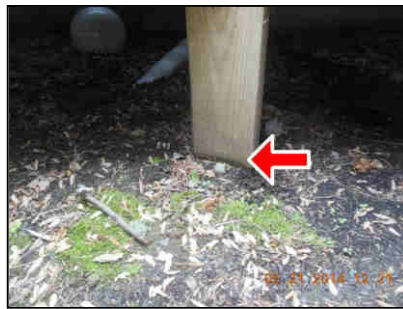
1.13 Item 1(Picture)

Dirt and debris should be removed from around deck columns to expose tops of footings. Keeping column ends dry will prevent moisture buildup and rot of columns.

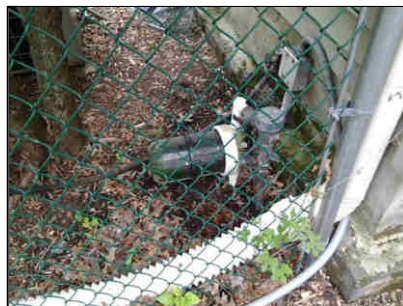
1.14 Item 1(Picture)

(1) The sprinkler system should be inspected by a qualified contractor to check the integrity and operation of controls, valves and sprinkler heads. If not in use the sprinklers should be drained and winterized to prevent damage. Any comments provided in this report about the sprinkler system are done so with the knowledge that I am not performing a sprinkler system inspection as part of my services.

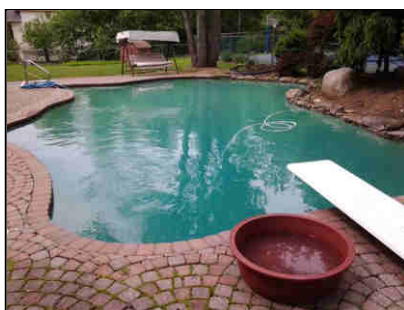
1.14 Item 2(Picture)

(2) The pool should be inspected by a qualified pool contractor to check the integrity of fences, liners, heaters, piping and filter equipment. Any comments provided in this report about the pool are done so with the knowledge that I am not performing a full pool inspection as part of my services.

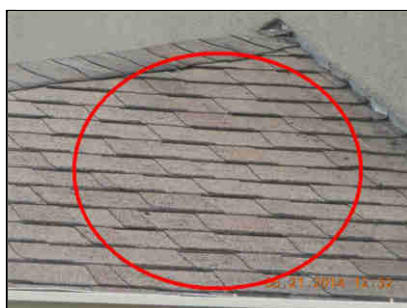
2.0 Item 1(Picture)

(1) The roof shingles are chipped and/or broken in several places. The shingle protective grit surface is beginning to deteriorate, the shingles have a pitted look. The roof needs repair in areas to help prevent leakage. Repair recommended by a qualified roofing contractor.

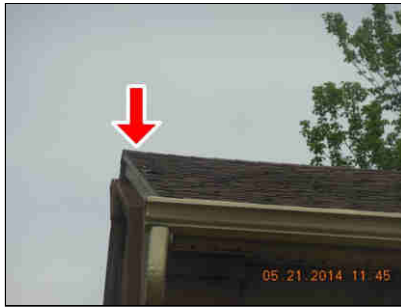
2.0 Item 6(Picture)

(2) Several fasteners are popped up under the shingles of the roof's surface. These fasteners should be driven back down before they puncture through the overlaying shingle, shortening the life of the shingles and causing leakage. I recommend evaluation and repair by a qualified roofing contractor.

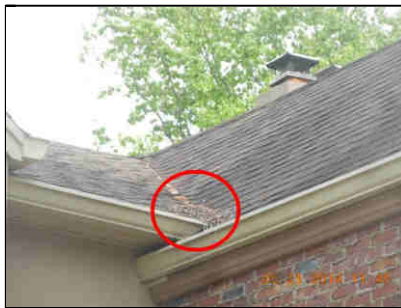
2.0 Item 7(Picture)

(3) Low angle of roof has trapped debris. Debris is trapping moisture against roof surface and clogging gutters causing undesired flow of rain water from roof. Clean debris to prevent moisture damage (leakage, rot and mold) and to allow the easy drainage of rain water. Cleaning the debris from the roof should be part of the annual lawn and garden maintenance and cleanup.

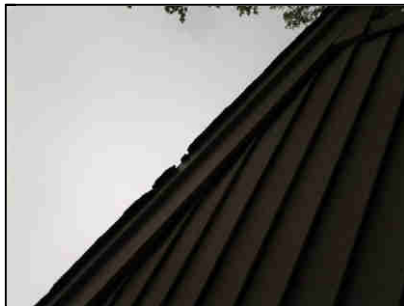
2.0 Item 8(Picture)

(4) Shingles are chipped and/or broken in along the roof edge. Water normally flowing down the roof surface may drip behind eave boards/trim and penetrate past shingles to damage roof sheathing and interior spaces. Shingle repair/replacement recommended to prevent leakage.

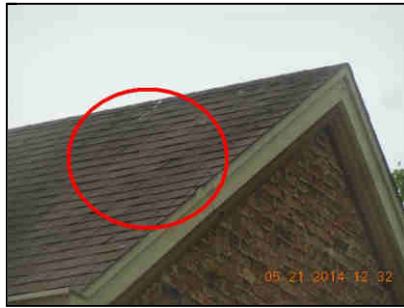
2.0 Item 11(Picture)

(5) Moss growth on roof surface present. Moss will trap moisture against roofing and siding to cause deterioration of shingle surfaces and eventual leakage. Cleaning and repair recommended by a qualified roofing contractor.

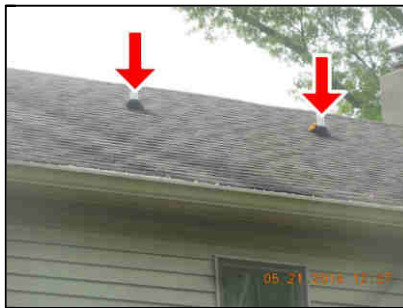
2.2 Item 1(Picture)

The rubber flashing around the plumbing vents are cracked and have holes. The flashing around the plumbing vents needs repair or replacement by a qualified roofing contractor to prevent leakage to attic and interior spaces of home.

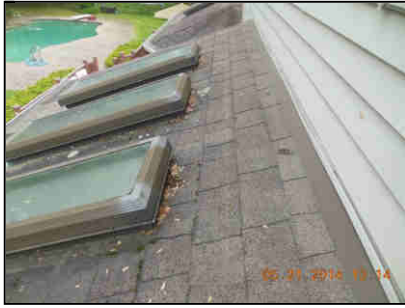
2.3 Item 1(Picture)

The seal between the double pane glass (or plexiglass) has ruptured causing moisture build-up and clouding between the layers. Window will continue to leak and cloud further unless replaced. Evaluation and repair or replacement recommended by a qualified window contractor.

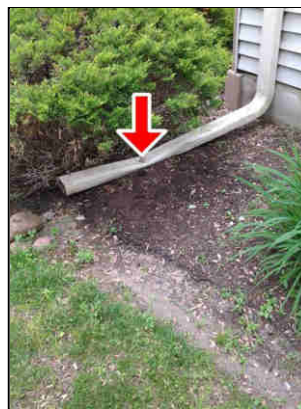
2.4 Item 1(Picture)

(1) Leaders are crushed and may clog. Gutters may overflow and drain/splash against foundation in rain storms. Puddling water against foundation may leak into basement causing moisture damage. Leader replacement is recommended.

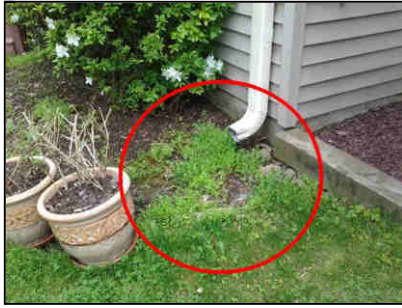
2.4 Item 2(Picture)

(2) Drainage around downspout and leader appears to puddle against foundation. Puddling against foundation can cause damage to structure and leakage into basement or crawlspace areas. Recommend regrading earth around structure and/or extending leaders to carry rain water further from foundation area.

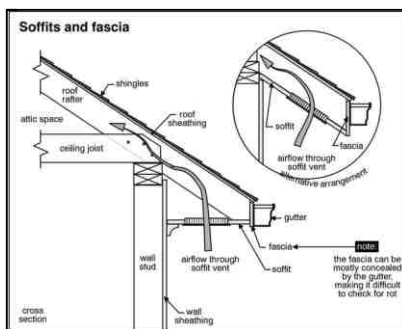
2.5 Item 1(Picture)

The gap where the rafters meet the joists should be left open all the way around the attic to help the interior soffit areas ventilate. Insulation removal recommended by a qualified contractor.

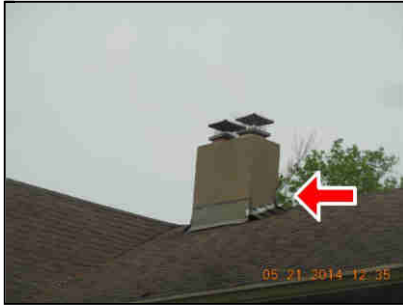
2.6 Item 1(Picture)

The chimney flashings are loose and have gaps where moisture may enter and leak into the attic and interior spaces of home. Flashing repair recommended by a qualified roofing contractor or masonry contractor.

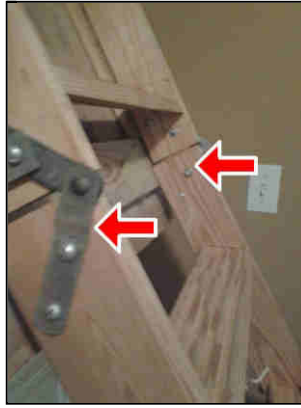
2.8 Item 2(Picture)

(2) Pull down ladder hardware loose. Recommend re-tightening all the hardware on the pull down ladder for stability and safety.

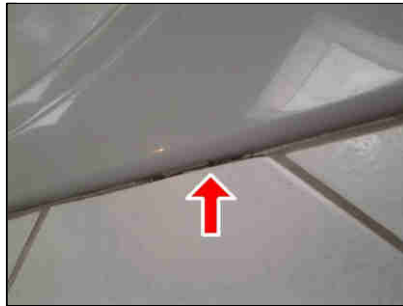
4.5.A Item 1(Picture)

Caulking between wall and spa surround area tile loose and missing. Repair caulking to help prevent the ingress of damage and mold causing moisture behind wall and into spa cabinet areas.

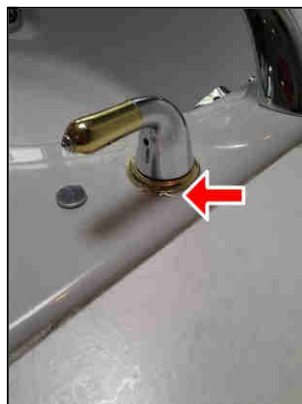
4.6.A Item 1(Picture)

Tub and shower control valves are leaking from the stems when operated. Moisture from leaking valve stems can find its way past valve trim to penetrate wall space. Repair valves to prevent the buildup of moisture and mold behind walls. Evaluation and repair recommended by a licensed plumber.

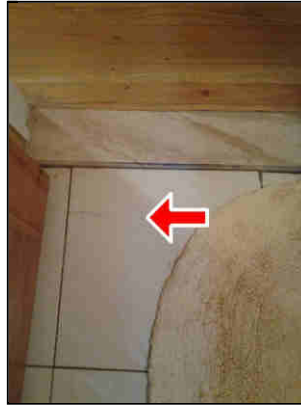
4.2.C Item 1(Picture)

The floor tile is cracked. Moisture may pass through cracks to damage the subfloors. Evaluation and repair recommended by a qualified tile floor contractor.

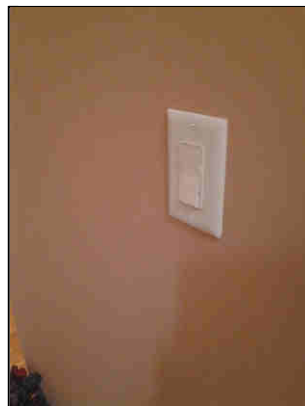
5.7.E Item 1(Picture)

Front Entrance - Either one of the "two-way" switches is broken and needs repair or the hallway lamp is installed with 2 switches that are not wired as a true "two-way" switch set up. The downstairs switch must be turned on for the upstairs switch to turn the hall light on or off. When the downstairs switch is off the lamp glows dimly when the upstairs switch is turned on. Evaluation and repair by a licensed electrician is recommended to make either switch turn the upstairs hall light on or off.

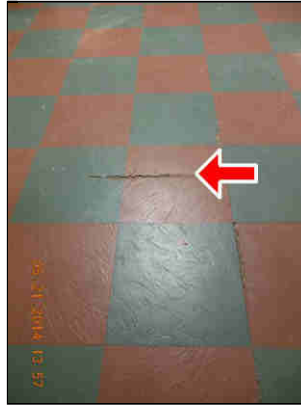
5.2.F Item 1(Picture)

Floor tiles are damaged in places. Repair recommended by a qualified contractor.

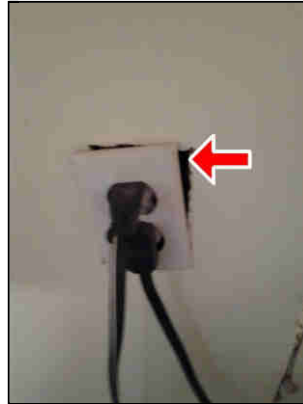
7.5 Item 1(Picture)

The outlet is loose. Electrical issues are considered a hazard until repaired. A qualified licensed electrician should perform repairs that involve wiring.

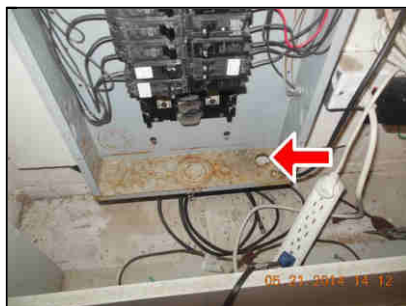
8.1 Item 1(Picture)

Wiring knockout missing, the hole should be plugged for electrical and fire safety.

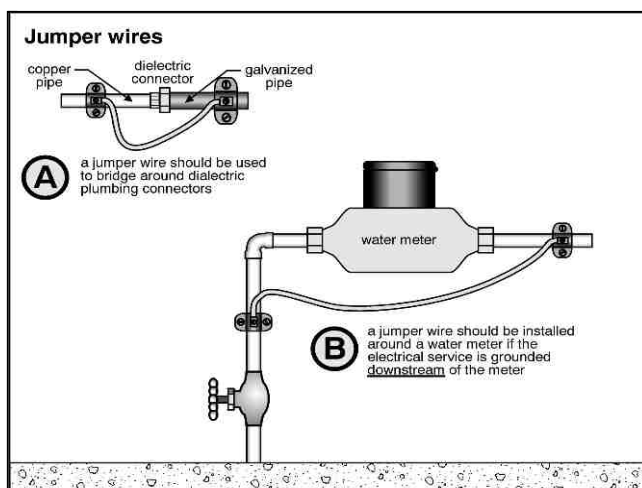
9.0 Item 1(Picture)

The ground wire is missing from around the water meter. Installation of a ground wire recommended by a qualified contractor for electrical safety.

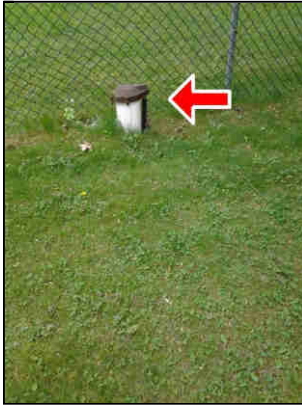
9.2 Item 1(Picture)

It is beyond the scope of the home inspection to test the well water quality, determine the location of the well head or evaluate the well performance. I recommend that the well operation and well water quality be inspected and evaluated by a qualified well inspection contractor.

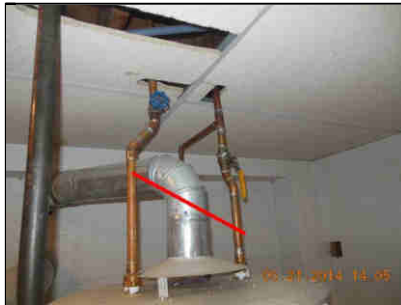
9.4 Item 1(Picture)

(2) The "bonding" wire for the hot to cold water pipes at the hot water is disconnected or missing. If the bond wire is not reattached an electrical shock hazard may become present on all the hot water piping in the home if the hot water piping were to come in contact with active electrical wiring. I recommend the installation of a bond wire by a licensed electrician.

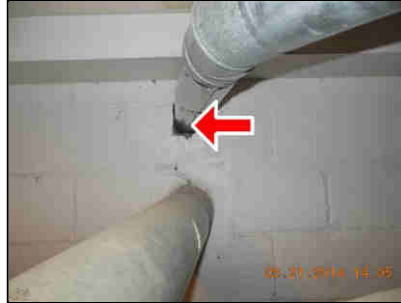
10.2 Item 1(Picture)

The mortar that seals the appliance vent pipe to the chimney is loose and missing. The open gaps between the vent pipe and chimney may leak poisonous carbon monoxide and hot flue gas into the interior spaces of the home. Improper connections between the appliance flues and chimney flue may result in the chimney needing to be lined. A fire and safety issue are present, evaluation and repair recommended by a qualified chimney contractor.

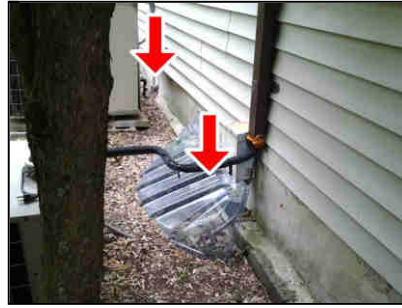
10.3 Item 3(Picture)

(3) The foam sleeve is missing from refrigerant lines near the condenser. Condensation will form on the cold copper surfaces potentially wicking past the exterior siding to damage interior spaces of the home. The missing foam sleeve may also effect cooling efficiency. Have foam sleeve repaired by a qualified contractor to help prevent moisture damage to home.

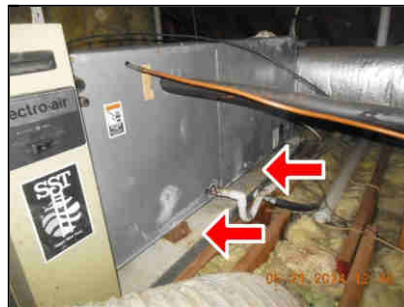
10.3 Item 4(Picture)

(4) Attic - Both Evaporators - The primary drip pan located inside the AC evaporator cabinet is leaking AC condensate water into the secondary drip pan. I recommend that the primary AC evaporator drip pan and drain be repaired to prevent leakage into the secondary (backup) drip pan. Failure to repair the primary evaporator drip pan may eventually lead to the secondary drip pan clogging and leaking AC condensation water into the interior spaces of home. Recommend evaluation and repair by a qualified HVAC technician.

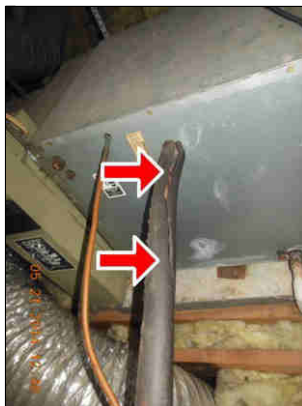
10.3 Item 6(Picture)

(5) The AC refrigerant line near the evaporator in the attic is missing its foam sleeve insulation. While the AC system is running, condensation may collect on the exposed copper tubing. Some of the condensation may be wicking between the the copper pipe and foam, flowing to a lower elevation located away from the evaporator and drip pan to a break in the foam sleeve. The condensation may leak from the break in the sleeve onto the attic flooring, attic insulation and interior ceiling. Recommend re-insulating the refrigerant line up to the opening in the AC evaporator to prevent condensation from forming on the cool cooper lines.

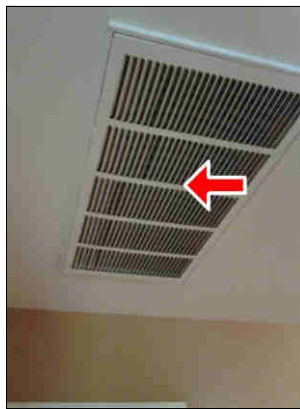
10.7 Item 1(Picture)

(1) The disposable filter is dirty. The filter needs to be replaced. Air filters in furnaces should be replaced somewhere between once a month and twice a year depending upon local conditions.

After you first move in, recommend inspecting every two weeks during heating or cooling season. If filter does not appear dirty then wait longer to check for dust build up. You will eventually figure out how often to change filter. If you can see dust on the filter, it is probably worth changing or cleaning. A totally clogged filter will cause the HVAC system to run inefficiently.

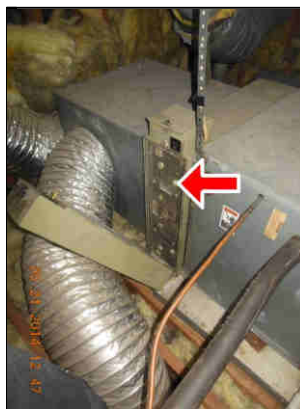
10.7 Item 2(Picture)

(2) After you first move in, recommend inspecting every two weeks during heating or cooling season. If filter does not appear dirty then wait longer to check for dust build up. You will eventually figure out how often to clean the electronic filter. If you can see dust on the filter, it is probably worth changing or cleaning. A totally clogged filter will cause the AC system to run inefficiently.

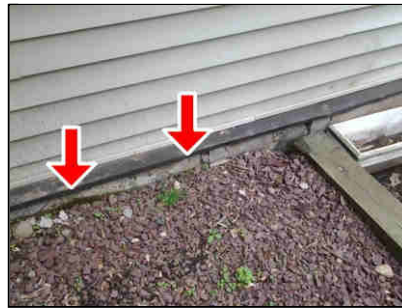
11.0 Item 1(Picture)

(2) Parging is cracked and loose around foundation exterior. Loose parging tends to deteriorate quicker due to exposure to moisture and thermal expansion. Repair parging to prevent excessive flaking.

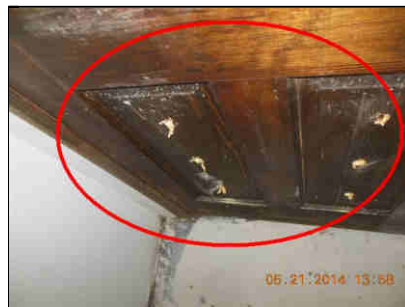
11.2 Item 1(Picture)

No vents present in the closet against the foundation wall. Holes drilled in the door are ineffective for ventilation. Dampness from foundation walls will cause high levels of humidity in enclosed spaces against the foundation. Lack of ventilation can lead to the buildup of humidity and mold in closet areas. Recommend installing louvered doors or vents to help vent and minimize humidity.
