Home Inspection Report

Multi-Family Report

Address

All In One Home Inspection LLC

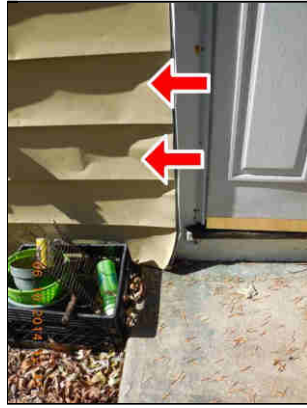
1.0 Item 1(Picture)

(1) The Aluminum siding is damaged from impacts. I recommend repair by a qualified contractor in order to prevent damage causing insects, vegetation and moisture from entering behind siding.

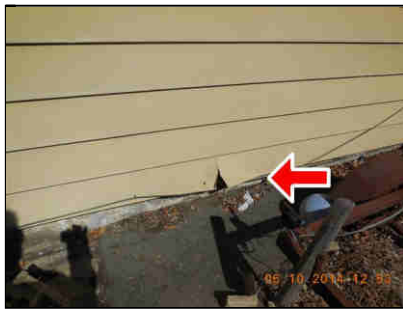
1.0 Item 3(Picture)

- 🏠 (3) The hole in siding needs closing off with sealant or liquid foam where compressor lines enter the building to prevent the ingress of moisture, insects and vermin.

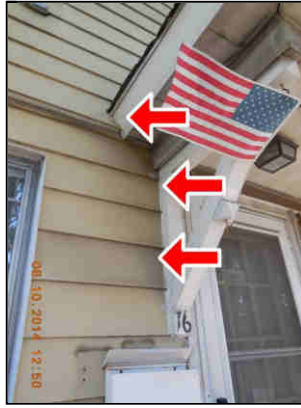
1.0 Item 5(Picture)

- 🏠 (4) Gaps between siding and trim should be caulked or sealed to prevent insects, vermin and moisture from entering past siding to interior spaces of home. Repair recommend by a qualified person.

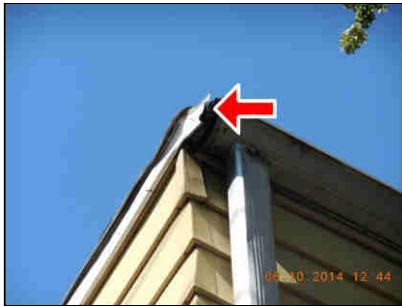
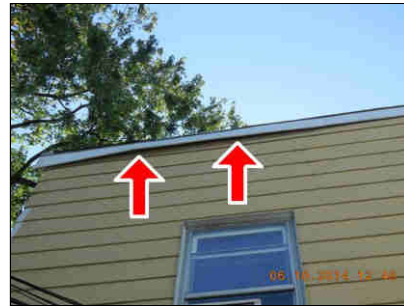
1.1 Item 1(Picture)

The eave trim is loose. Refasten trim to prevent ingress of moisture and insects to interior spaces.

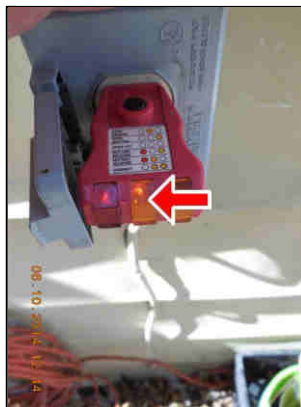
1.3 Item 1(Picture)

Outlet is reverse polarity. This is considered a safety hazard until repaired. Repair recommended by a licensed electrician.

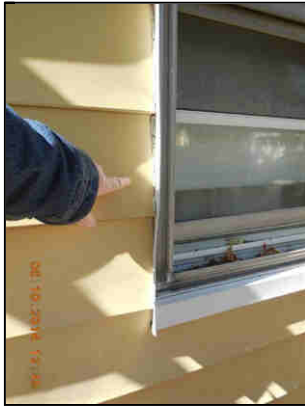
1.5 Item 1(Picture)

(1) Gaps between the siding and window frames/sills present. Caulk and seal cracks and gaps to prevent the ingress of moisture, vermin and insects.

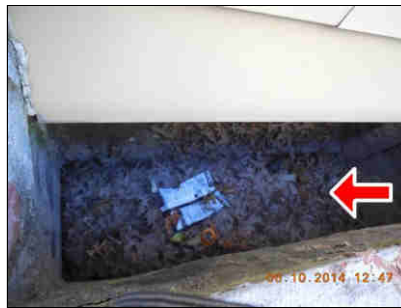
1.5 Item 4(Picture)

(2) Dirt and debris are piled against the window. Debris can trap moisture against window that may leak into basement. Debris may harbor insects that attack the wood frames or sill joists around windows. I recommend removing debris around the window.

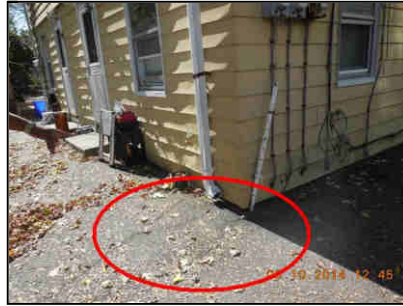
1.10 Item 1(Picture)

Water from downspout discharges across driveway. Water on driveway can freeze in the winter causing slip and stumble hazards. Move downspout discharge point or install underground leaders to help prevent ice on driveway walk areas.

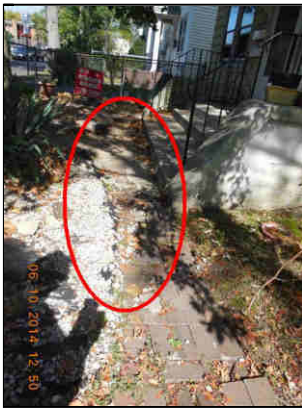
1.12 Item 1(Picture)

(1) There is a negative slope of the walk in the front that puddles water. I recommend correcting the slope of the walk to drain water away. Repair by a qualified contractor.

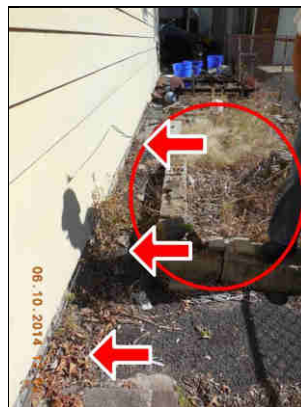
1.12 Item 4(Picture)

(2) Several areas have a neutral or negative grade towards foundation. Rain water in these areas will run along foundation, pocket and/or puddle against foundation resulting in leakage to the basement area. I recommend regrading and improving drainage by a qualified irrigation and landscaping contractor to carry rain water away from siding and foundation.

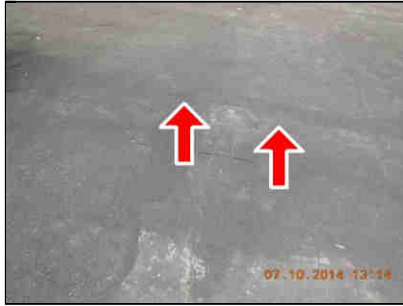
2.0 Item 6(Picture)

(2) Open gaps and cracks at seams of roll roofing are prone to the ingress of moisture. Seal and patch gaps to prevent the ingress of damage causing moisture to attic and interior spaces of home.

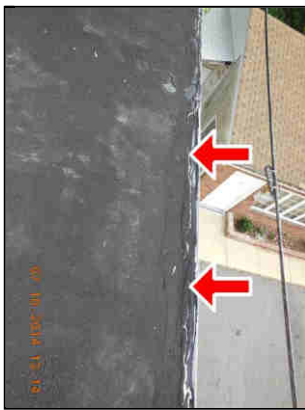
2.1 Item 1(Picture)

The asphalt patch over the roof flashing is cracked and may be prone to leaking. I recommend repair by a qualified chimney contractor.

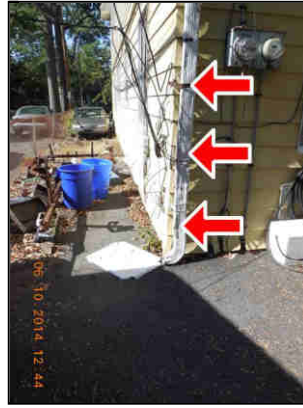
2.4 Item 1(Picture)

(1) Downspouts are crushed and may clog. Gutters may overflow and drain/splash against foundation in rain storms. Puddling water against foundation may leak into basement causing moisture damage. Downspout repair is recommended.

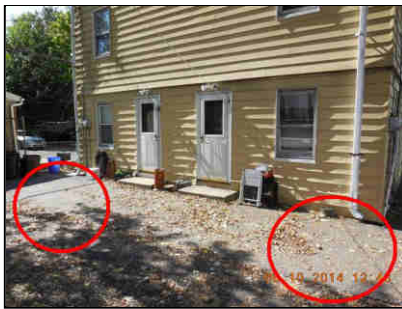
2.4 Item 2(Picture)

(2) Drainage around downspout and leader appears to puddle against foundation. Puddling against foundation can cause damage to structure and leakage into basement or crawlspace areas. Recommend regrading earth around structure and/or extending leaders to carry rain water further from foundation area.

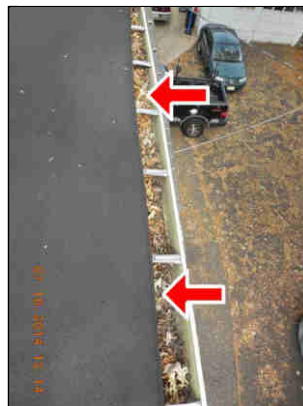
2.4 Item 4(Picture)

(3) The gutters are full of debris in areas and needs to be cleaned. Debris in gutters are blocking downspouts, causing gutter overflows and rain splatter onto siding and foundation. Cleaning of gutters is recommended to prevent unwanted water damage to exterior and interior of home. Consider installing gutter guards to help prevent build up of debris in gutters.

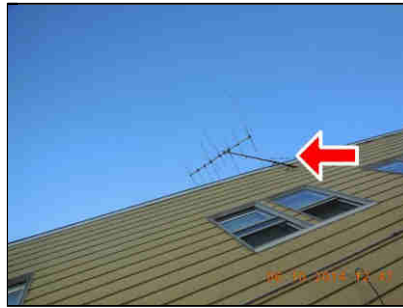
2.5 Item 1(Picture)

(1) An abandoned antenna mast is present attached to the side of the home. The mast is bent and broken. The mast should be removed before it damages roof and chimney.

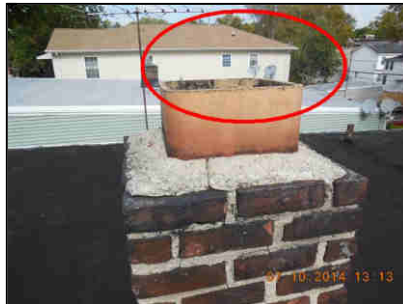
2.5 Item 2(Picture)

(2) Consider installing a flue cap to prevent the ingress of moisture, debris and vermin.

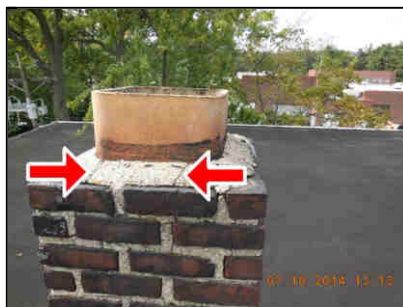
2.5 Item 4(Picture)

(3) The concrete chimney cap is cracked. The cracked chimney cap may let moisture enter the cavity between the chimney wall and flue pipe. Moisture in the chimney can damage bricks, block, mortar and flue pipe. I recommend patching cracks in cap or replacing cement cap to prevent deterioration of chimney.

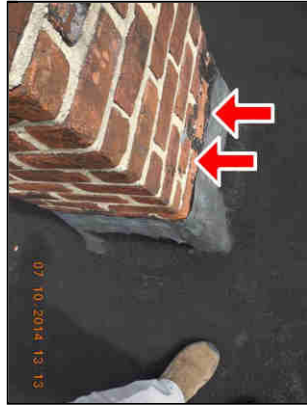
2.5 Item 6(Picture)

(4) The chimney flashing is loose and has gaps where moisture may enter and leak into the attic and interior spaces of home. Flashing repair recommended by a qualified roofing contractor or masonry contractor.

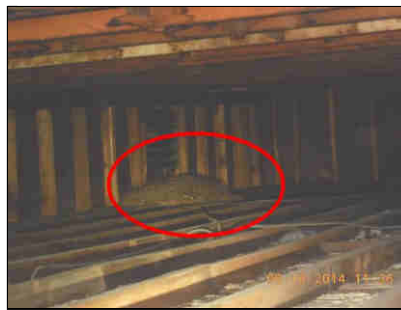
2.7 Item 1(Picture)

(1) Vermin nests present in attic under gable vents. I recommend cleaning out nests for health and safety. Vents may need repair to help prevent moisture leakage.

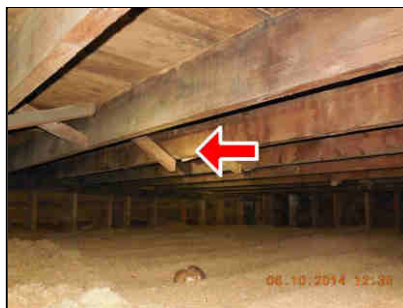
2.7 Item 2(Picture)

(2) Cross-bridging is loose and missing in several places. Loose cross-bridging can lead to twisting joints. I recommend a qualified contractor refasten the cross bridging on the roof rafters.

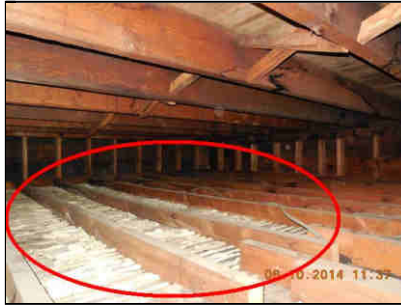
2.9 Item 1(Picture)

Attic insulation is missing between ceiling joists in the right side attic. For best operating efficiency of the heating and cooling systems insulation should cover the ceilings of the living spaces in the home. I recommend the installation of insulation in attic spaces.

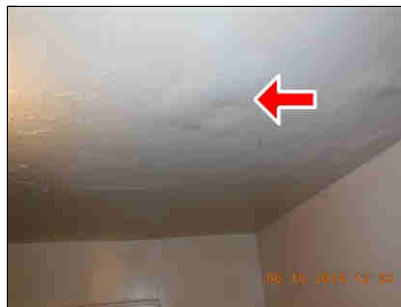
3.0 Item 1(Picture)

Ceiling damaged from moisture penetration. The roof appears to have leaked on the ceiling in various places at one time. The ceilings appeared dry at time of inspection. Repair recommended by a qualified contractor.

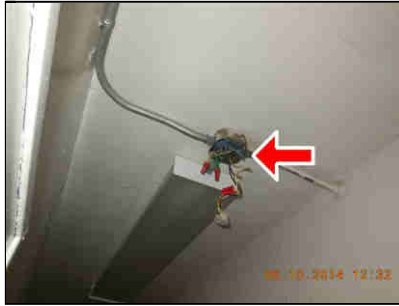
3.7 Item 1(Picture)

(1) Cover plate missing from junction box. Exposed wiring present. Replace cover plate for electrical safety.

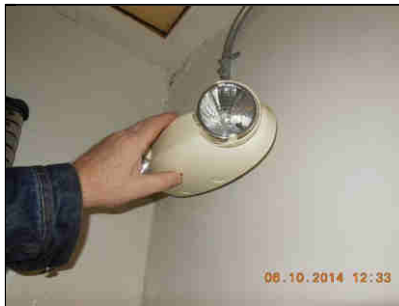
3.7 Item 2(Picture)

(2) The emergency light was inoperative at time of inspection. Repair recommended for building safety.

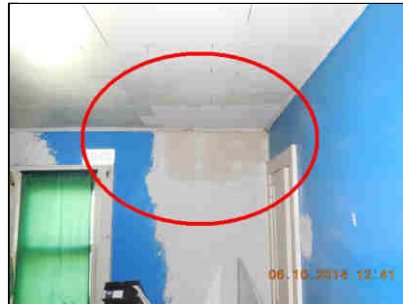
4.1.A Item 1(Picture)

Stains and moisture damage present on the ceilings from moisture leakage past the roof and flashings in the rear of the home. Some repairs to the ceiling area were noted. The ceilings were dry at time of inspection. Repair recommended by a qualified contractor.

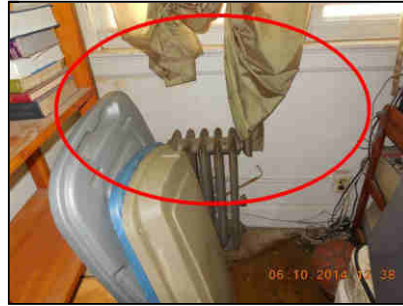
4.2.A Item 1(Picture)

Stains and moisture damage present on the walls from moisture leakage past the roof and flashings in the rear of the home. Some repairs to the ceiling area were noted. The ceilings were dry at time of inspection. Repair recommended by a qualified contractor.

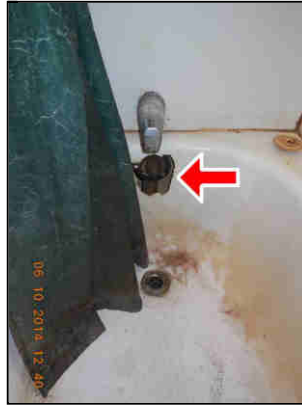
4.17.A Item 1(Picture)

The bathtub has a hole near the overflow that will pass moisture with every bath or shower. The tub needs replacement by a qualified contractor.

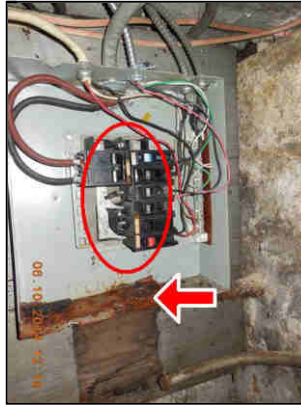
4.25.A Item 1(Picture)

Rust is present in the bottom of the electrical panel. Corrosion is present on the circuit breakers and wire connections. The moisture source is typically leakage from outside at the mast head, service wire entrance at the meter box or the meter box enclosure cover. Repair of the moisture leakage source and clean up of the corrosion in the enclosure is recommended by a licensed electrician.

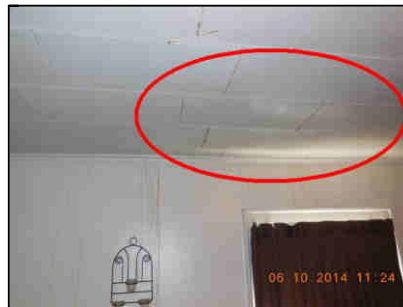
4.16.B Item 1(Picture)

Stains and moisture damage present on the ceilings from moisture leakage past the roof and flashings in the rear of the home. Some repairs to the ceiling area were noted. The ceilings were dry at time of inspection. Repair recommended by a qualified contractor.

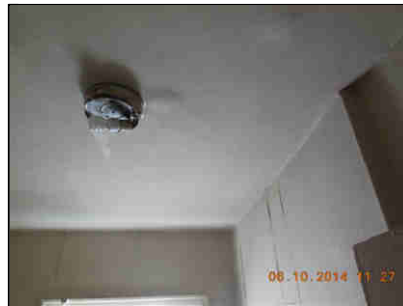
4.26.B Item 1(Picture)

The ceiling is damaged from exposure to high humidity from the bath and a lack of ventilation. A ceiling exhaust fan should be installed and the ceiling painted with an antibacterial paint.

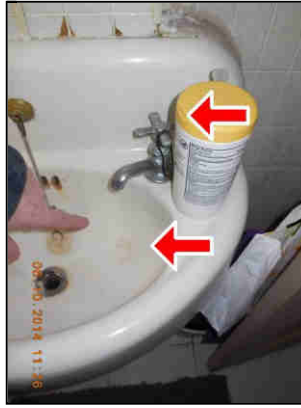
4.32.B Item 1(Picture)

Sink faucet is dripping. The flow of water will not shut off. Repair valves to prevent unwanted dripping of water and to prevent possible sink overflows from accidental sink clogging.

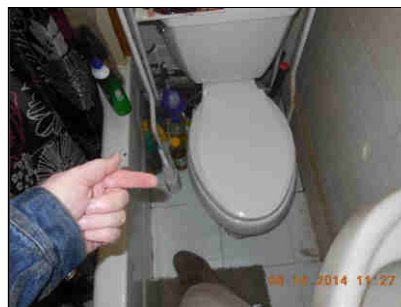
4.33.B Item 2(Picture)

(2) The toilet is loose at floor at the bath. Repairs may involve re-setting the toilet on a new wax seal. I recommend a qualified licensed plumber repair or correct as needed.

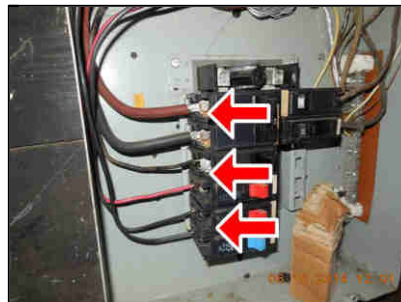
4.41.B Item 2(Picture)

(2) Rust is present in the bottom of the electrical panel. Corrosion is present on the circuit breakers and wire connections. The moisture source is typically leakage from outside at the mast head, service wire entrance at the meter box or the meter box enclosure cover. Repair of the moisture leakage source and clean up of the corrosion in the enclosure is recommended by a licensed electrician.

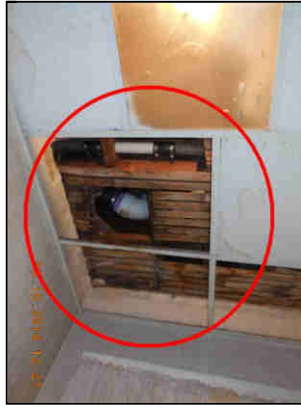
4.26.C Item 1
(Picture)

The ceiling is damaged from leakage in the overlying bathroom. The ceilings appeared dry at time of inspection. Ceilings need repair by a qualified contractor.

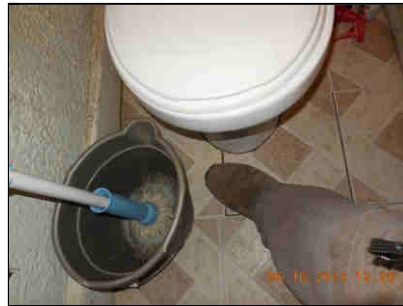
4.28.C Item 1(Picture)

The bathroom subfloors appear soft and rotted near tub, sink cabinet and toilet. The subflooring will probably need replacement to be able to apply new bathroom flooring.

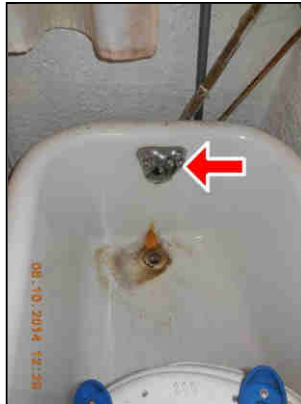
4.33.C Item 1
(Picture)

The tub stopper hardware is not working or missing. Repair or replacement recommended by a qualified contractor.

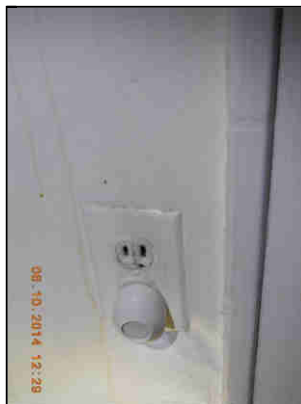
4.34.C Item 1
(Picture)

I recommend having Ground Fault Circuit Interrupter (GFCI) outlets installed by an electrician for electrical safety when working around the home's exterior.

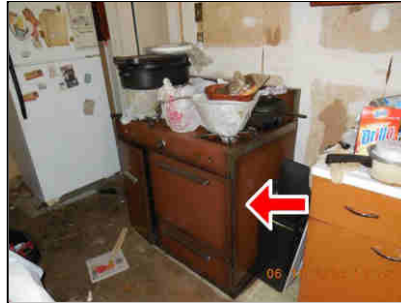
4.10.D Item 1(Picture)

The range and oven appears inoperative at time of inspection. The range/oven needs replacement by a qualified contractor.

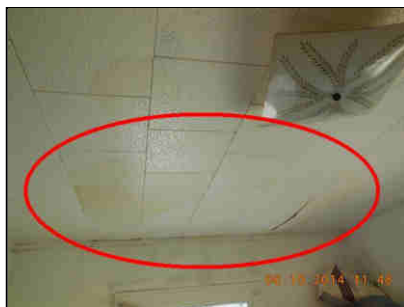
4.16.D Item 1(Picture)

Stains and moisture damage present on the ceilings from moisture leakage past the roof and flashings in the rear of the home. Some repairs to the ceiling area were noted. The ceilings were dry at time of inspection. Repair recommended by a qualified contractor.

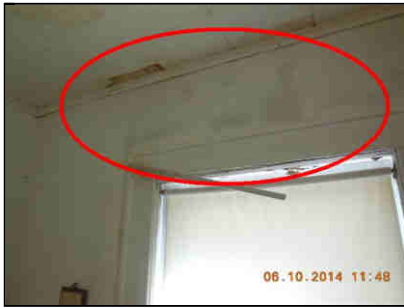
4.17.D Item 1(Picture)

Stains and moisture damage present on the walls from moisture leakage past the roof and flashings in the rear of the home. The walls were dry at time of inspection. Repair recommended by a qualified contractor.

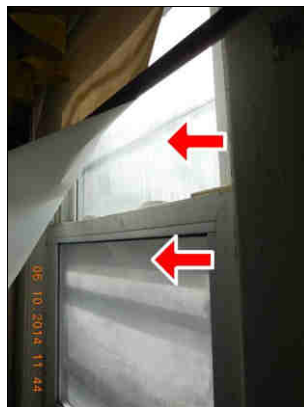
4.20.D Item 1
(Picture)

Seals between double pane windows have broken, moisture present obscuring view from windows. Repair of windows is recommended by a qualified window contractor.

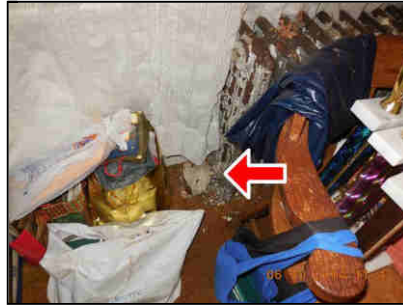
4.23.D Item 1(Picture)

Corrosion around the radiator valve is a sign that the valve is leaking. Repair recommended by a qualified contractor.

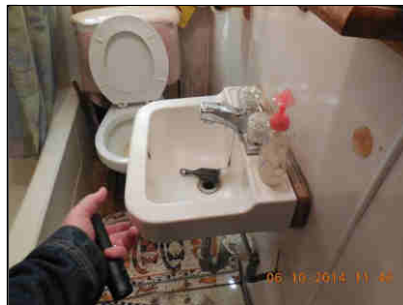
4.32.D Item 1(Picture)

(1) The sink basin is loose on the wall. Secure sink basin to the wall to prevent drain leakage and for safety.

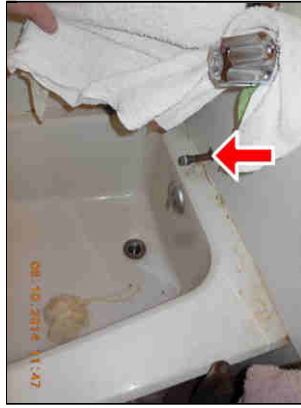
4.32.D Item 2
(Picture)

(2) The spigot is missing. The bath and shower is unusable until replaced by a plumber.

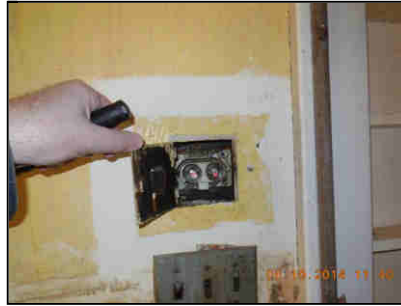
4.41.D Item 1(Picture)

A fuse panel is present for protecting house circuits. Although not illegal, fuse boxes are considered outdated and should be replaced with a circuit breaker panel. The fuse boxes appear to have no electrical protection for the home owner from shock hazards when fuses need changing, fuse sockets and wiring connections are all exposed to touching. I recommend changing fuse panels to modern updated circuit breaker panels.

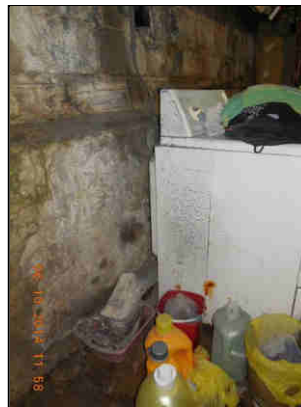
5.2 Item 1(Picture)

(1) Vinyl duct should be replaced with rigid or flexible metal duct. The spiral vinyl duct tends to catch lint more easily and tends to catch fire more easily. Vinyl also becomes brittle with time and may crack which will leak lint, warm humidity and monoxide into the laundry area and home.
-

(2) The dryer vent line discharges humid warm air to laundry area and interior spaces of home. Warm humid air can lead to mold build up on laundry area surfaces. Repair the vent to discharge to the exterior.

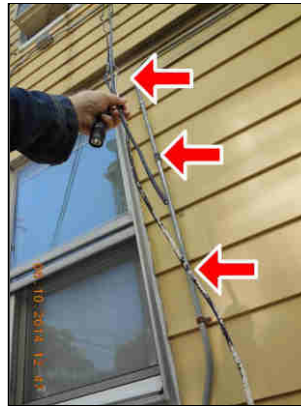
6.1 Item 1(Picture)

A communication wire has loosened from siding and hangs from roof. Reattach wire to guides and supports to help prevent accidental damage to wires from those maintaining and recreating on lawn.

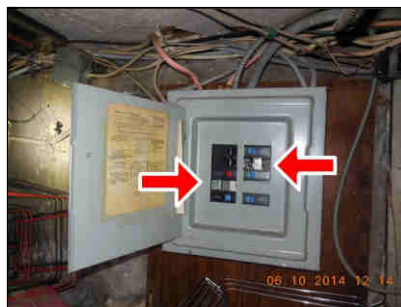
6.2 Item 1(Picture)

Circuit breaker "knock-outs" missing where breakers may have been installed. Tools and fingers may come in contact with electrically active circuits though the holes. Breaker blanks, which will cover the circuit breaker holes in the panel, should be installed for electrical safety.

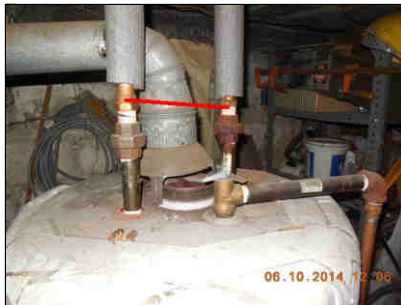
7.4 Item 1(Picture)

(2) The "bonding" wire for the hot to cold water pipes at the hot water is disconnected or missing. If the bond wire is not reattached an electrical shock hazard may become present on all the hot water piping in the home if the hot water piping were to come in contact with active electrical wiring. I recommend the installation of a bond wire by a licensed electrician.

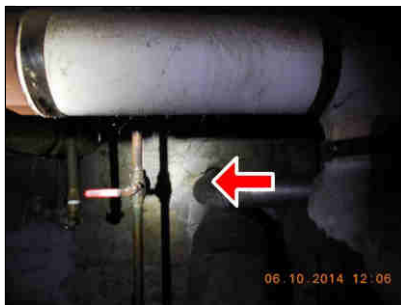
7.4 Item 2(Picture)

(3) The mortar where the flue enters the chimney is cracked and missing. Monoxide may leak into the structure when the hot water heater is operated. Repair and seal mortar around flue and chimney for health and safety.

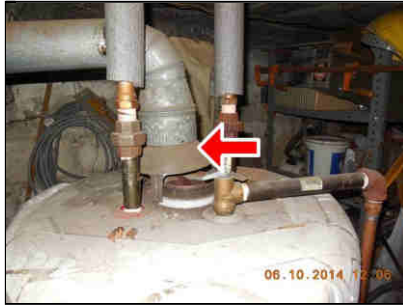
7.4 Item 3(Picture)

(4) The draft hood on the hot water heater should be fastened to the enclosure to prevent the exhaust flue from coming loose and venting poisonous dangerous carbon monoxide into the interior spaces of the home. Repair recommended by a licensed plumber for safety.

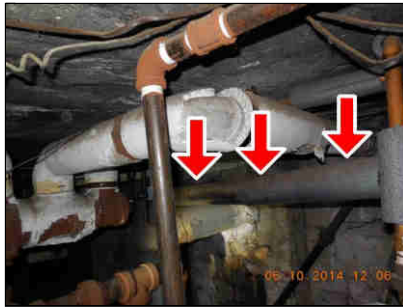
7.4 Item 4(Picture)

- 🏠 (5) The water heater vent pipe is pitched downward which may not allow an effective draft to build to vent the water heater exhaust gas. A buildup of dangerous monoxide gas in the home may result if this installation fails to vent to the chimney. This vent installation is considered a safety hazard until repaired. I recommend that the appliance vent be repaired by a licensed plumber.

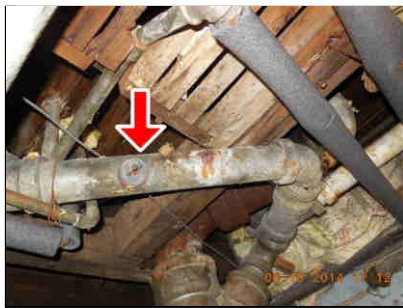
7.5 Item 1(Picture)

- 🏠 (1) Waste drain pipes have temporary plugs patching corrosion holes. Piping appears to be rusting from the inside out. Recommend evaluation and repair by a licensed plumber.

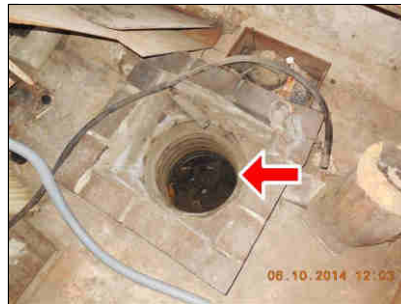
7.6 Item 1(Picture)

Water is present in the sump pit. Water in the sump pit is an indication that the soil around the foundation is moist. I could not tell at time of inspection if this was a high level, low level or normal level of moisture. I recommend the installation of a sump pump to keep moisture from overflowing the sump pit during rainy seasons, especially if the basement is finished.

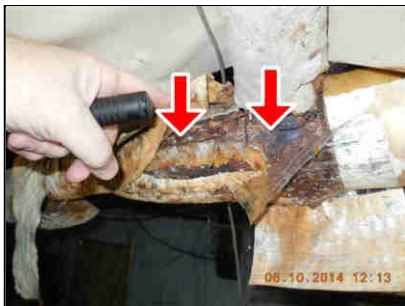
8.6 Item 2(Picture)

(2) Steam distribution piping in the basement has leaked and rusted through in several areas. Repair recommended by a qualified contractor to help prevent steam loss and equal distribution of heat when the system is operated.

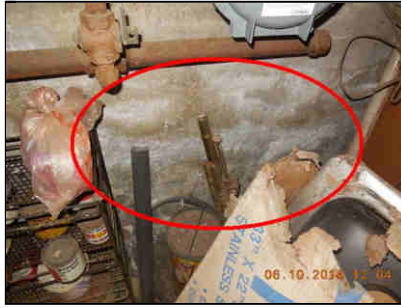
9.0 Item 1(Picture)

(1) White efflorescence (powder substance) on block wall indicates moisture is in contact with the masonry. This does not necessarily indicate that intrusion will occur. I recommend checking the gutters and the downspout drain lines for proper operation. Also, a water proofing paint could be applied to the interior side of the block if necessary. Efflorescence is found on many homes without water intrusion occurring inside the building. But, it should alert you to the possibility that future steps may be needed.

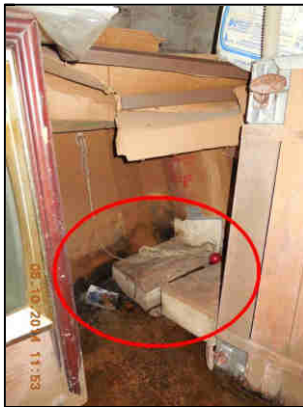
9.0 Item 2(Picture)

Leaders that carry rain water away from foundations, grading that slopes away from foundations, french drains, basement dehumidifiers, breathing spaces behind finished basement walls and moisture barriers between concrete slab and flooring can be used to help control humidity and moisture in basement areas.

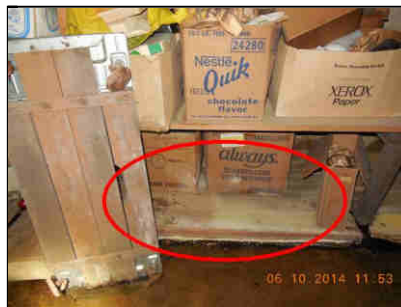
9.0 Item 3(Picture)

(2) Mold deposits present on stored items, walls and baseboard surfaces throughout lower basement area. We did not inspect, test or determine if this growth is or is not a health hazard. The underlying cause is moisture. I recommend that you consult with a mold remediation contractor to determine the best way to prevent further mold buildup in basement area.

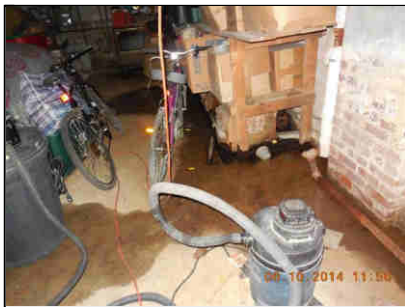
9.0 Item 7(Picture)

(3) Moisture puddles and efflorescence appear concentrated along the foundation where the local grading is pitched towards the foundation and the downspouts/leaders appear to be puddling against foundation. The local earth needs to be regraded to pitch away from the foundation. I recommend installing and/or extending leaders to help carry rain water and snow melt away from foundation. Installation of a french drains and a sump pump would also help with moisture control in the basement area. Regrading and installation of french drains recommended by qualified contractors.

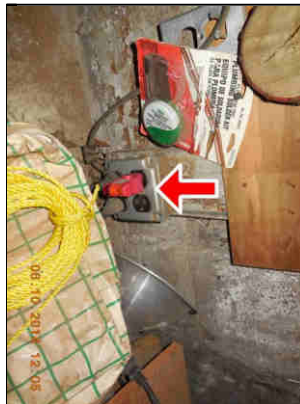
9.13 Item 1(Picture)

Outlets with three prongs have open grounds, this electrical hazard presents a safety issue to the occupants of the home, repairs are recommended. A qualified licensed electrician should perform repairs that involve wiring.

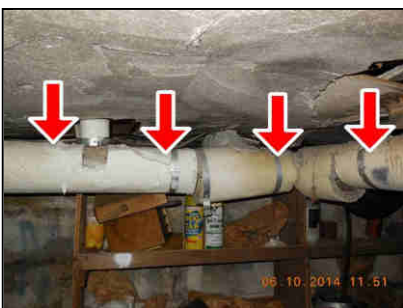
9.16 Item 1(Picture)

Suspected asbestos present on steam piping. Asbestos appears friable (crumbling). Asbestos is a health and safety concern. Recommend consulting with a qualified asbestos removal company for removal. To learn more about asbestos and living with asbestos fiber products in your home I recommend reviewing information at the Environmental Protection Agency's (EPA) web site: <http://www.epa.gov/asbestos/>
