Home Inspection Report

Town House Sample Report

All In One Home Inspection LLC

Joseph W Fleming III, PE, ACI - Home Inspector License 24GI00045600

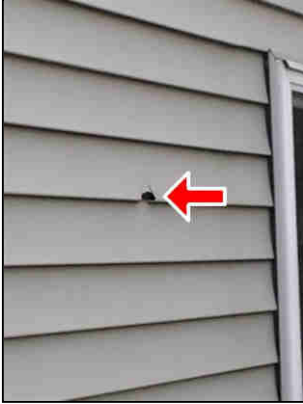
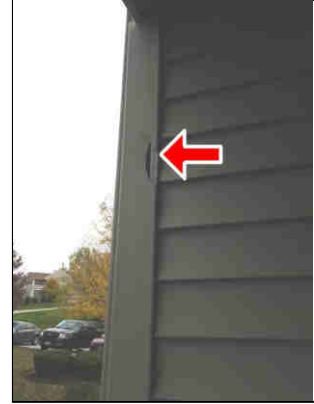
Siding damaged from impacts. I recommend repair in order to prevent insects, vegetation and moisture from entering behind siding. I recommend repair a qualified contractor.

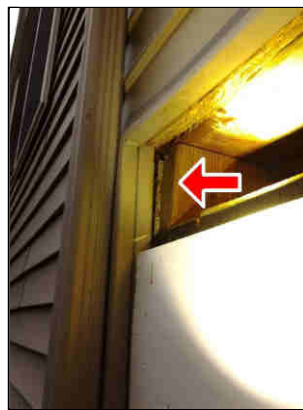
1.0 Item 5(Picture)

(3) A bees nest is present behind the siding under the deck. Dead bees were seen on several downstairs window sills suggesting that they are finding their way into the home. The bees nest needs to be exterminated and the holes sealed for safety and to help prevent their return.

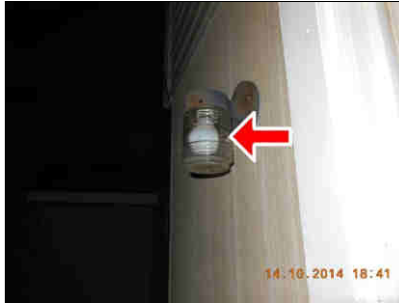
1.3 Item 1(Picture)

The light bulb needs replacement or the electric circuit needs repair. Recommend bulb replacement first, if the light does not illuminate then consult with a licensed electrician to evaluate and make repairs.

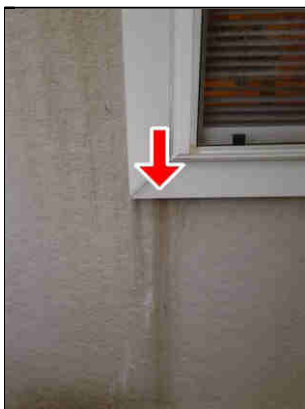
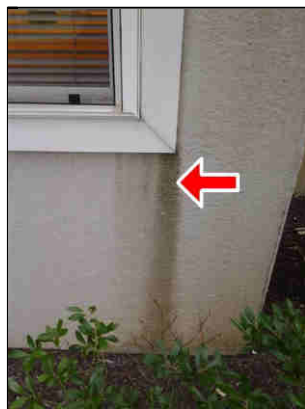
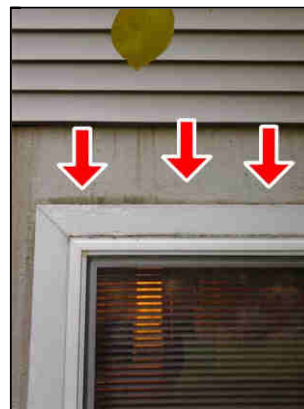
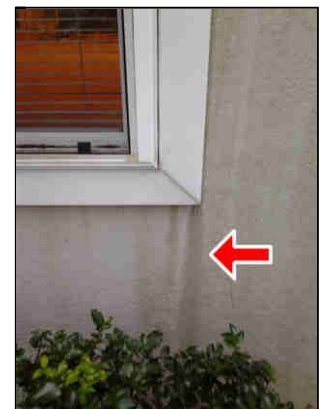
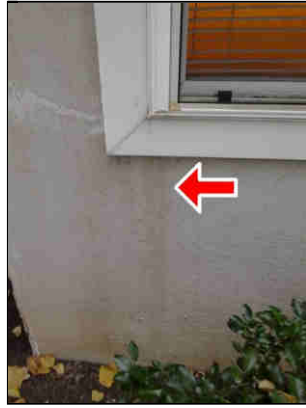
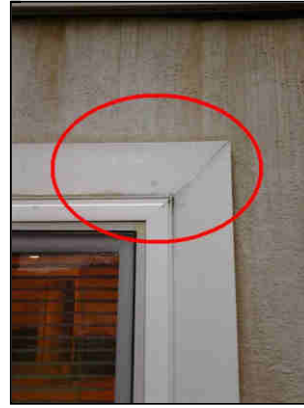
The windows in the foundation wall are leaking past their exterior trim. The windows appear to be missing their drip edge flashing. Moisture is seeping out from under the window trim at the exterior bottom. Moisture appears to seeping into the wall cavity to damage the interior walls and trim around the windows. Repair recommended by a qualified contractor.

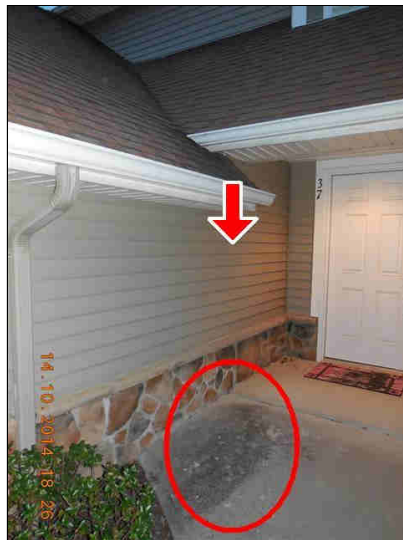
1.8 Item 1(Picture)

The cement front walkway is deteriorated and crumbling where moisture appears to splash and drip uncontrolled from the roof and gutters. Slip and trip hazards are present. The roof drainage and walkways need repair by a qualified contractor.

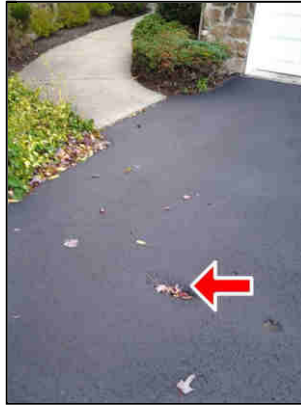
1.9 Item 1(Picture)

Holes are present in the driveway that are tripping hazards for those headed to the front walk. Repair recommended by a qualified contractor.

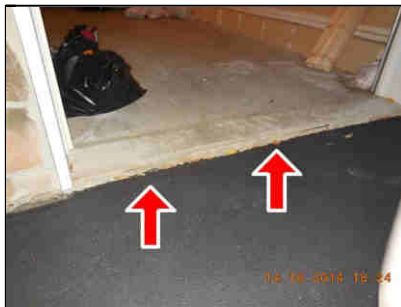
1.9 Item 2(Picture)

(2) The driveway in front of the garage has settled. A tripping hazard is present at the entrance to the garage. Repair recommended by a qualified contractor for safety.

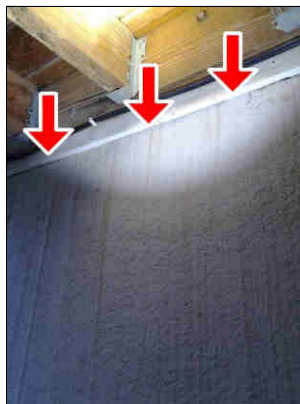
1.12 Item 1(Picture)

Moisture stains are present that from water leaking out from under the deck flashing suggesting that water is getting past the siding above the deck. Moisture may be entering the interior spaces of the home to cause damage to walls and interior surfaces. Repair recommended by a qualified contractor.

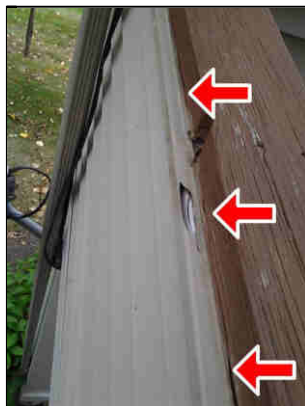
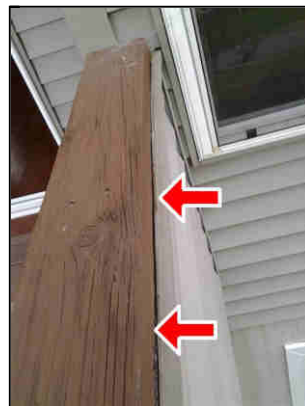
I recommend caulking gaps between the siding and railings help prevent moisture damage to balcony railings.

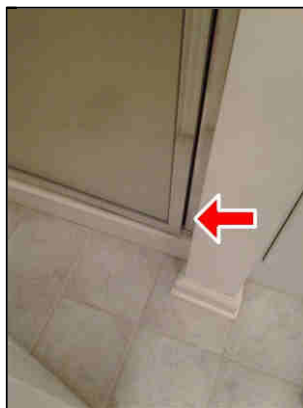
4.4.A Item 1(Picture)

The door is binding in the frame. The door not closing may cause moisture leakage into the bathroom. The door needs adjustment by a qualified contractor to open and latch closed without force.

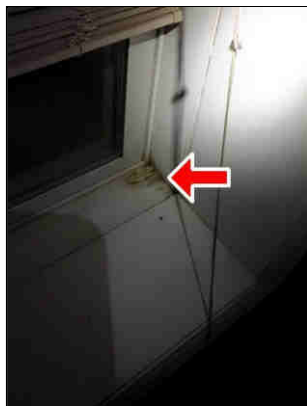
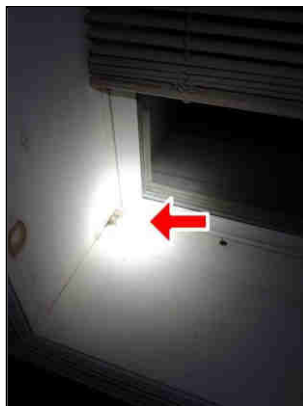
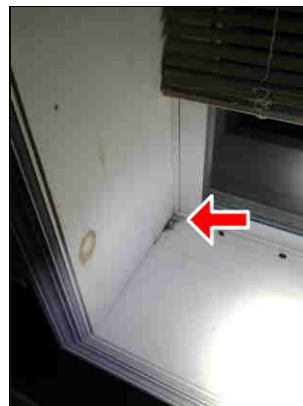
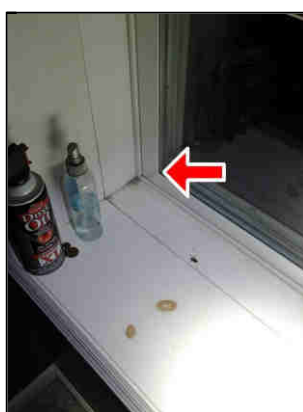
The windows in the foundation wall are leaking past their exterior trim. The windows appear to be missing their drip edge flashing. Moisture is seeping out from under the window trim at the exterior

bottom. Moisture appears to seeping into the wall cavity to damage the interior walls and trim around the windows. Repair recommended by a qualified contractor.

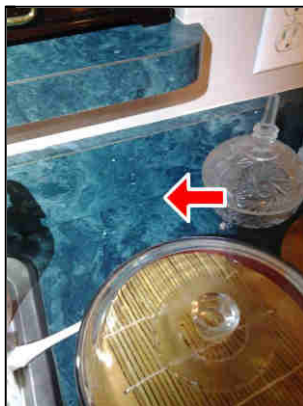
6.6 Item 1(Picture)

Caulking between wall splash and countertop loose and missing. Repair caulking to help prevent damage causing moisture ingress into cabinet space.

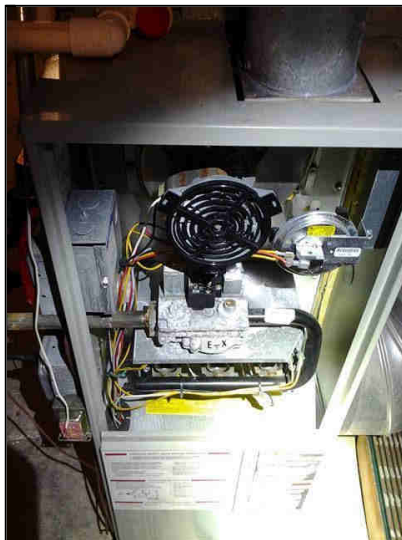
10.0 Item 1(Picture)

Corrosion in the furnace cabinetry suggest either evaporator leakage when the AC is operated or flue leakage from a damaged or missing flue cap. Recommend evaluation and repair by a licensed HVAC technician.

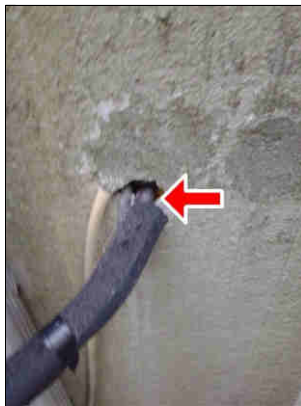
10.3 Item 1(Picture)

(1) The AC refrigerant lines pass through an open hole in the siding and/or foundation. Caulk holes to prevent the ingress of moisture, vermin and insects to interior spaces.

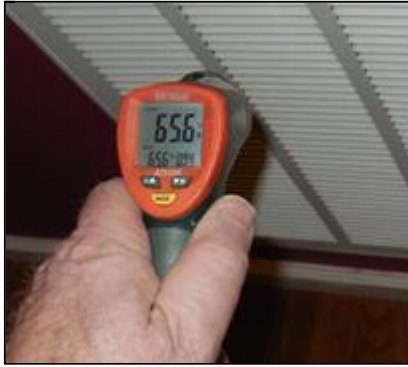
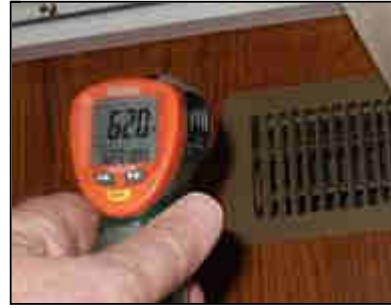
(2) When operating, the AC system changed (dropped) the temperature of the air from the return to the supply registers less than 5 degrees F. Generally a change of 15 degrees F or more is considered normal and ideal. The home may not stay cool on warm days. The AC system is in need of evaluation and repair by a qualified AC contractor.

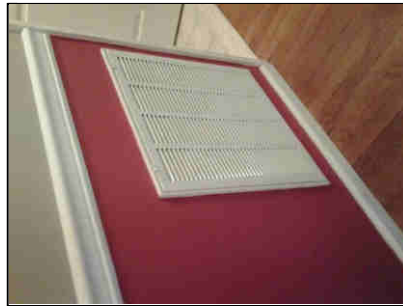
10.4 Item 1(Picture)

After you first move in, recommend inspecting every two weeks during heating or cooling season. If filter does not appear dirty then wait longer to check for dust build up. You will eventually figure out how often to change filter. If you can see dust on the filter, it is probably worth changing or cleaning. A totally clogged filter will cause the HVAC system to run inefficiently.

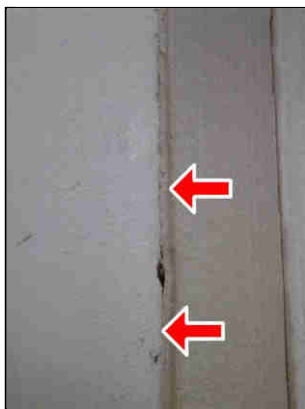
There are gaps and cracks in the sealant between section of the pre-cast foundation. The gaps will be prone to the ingress of moisture past the foundation unless repaired by a qualified contractor.
