# Inspection Report

Inspection Date: 1/1/2011

## Condo Sample

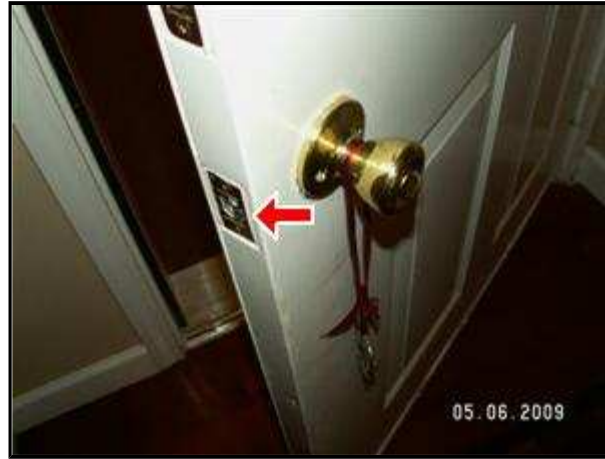
2.5 Picture 1

(1) The door latch sticks open causing the door to not latch or lock closed. The bolt probably needs lubrication to work properly. Otherwise evaluation and repair is recommended by a qualified person, door contractor or locksmith for security.

(1) The door latch sticks open causing the door to not latch or lock closed. The bolt probably needs lubrication to work properly. Otherwise evaluation and repair is recommended by a qualified person, door contractor or locksmith for security.

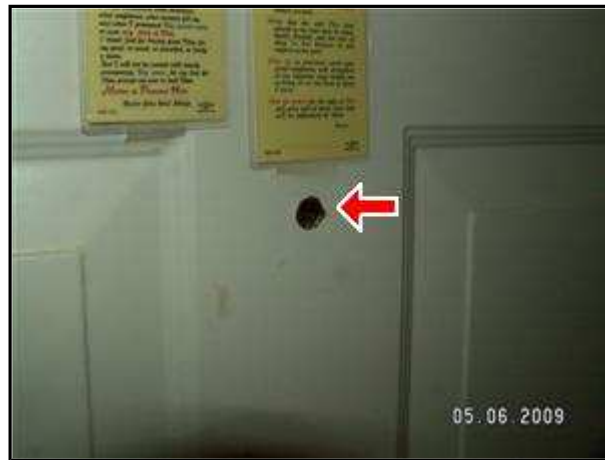
2.5 Picture 2

(2) The cover plate is missing from the "peep" hole viewer. Replace the cover plate for privacy and security.

(2) The cover plate is missing from the "peep" hole viewer. Replace the cover plate for privacy and security.

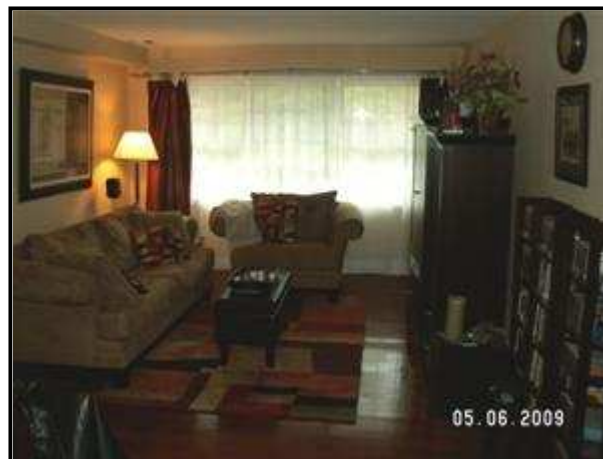
The living room floor is crowned towards the middle. Evaluation and repair by a qualified flooring contractor if desired. Get quotes from several contractors to understand estimated costs.

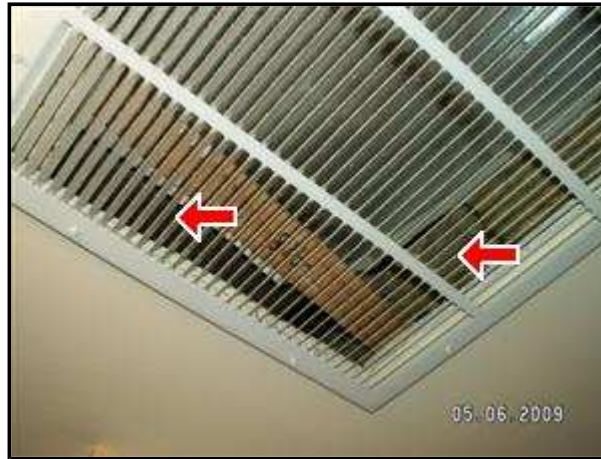
10.7 Picture 1

The return duct to the furnace is not attached at the intake register. The duct is drawing air from the interior spaces of walls and ceilings that contains dust, fiberglass, construction debris and other foreign contaminants. I recommend evaluation and repair by a qualified HVAC contractor.

The return duct to the furnace is not attached at the intake register. The duct is drawing air from the interior spaces of walls and ceilings that contains dust, fiberglass, construction debris and other foreign contaminants. I recommend evaluation and repair by a qualified HVAC contractor.
